Crash Reconstruction and Transportation Engineering Analysis

40-12724 (State v. Norris)

Kelly Palframan, Ph.D., P.E.

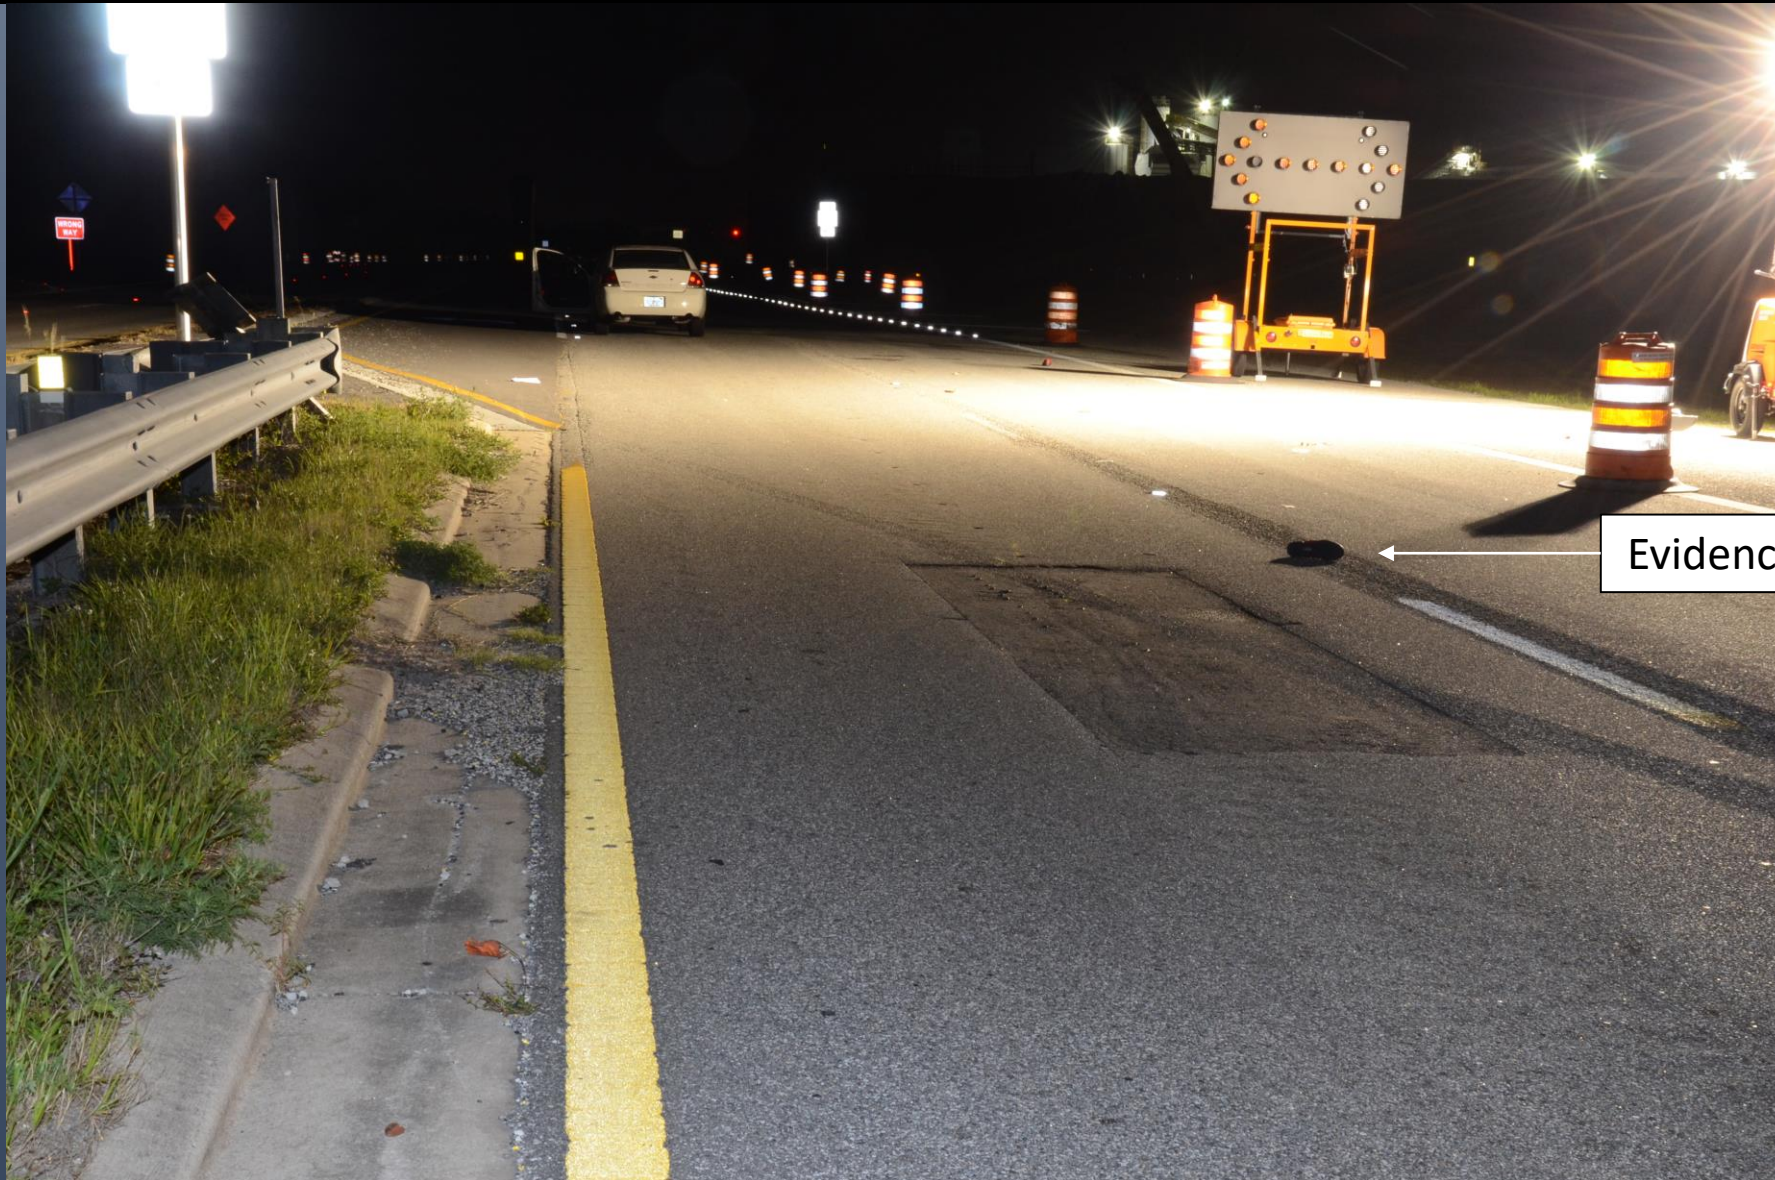
Evidence of Impact

- The first piece of evidence was found on the skip line approximately 78 ft north of Ms. Lucas's final rest.

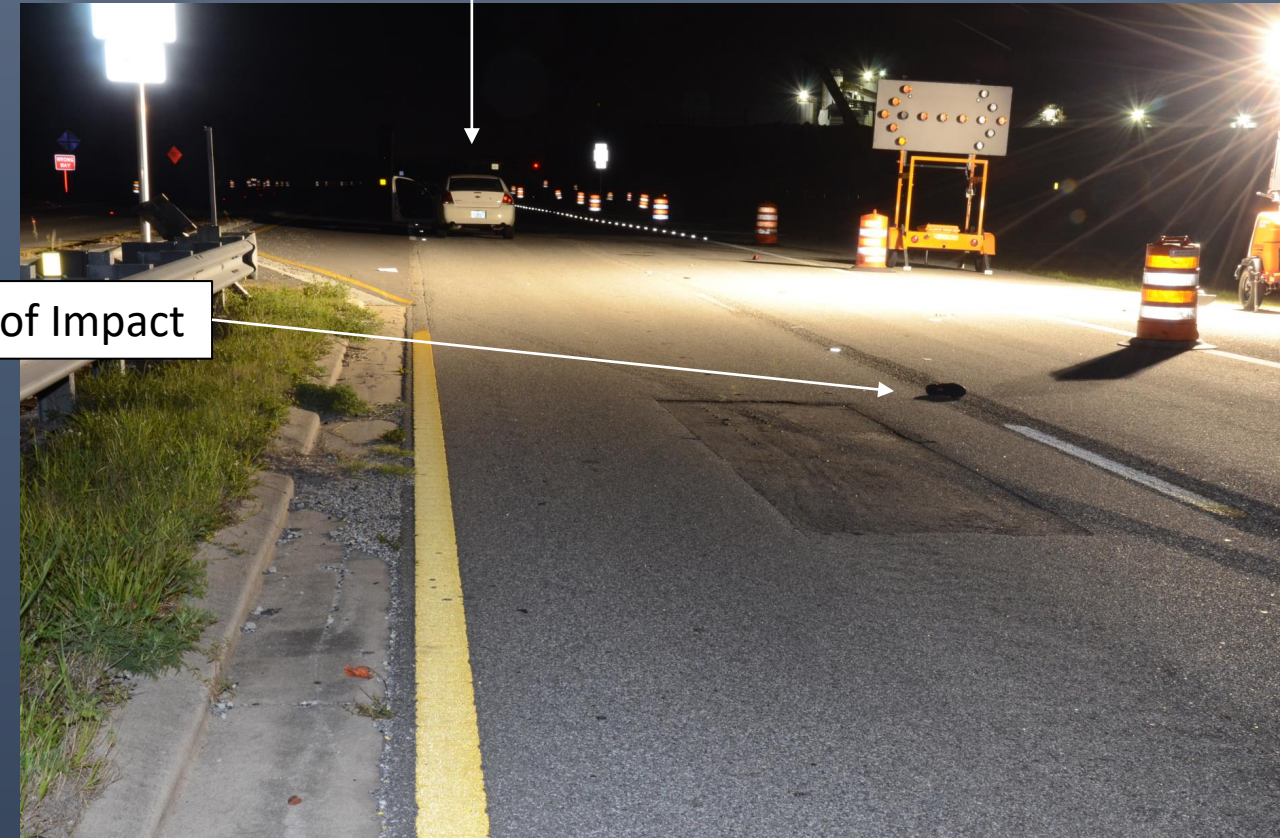
Chevy Impala at Rest

- There were no tire marks prior to impact and no tire marks from impact to the vehicle's rest position.

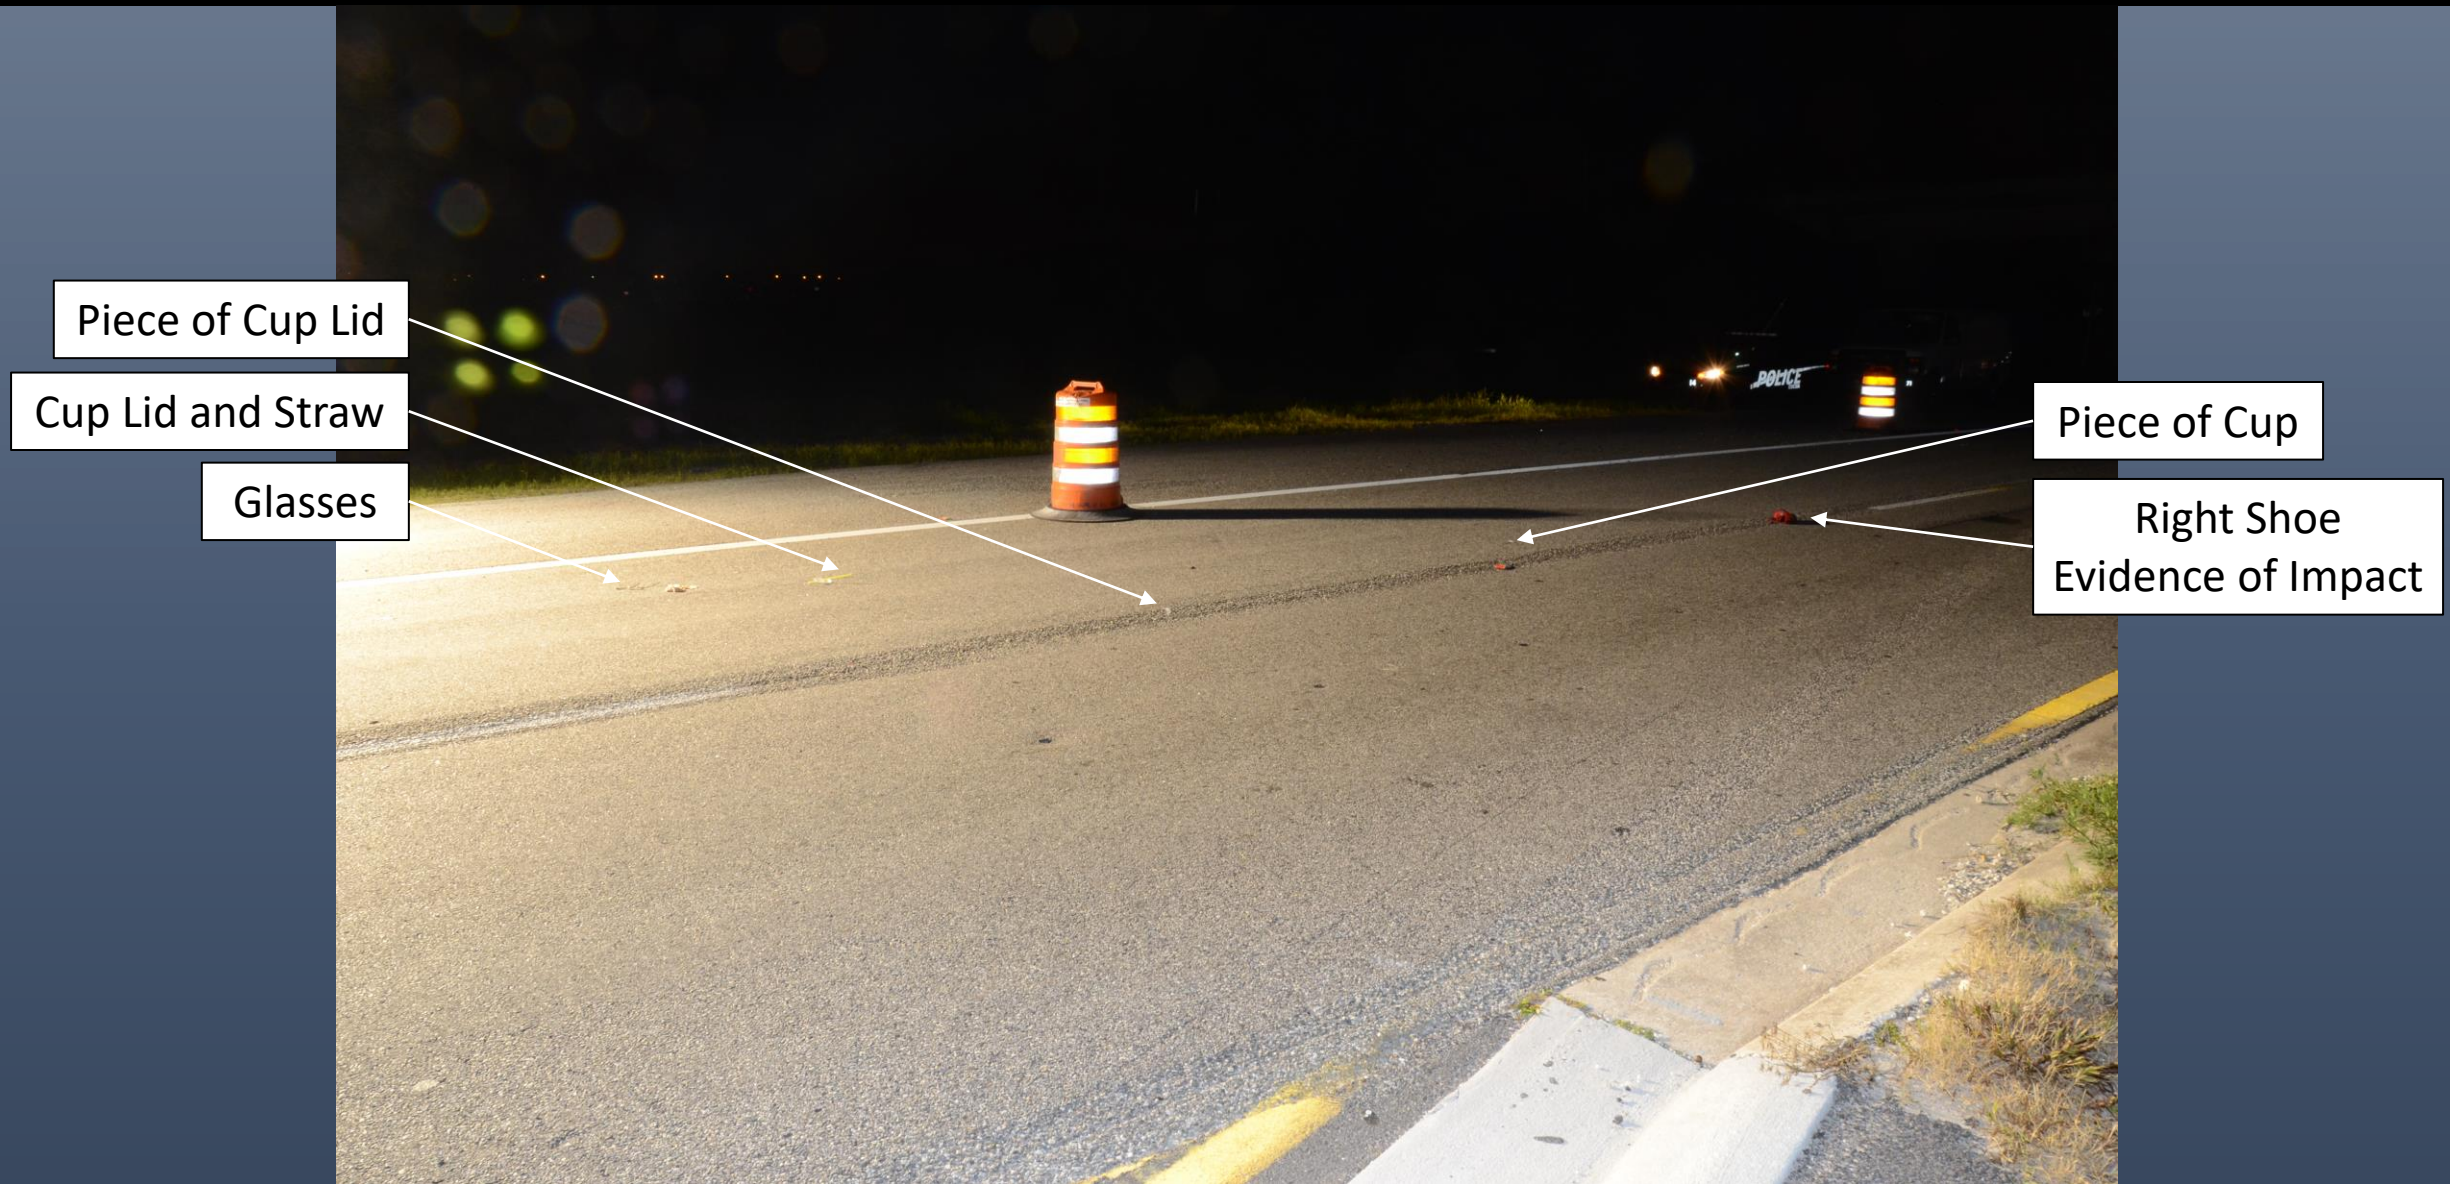
- Looking backwards towards impact.
- No visible tire marks after impact.

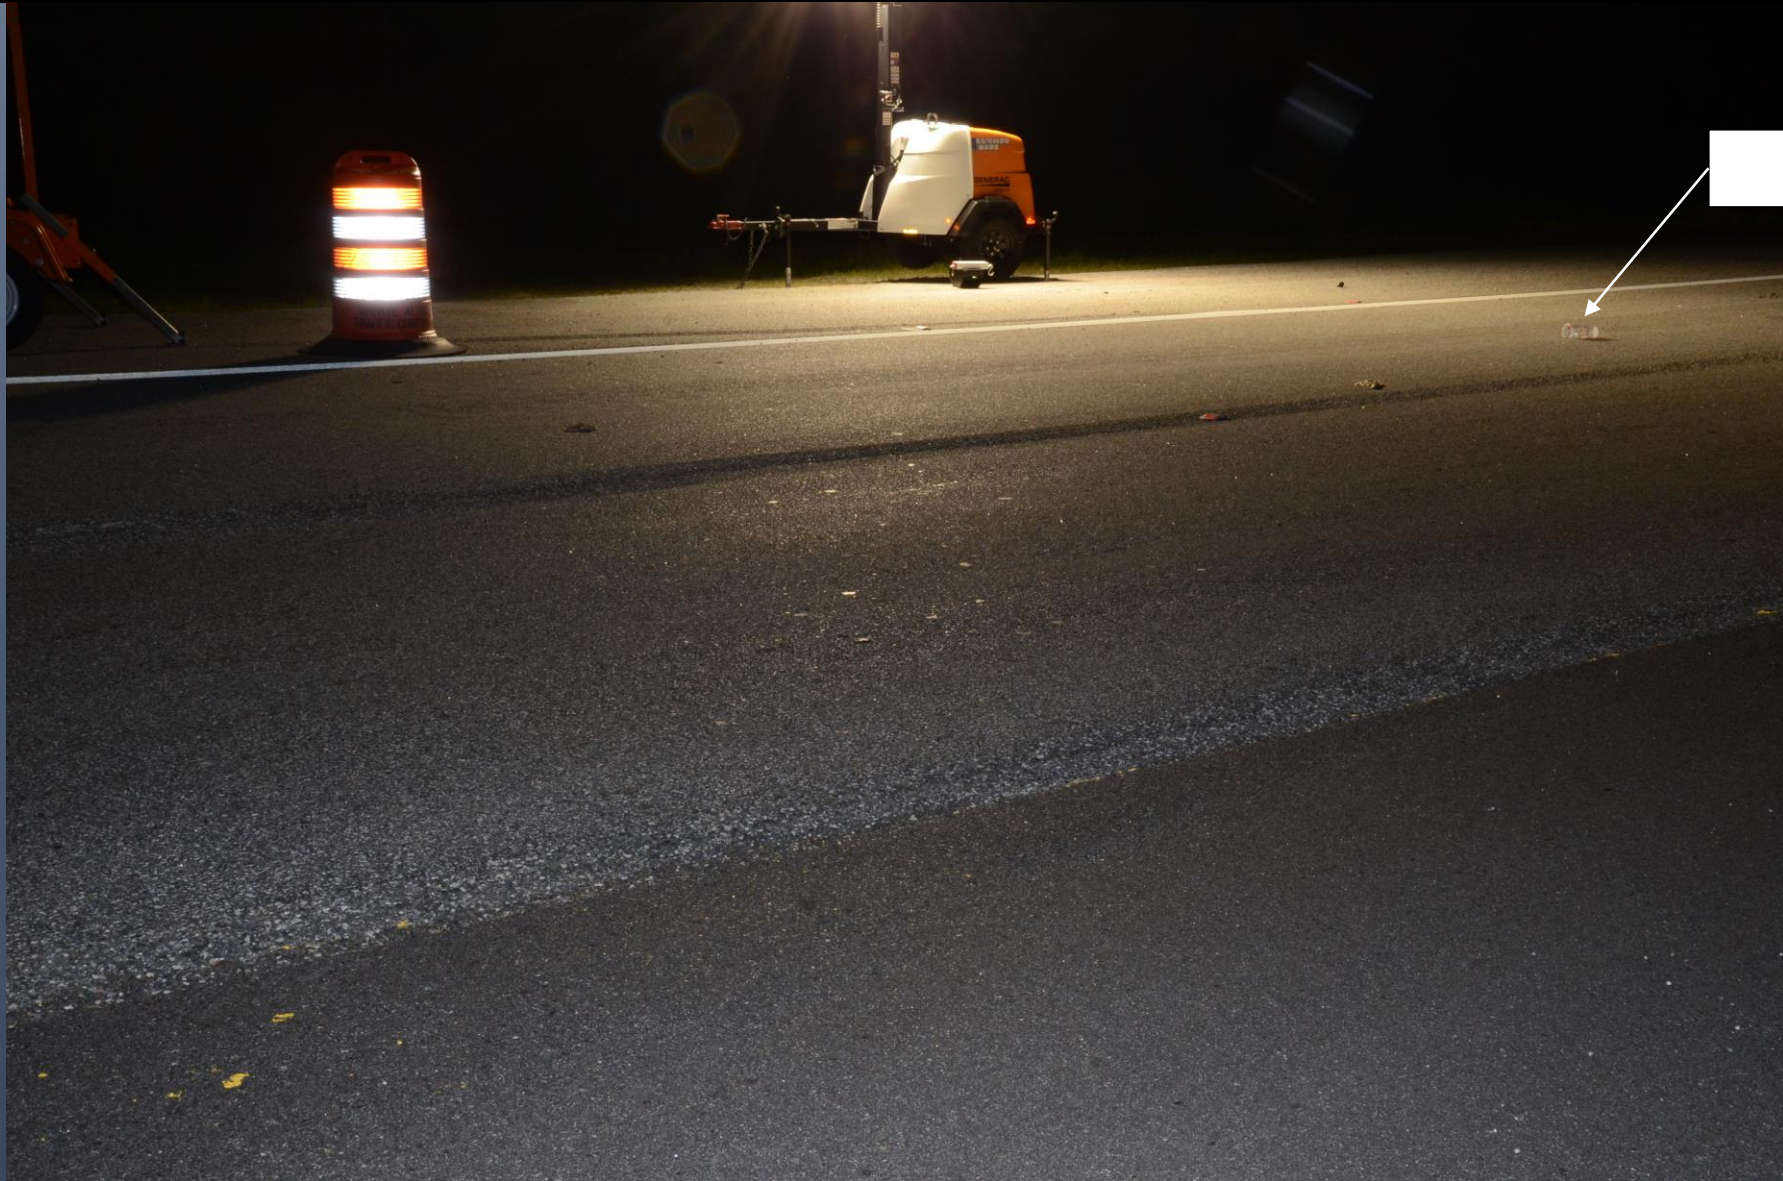
Plastic Cup

- Looking at debris field.
- No visible tire marks after impact.

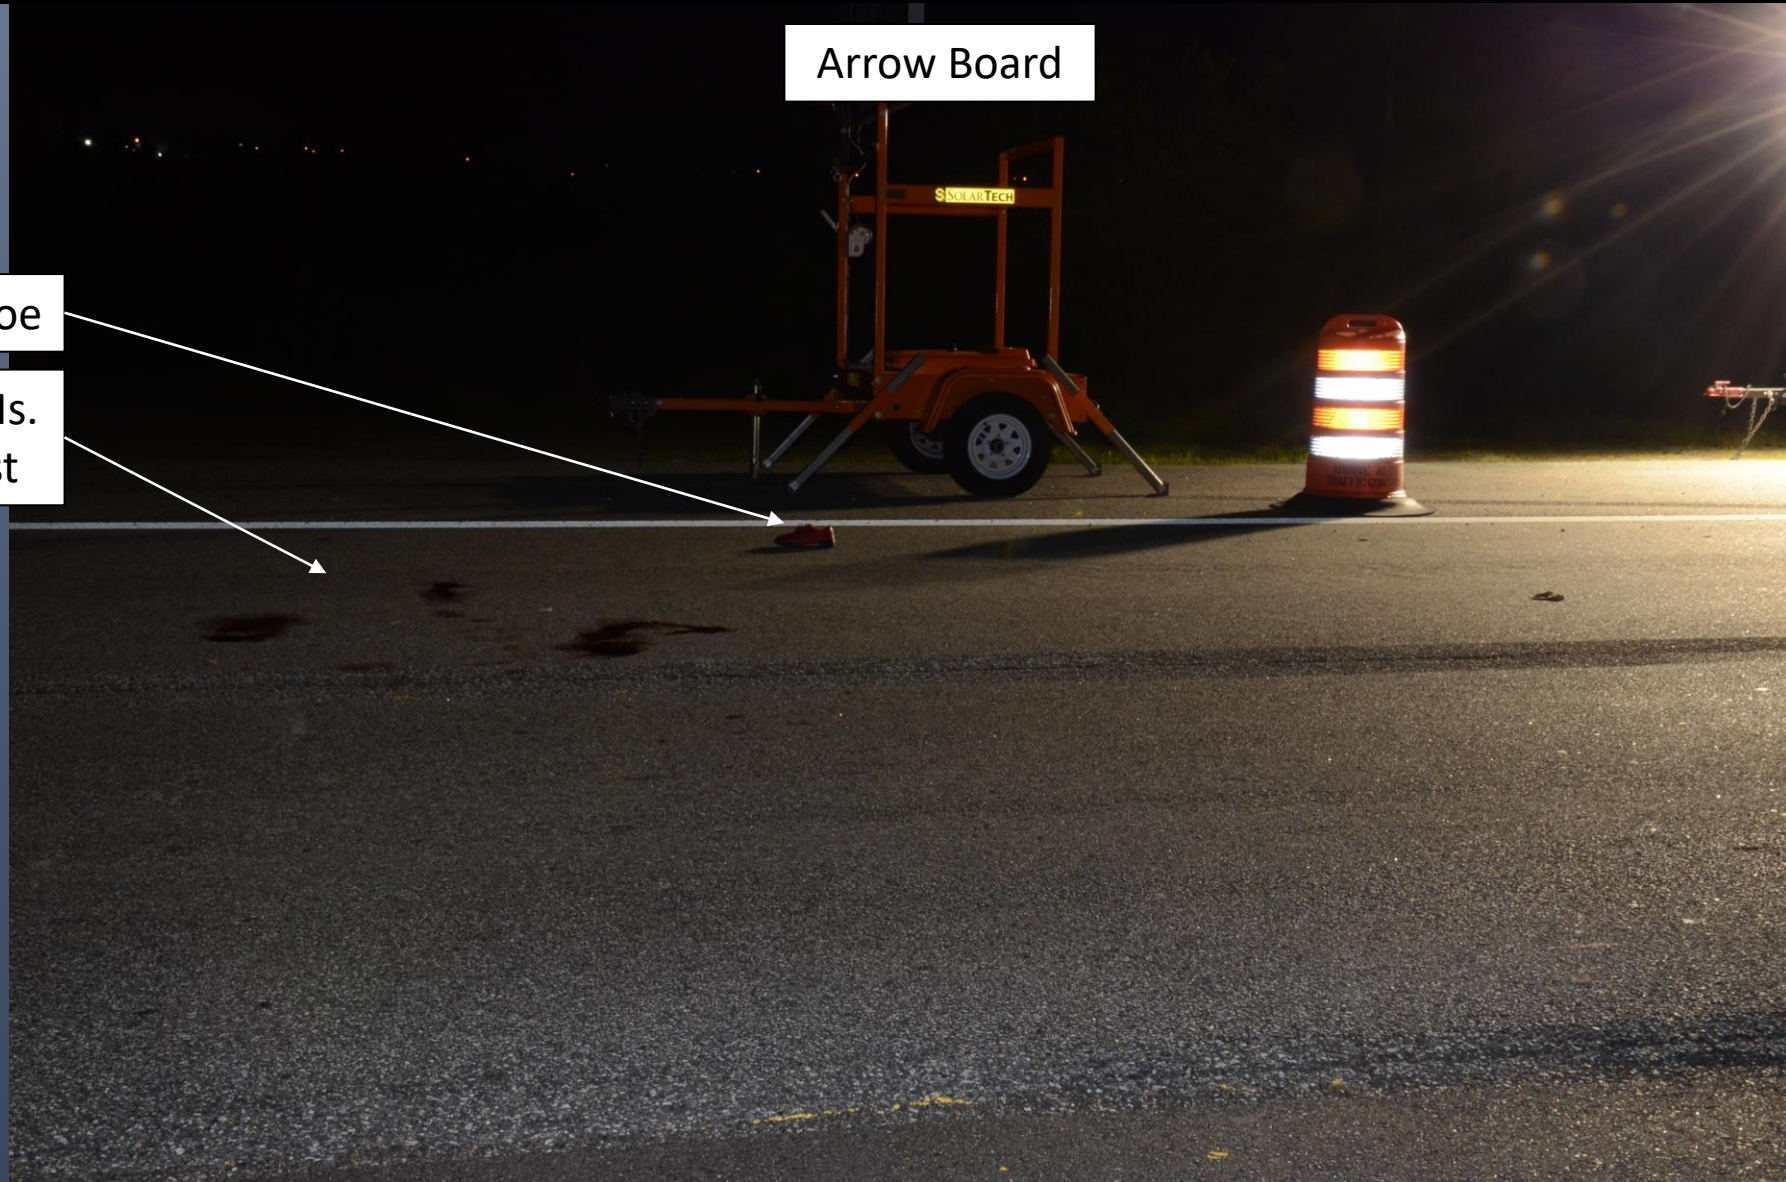
- Blood stains indicate that Ms. Lucas came to rest just north of the flashing arrow board.

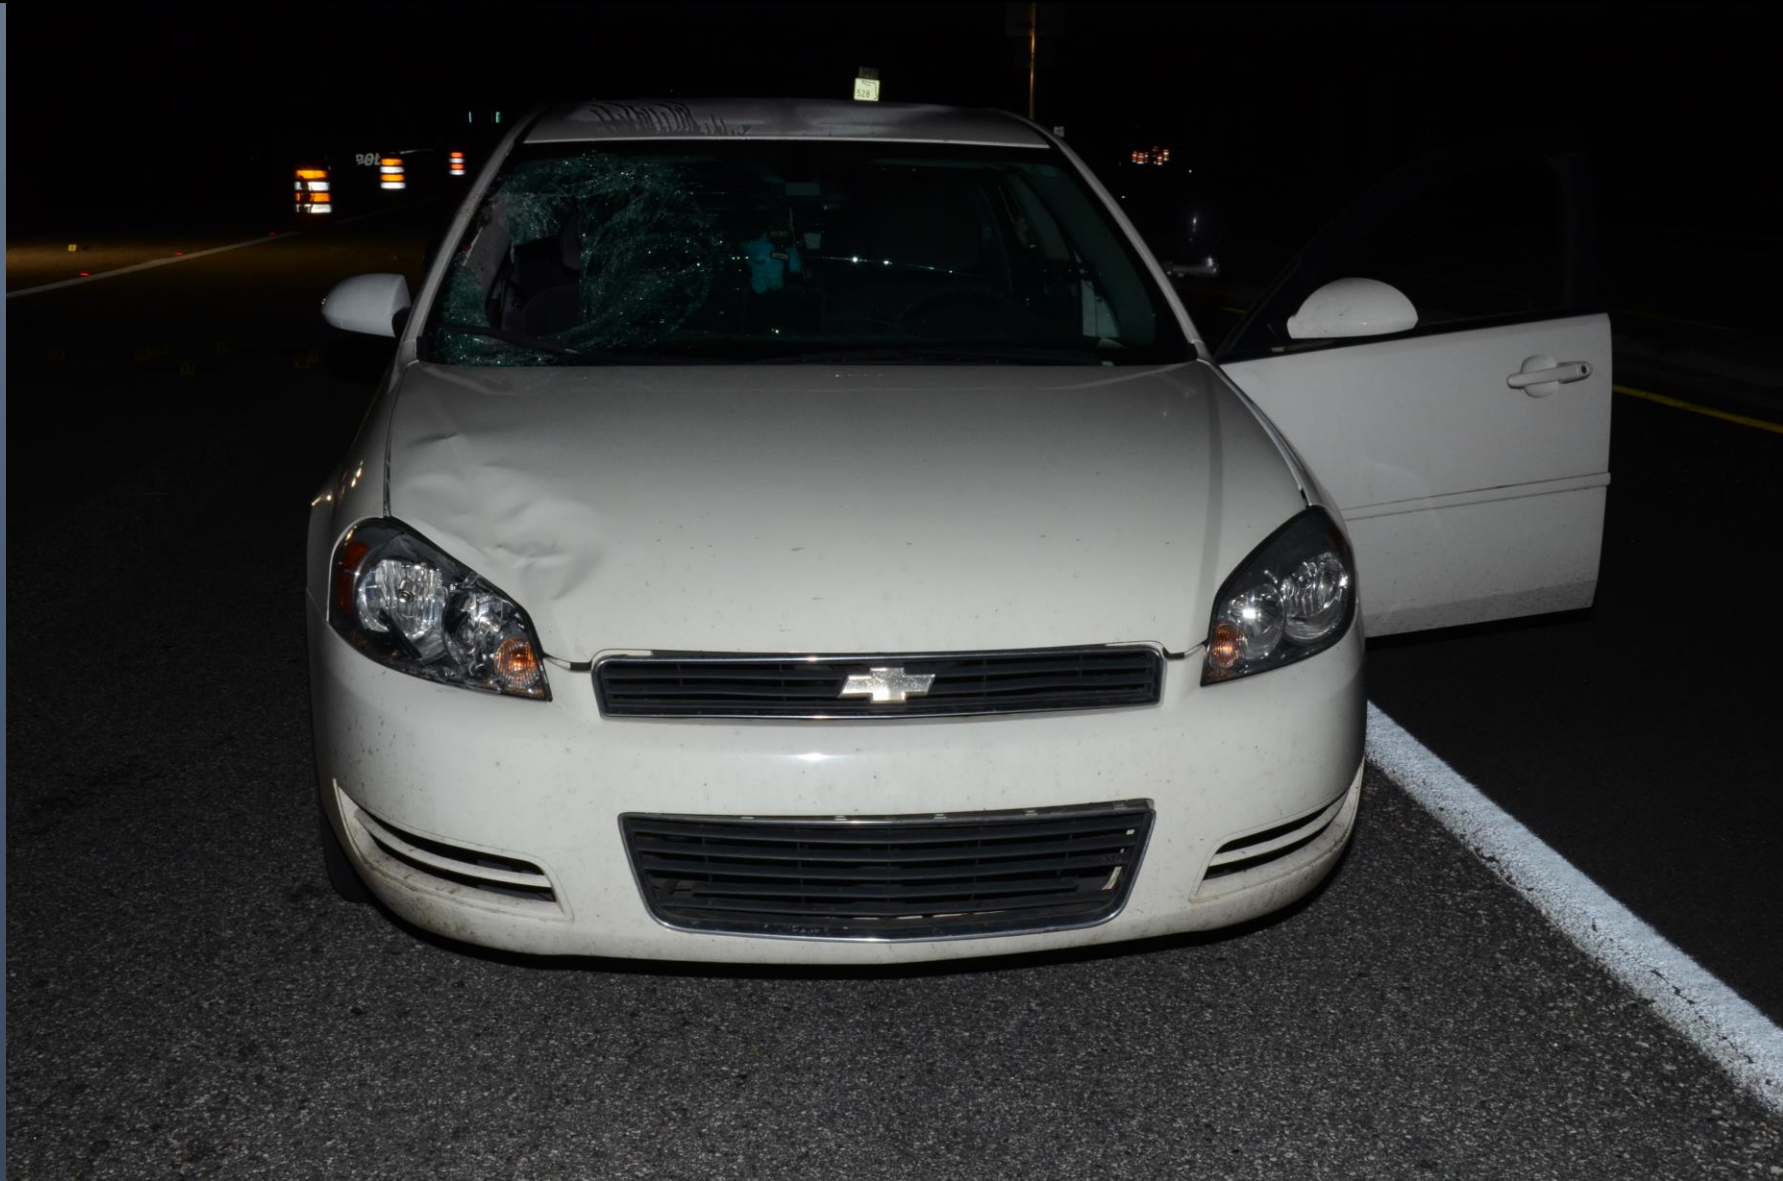
- Damage to the front right headlight, front right portion of the hood, and passenger side of the windshield.

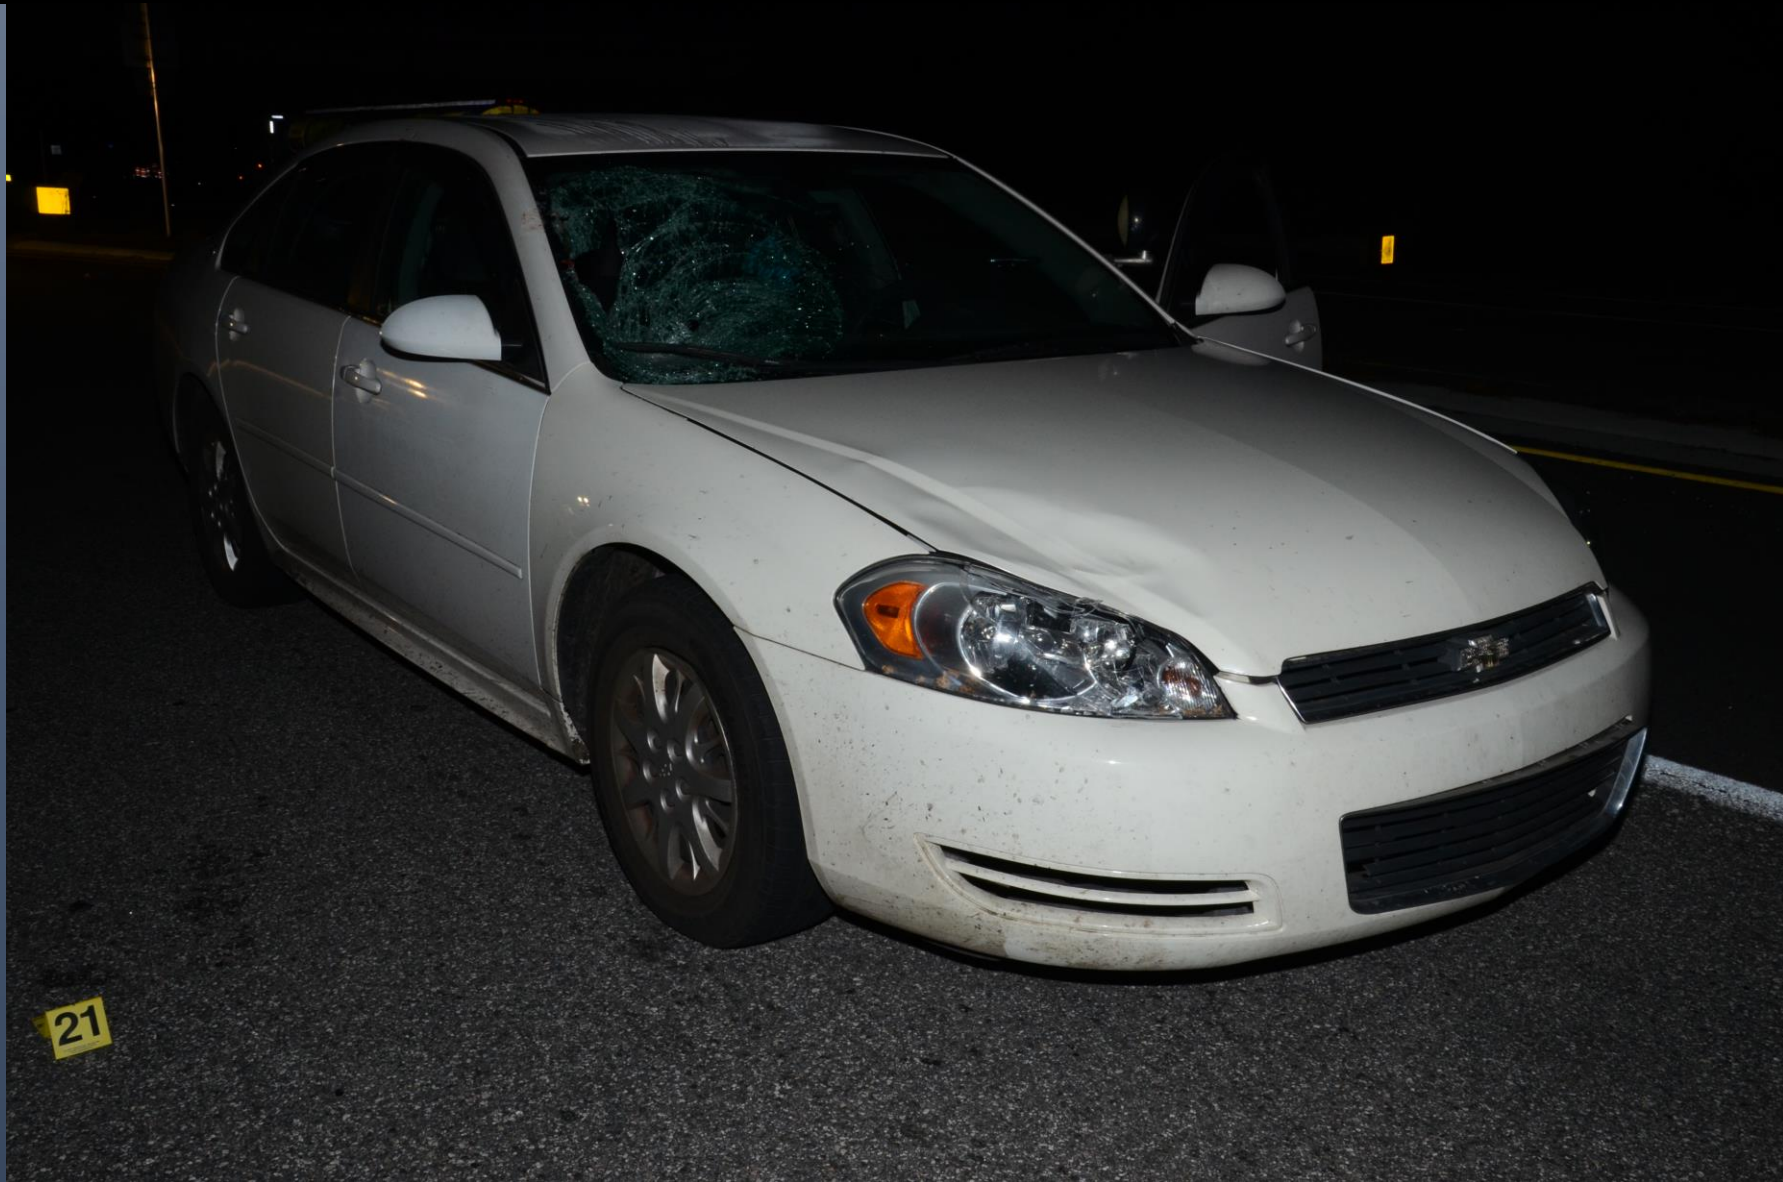
- Damage to the front right headlight, front right portion of the hood, and passenger side of the windshield.

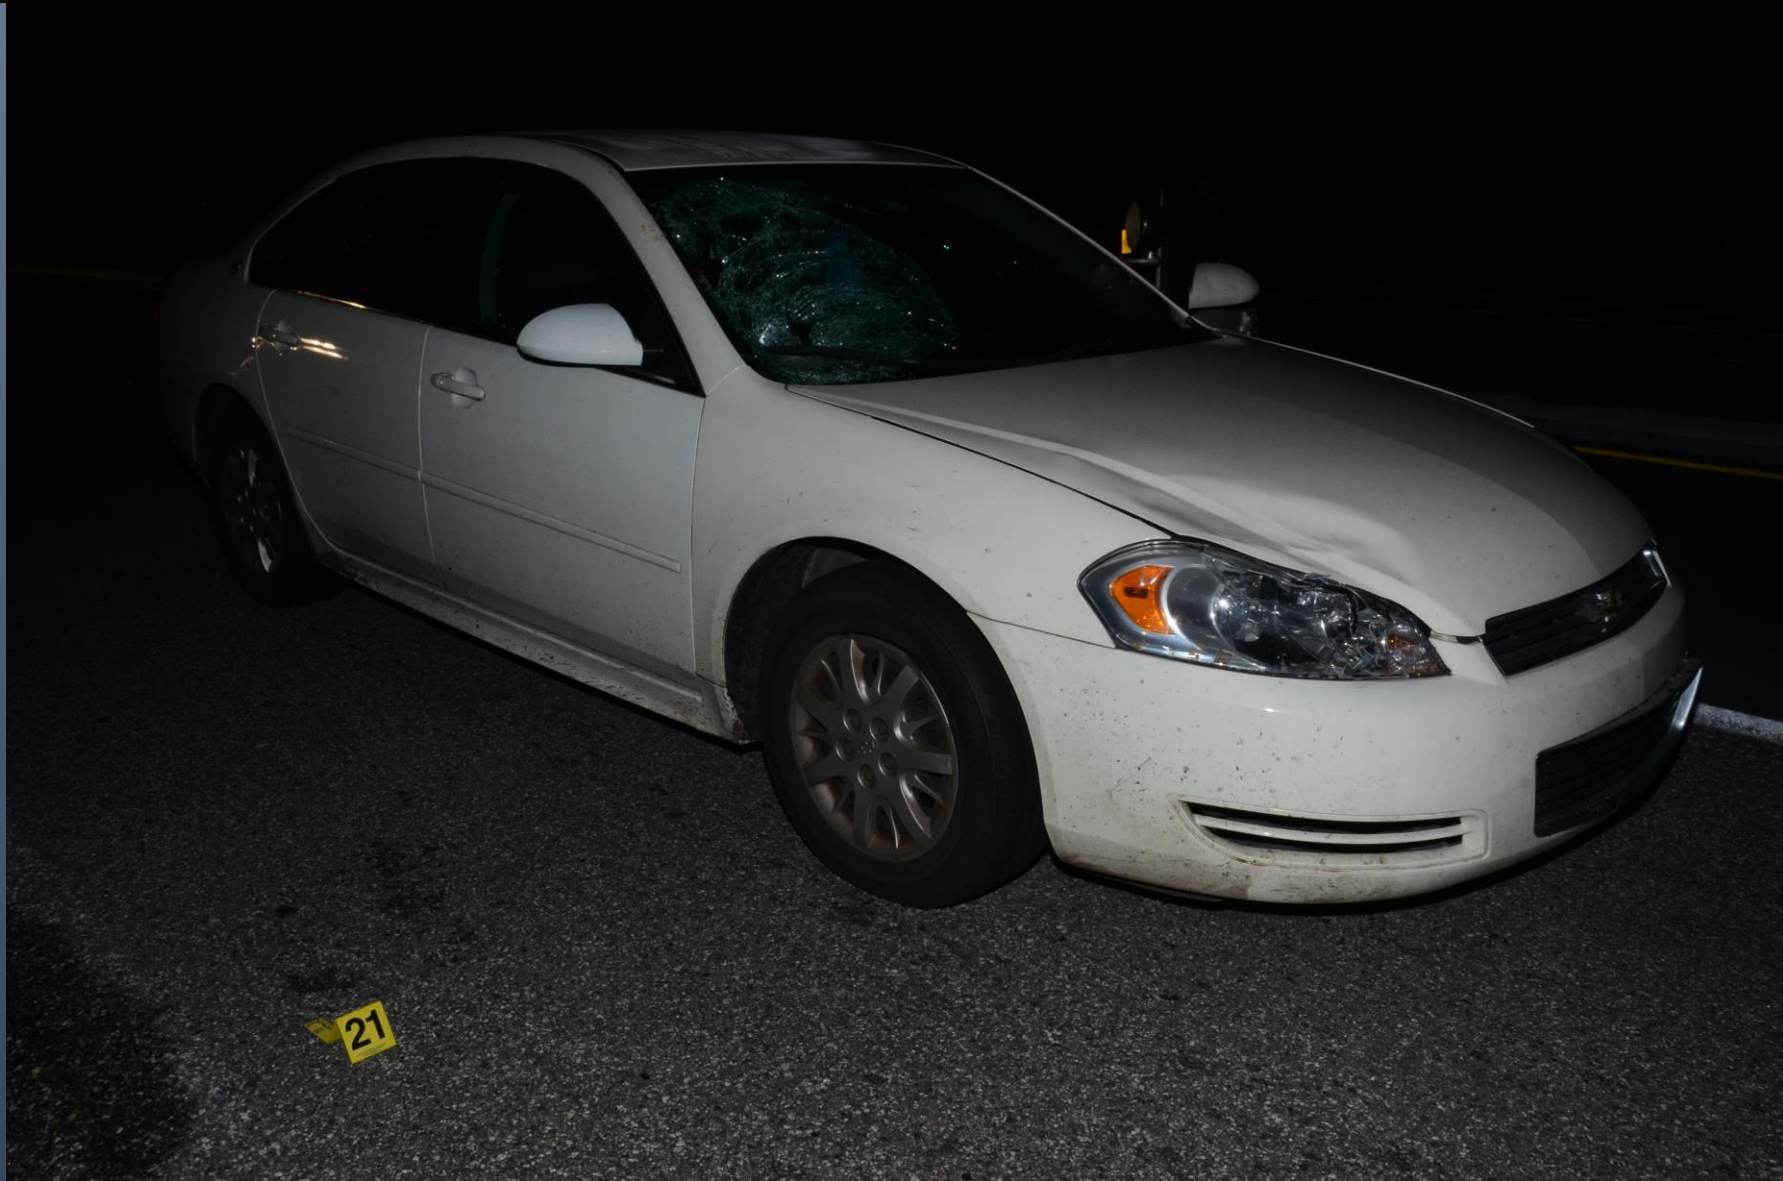
- Damage to the front right headlight, front right portion of the hood, and passenger side of the windshield.

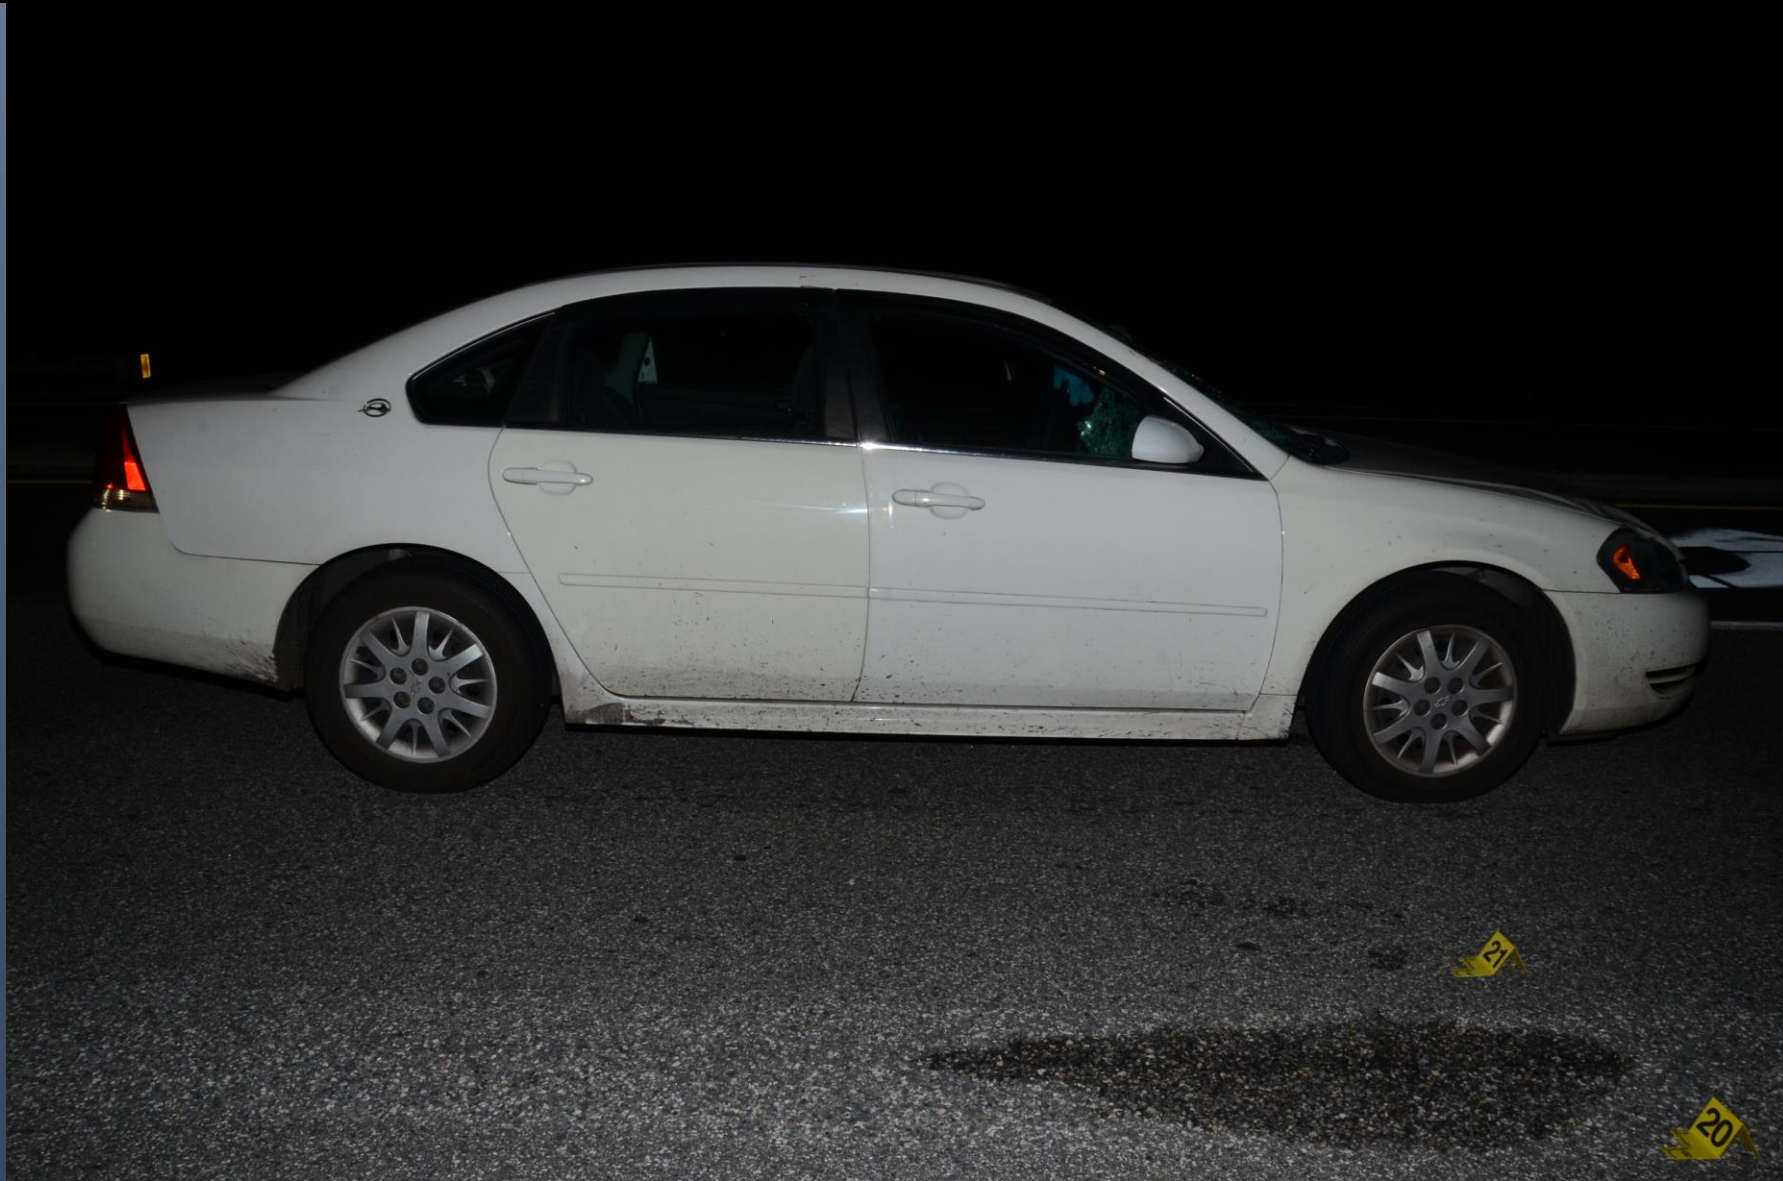
- The right side view shows no signs of contact with Ms. Lucas's body.

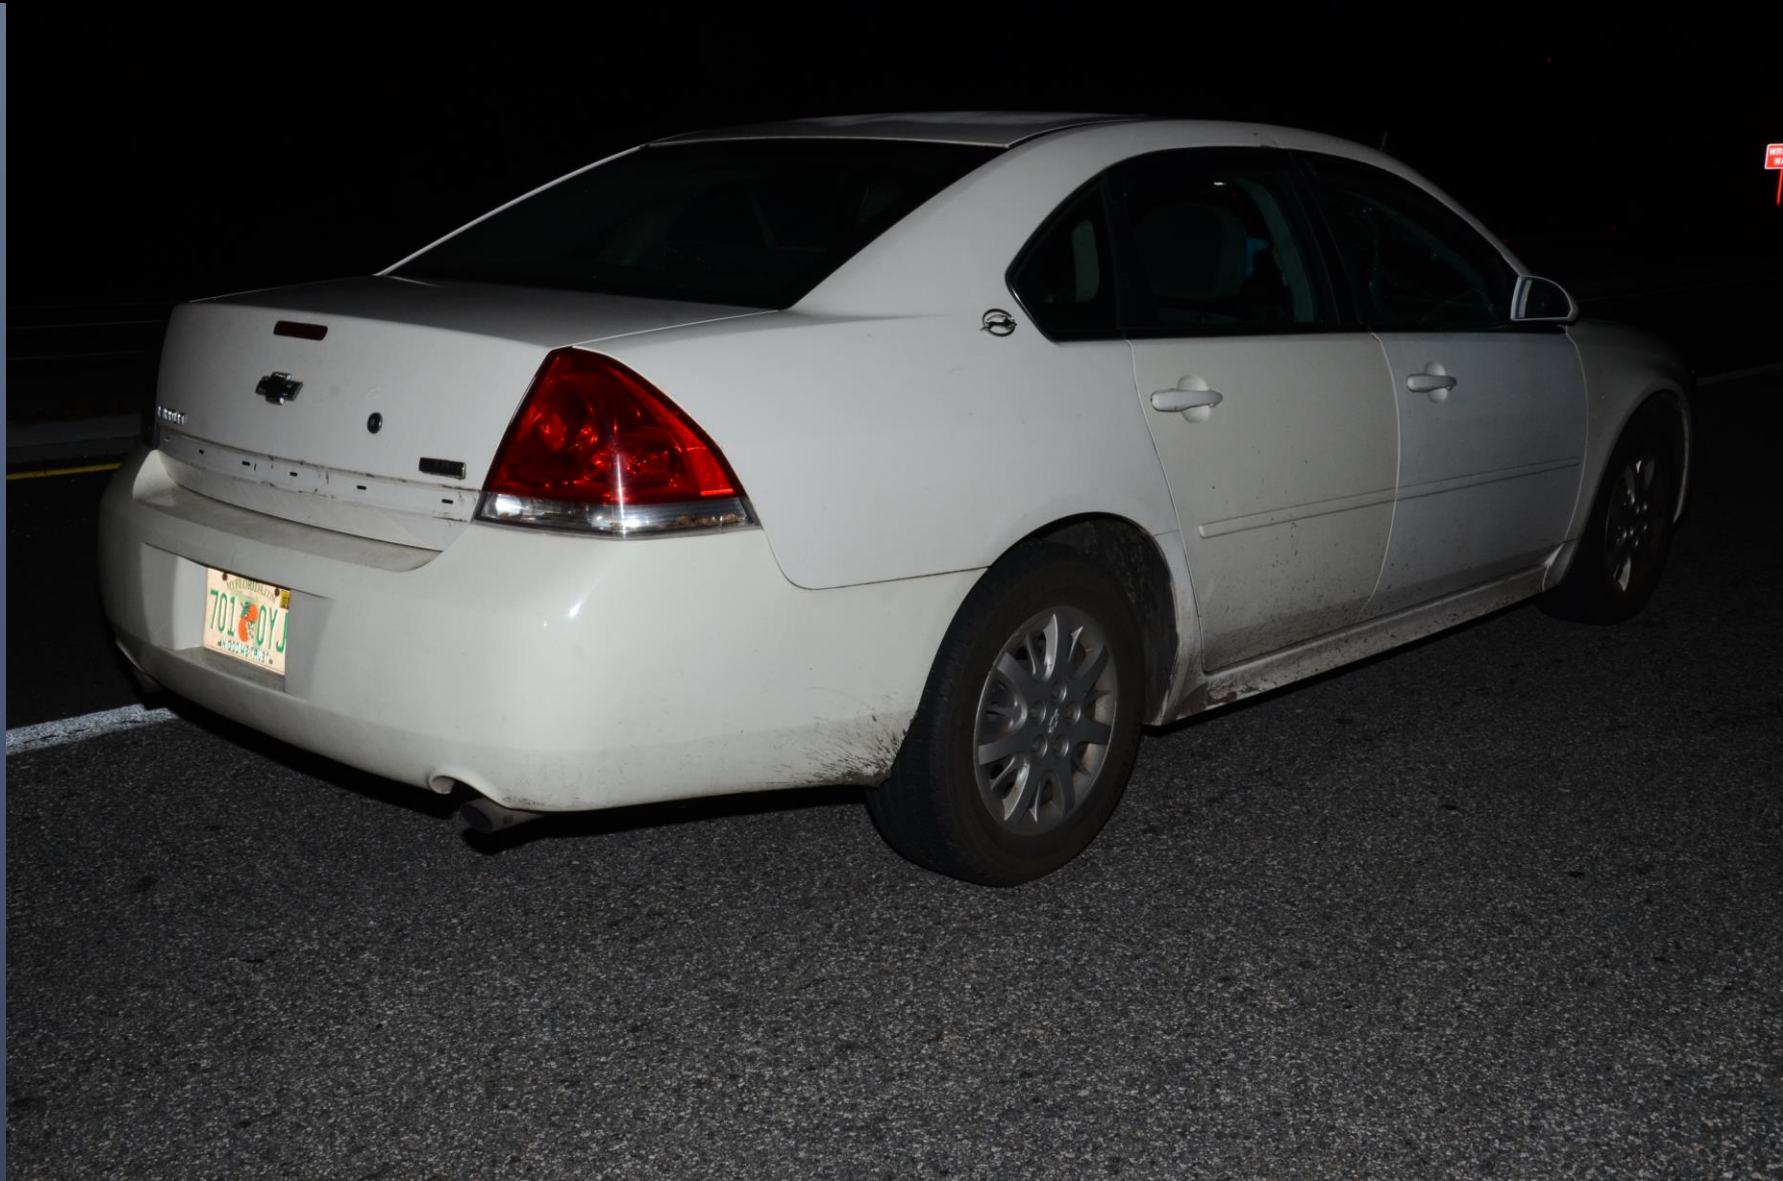
- The right rear view shows no signs of contact with Ms. Lucas's body.

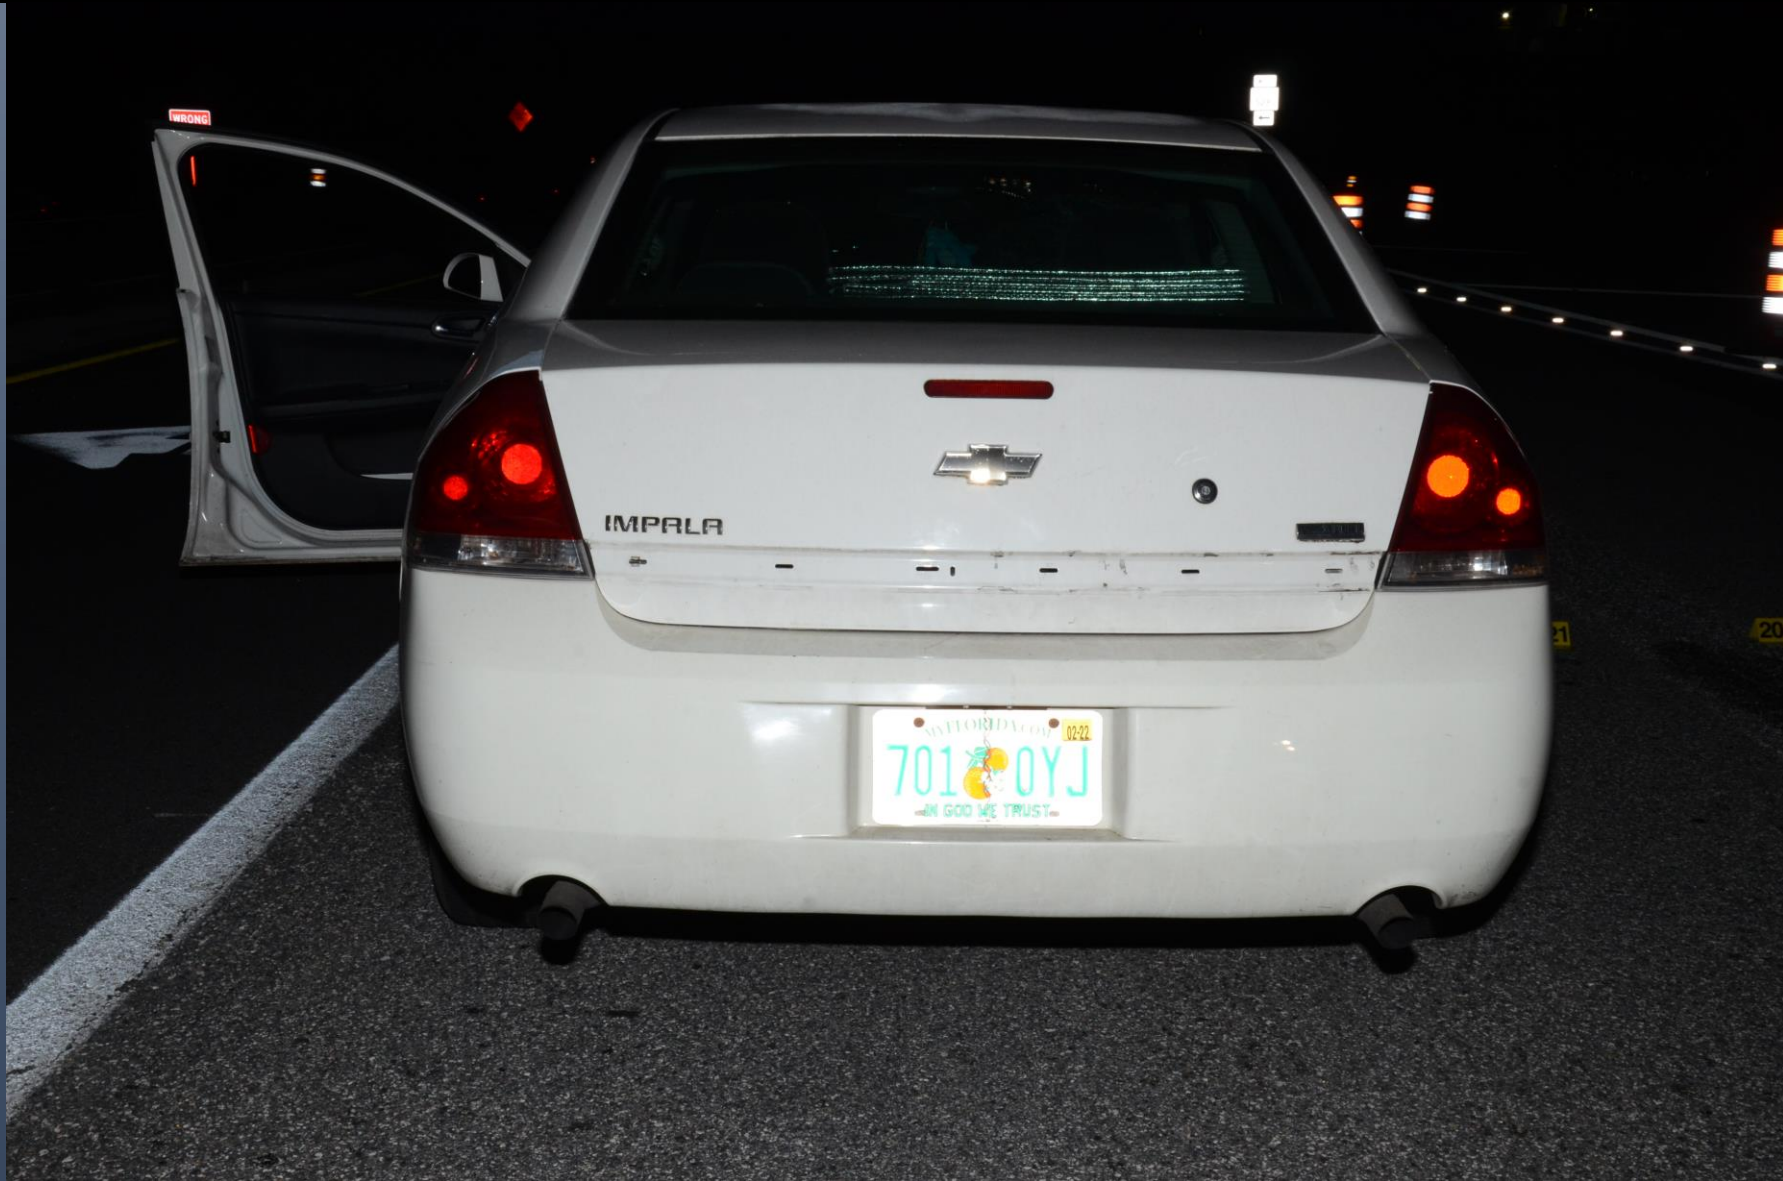
- The rear of the vehicle shows no signs of contact with Ms. Lucas's body.
