Crash Reconstruction and Transportation Engineering Analysis

40-12724 (State v. Norris)

Kelly Palframan, Ph.D., P.E.

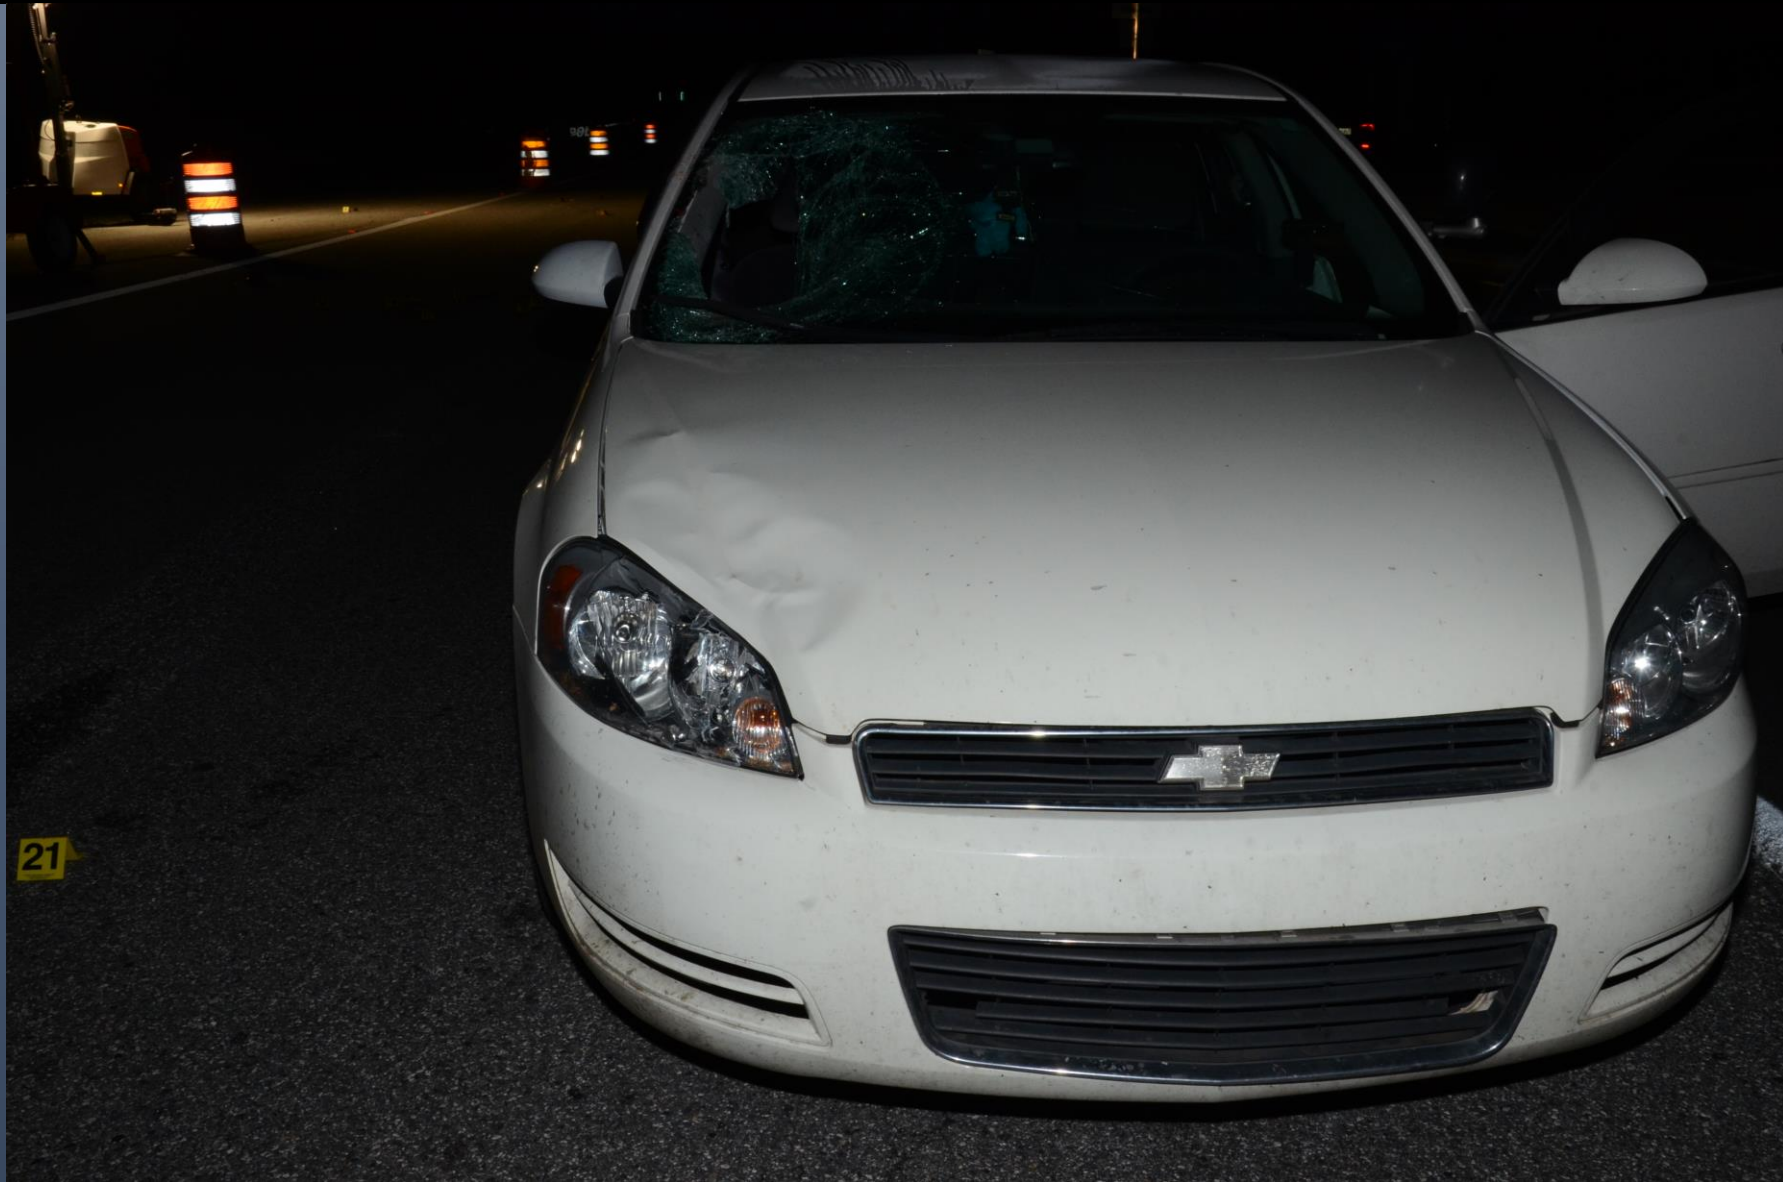
- Close-up of contact evidence and vehicle damage.

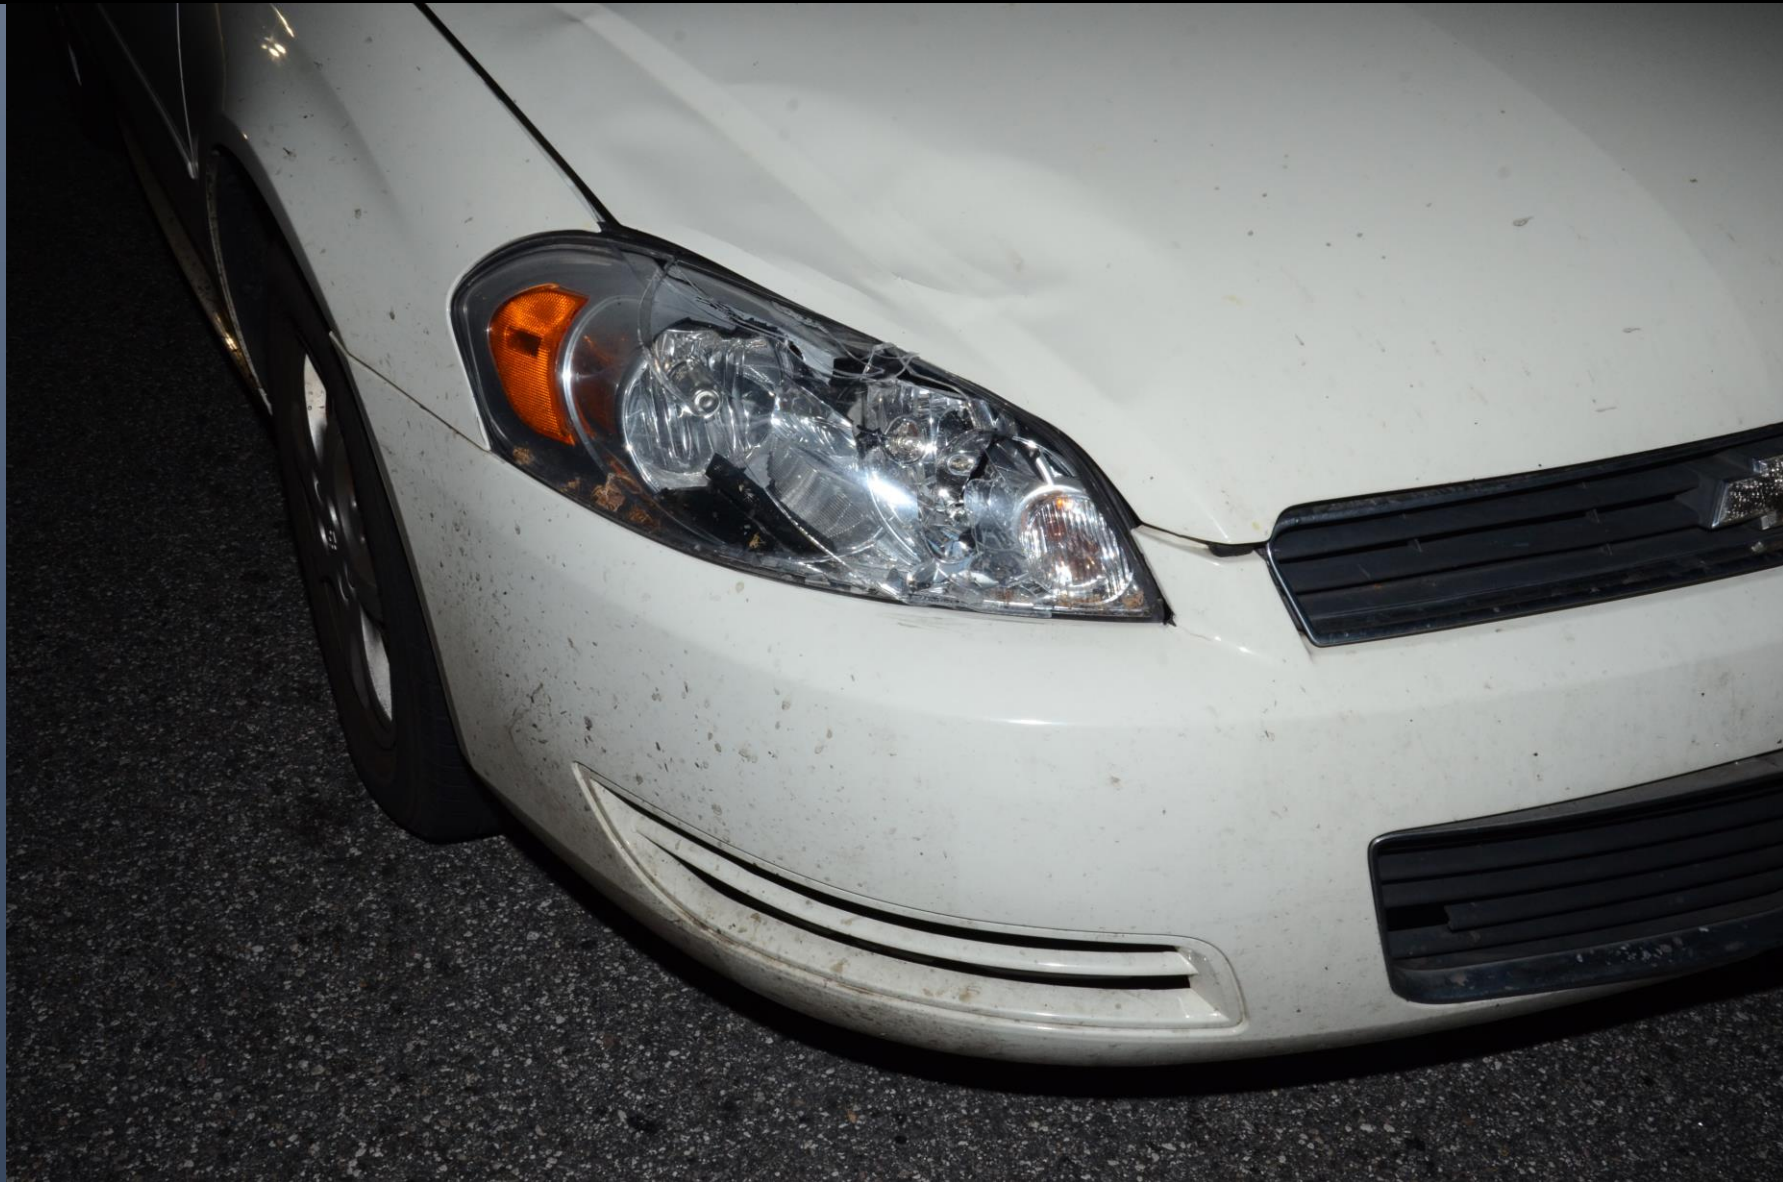
- Front right headlight assembly was broken.

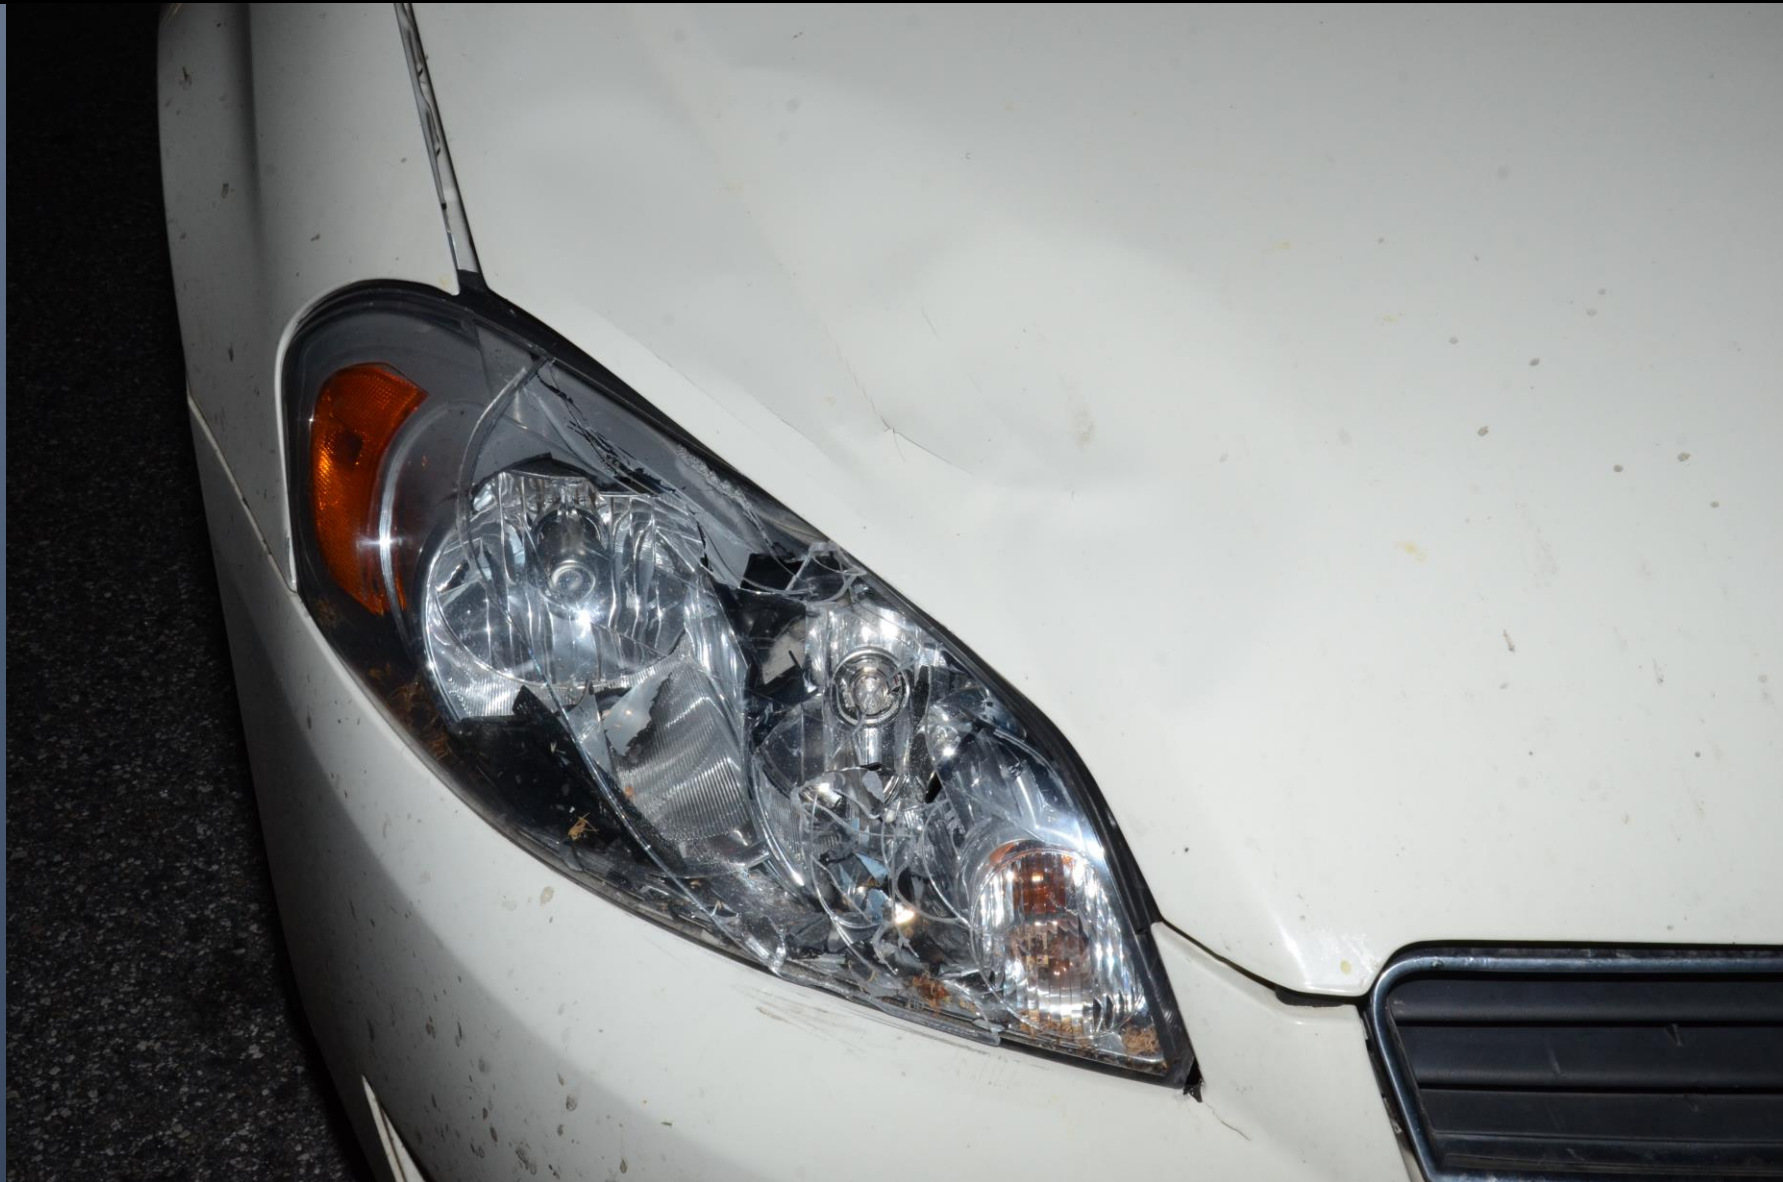
- Dent from body contact is in line with the front right headlight.

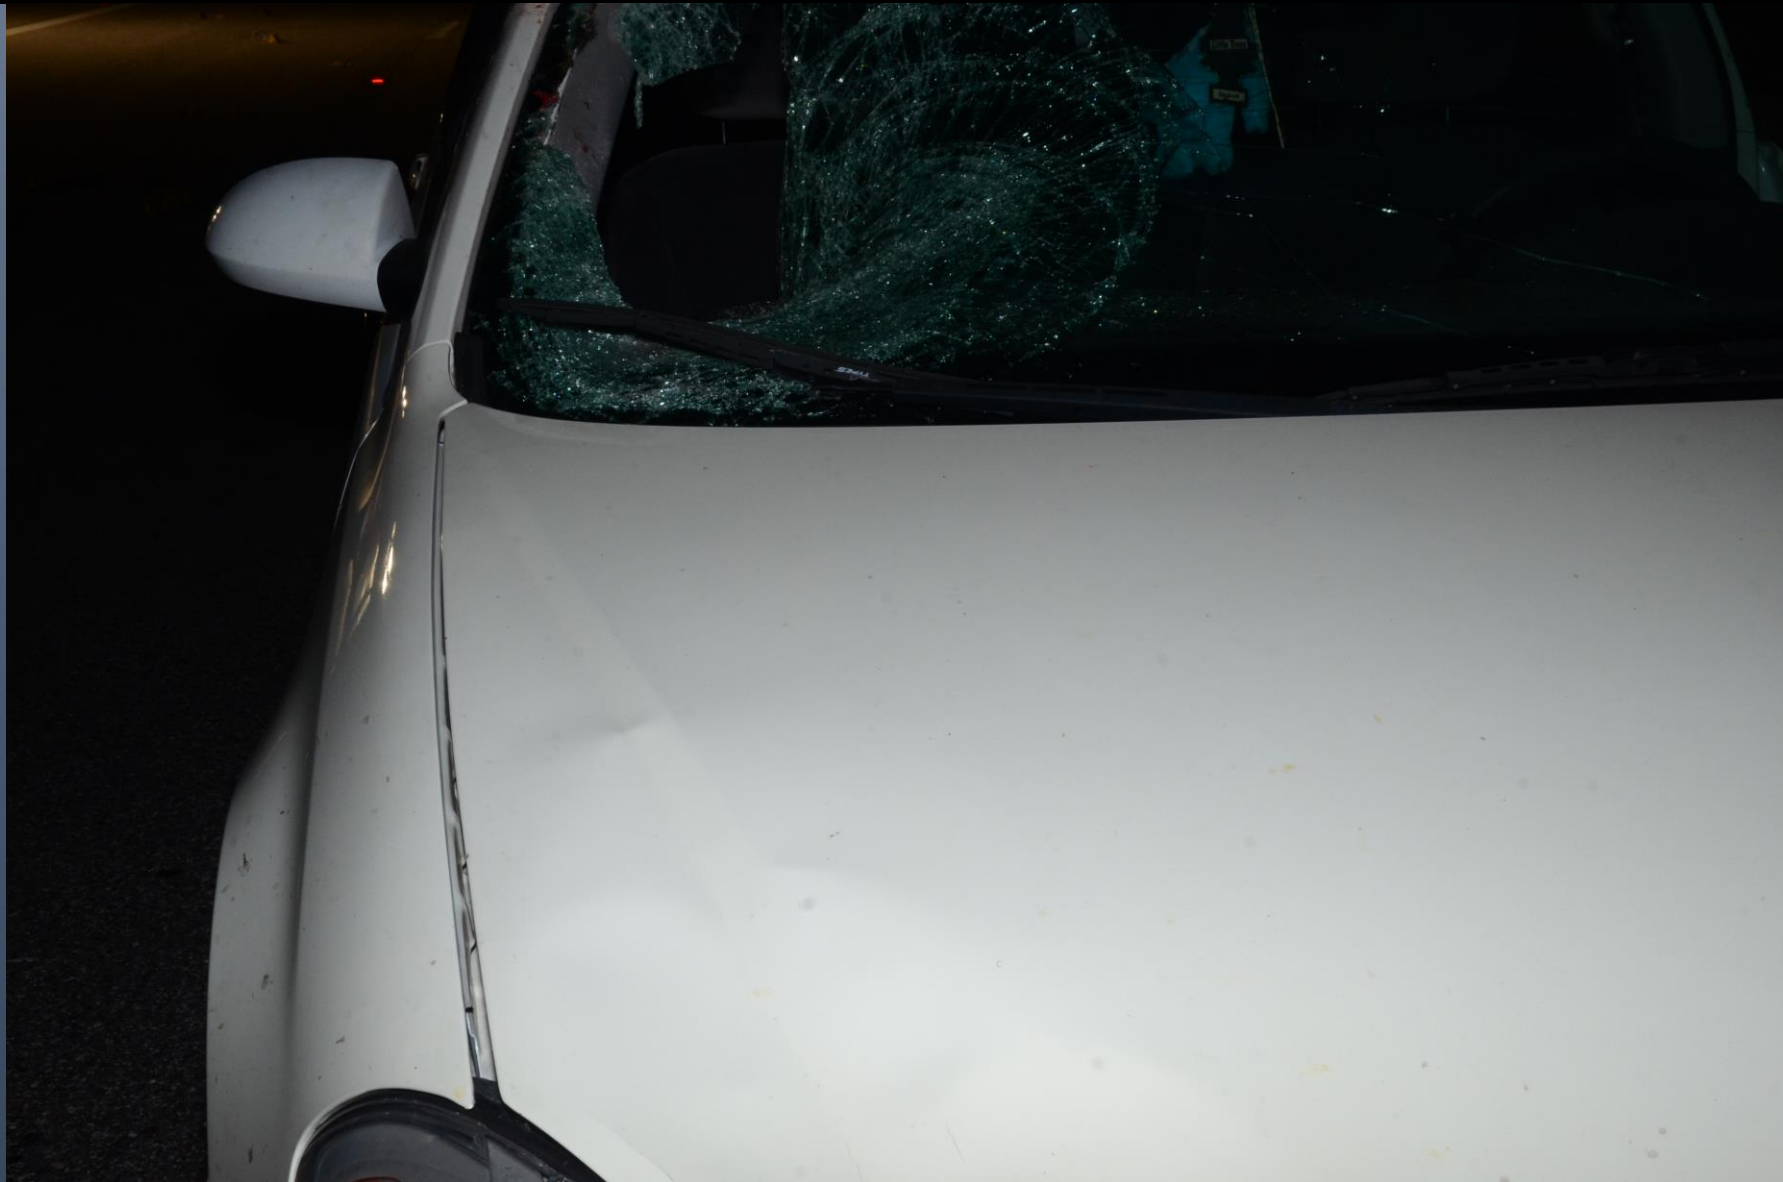
- Dent from body contact continues along the hood.

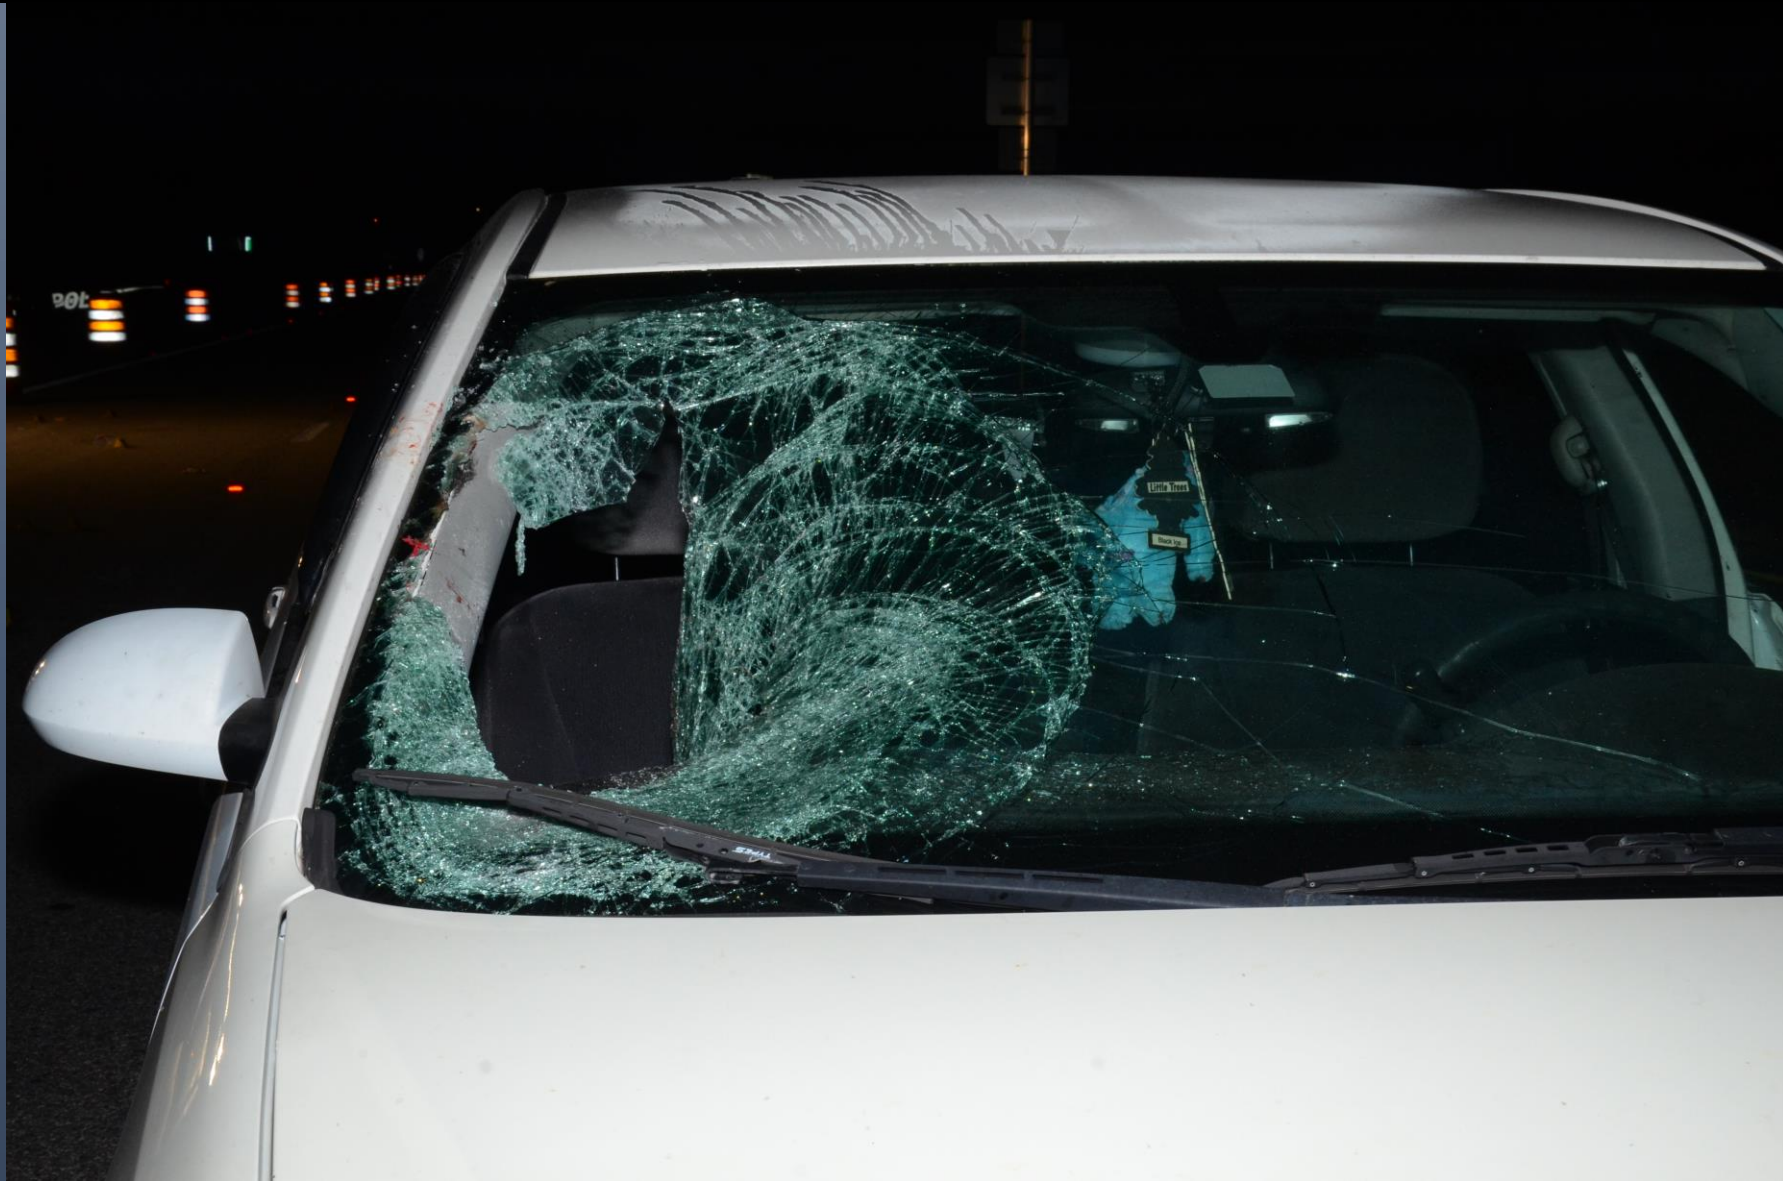
- Dents approximately halfway up the A-pillar from contact with Ms. Lucas's head.
- Black hair is visible in the cracked glass near the A-pillar.

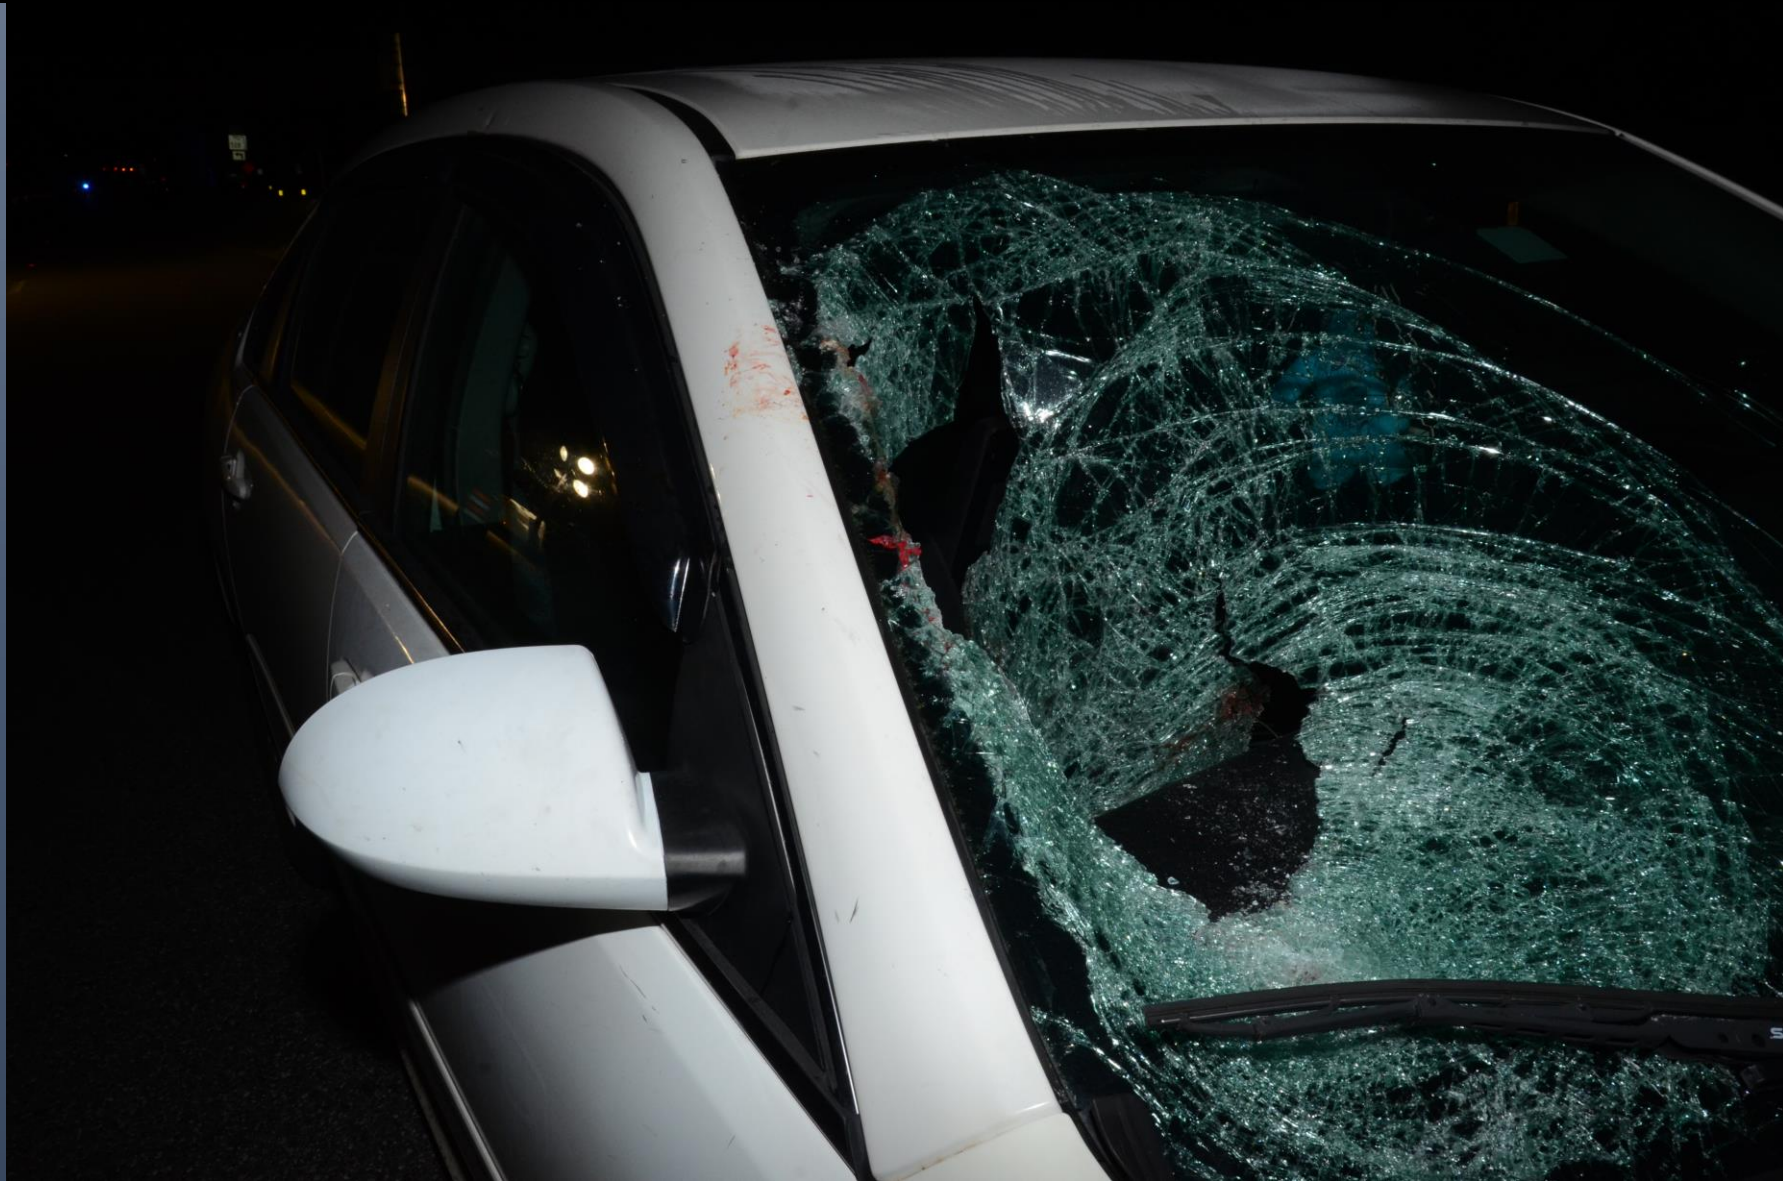
- Ms. Lucas's head penetrated the windshield and temporarily intruded into the occupant compartment.

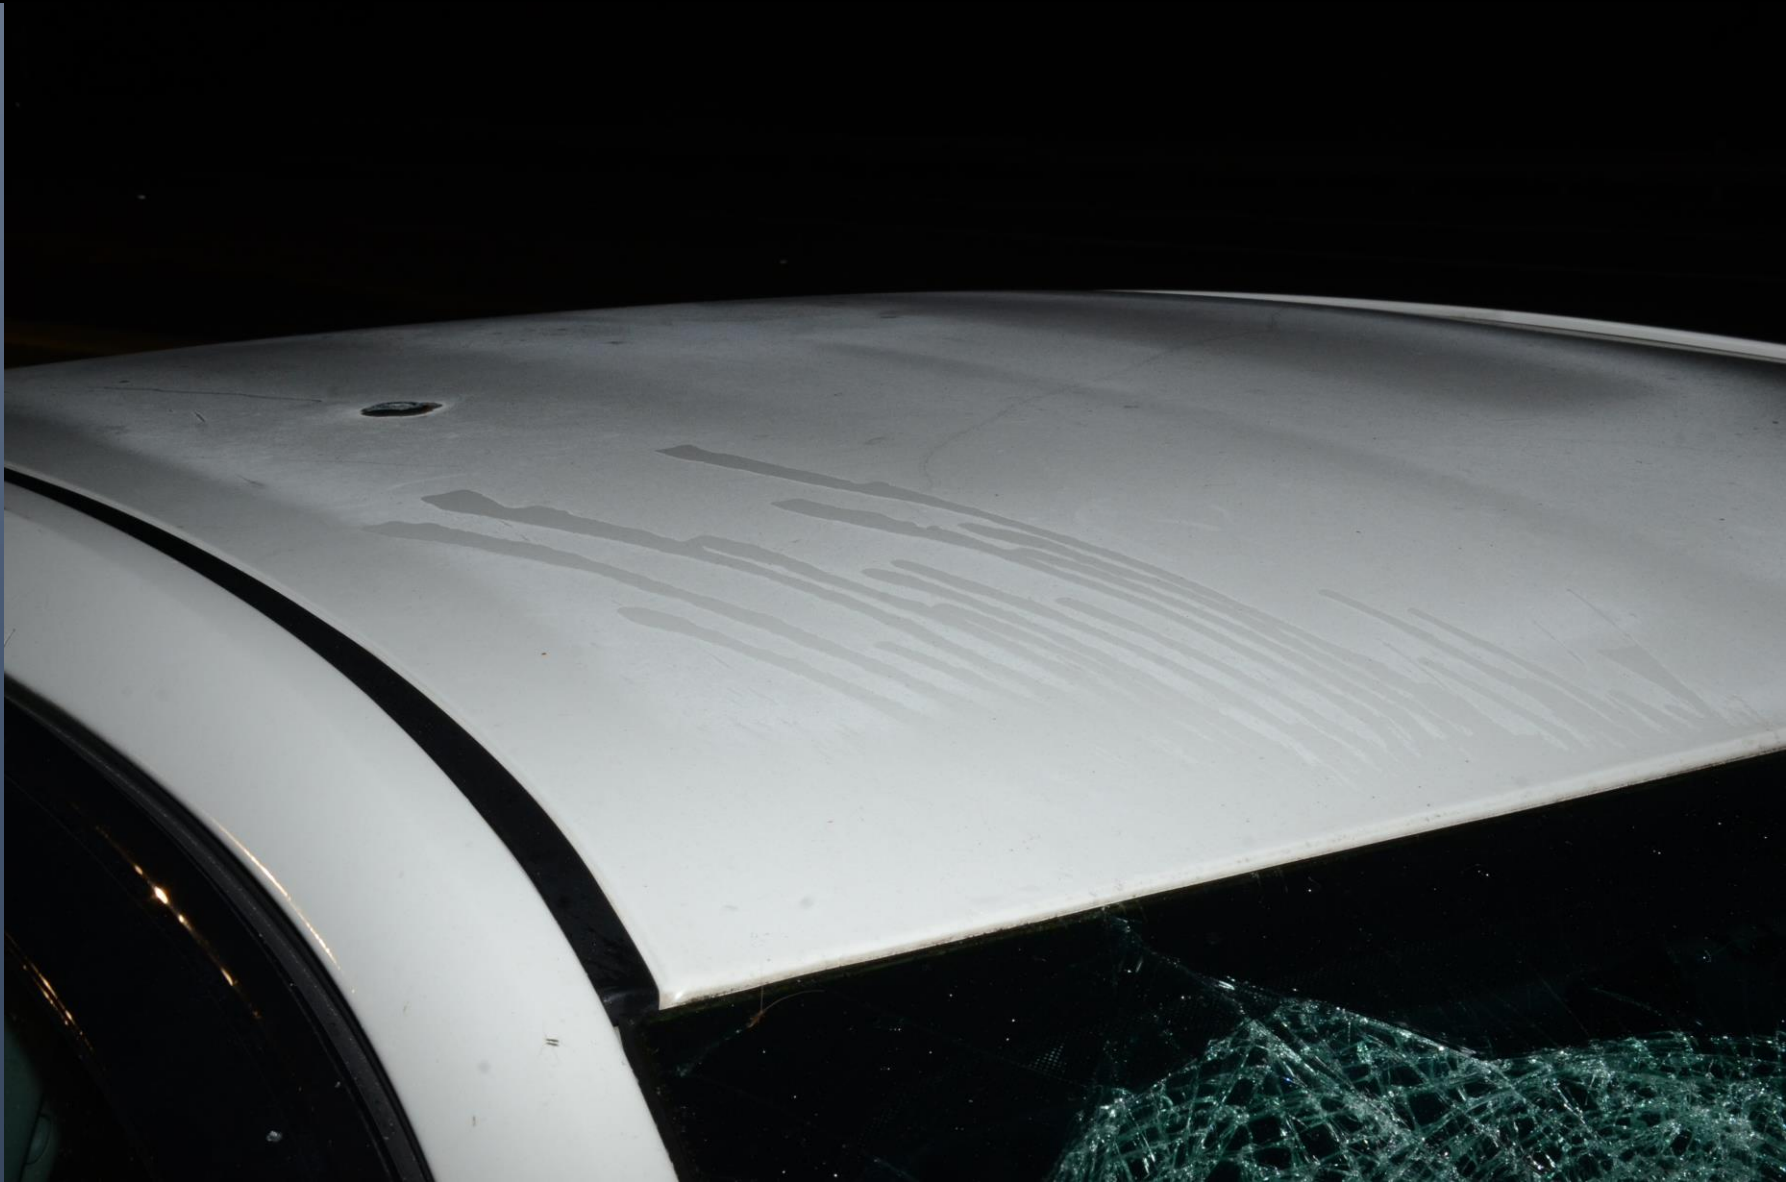
- Markings on the roof of the vehicle are not consistent with marks from pedestrian-to-vehicle contact.

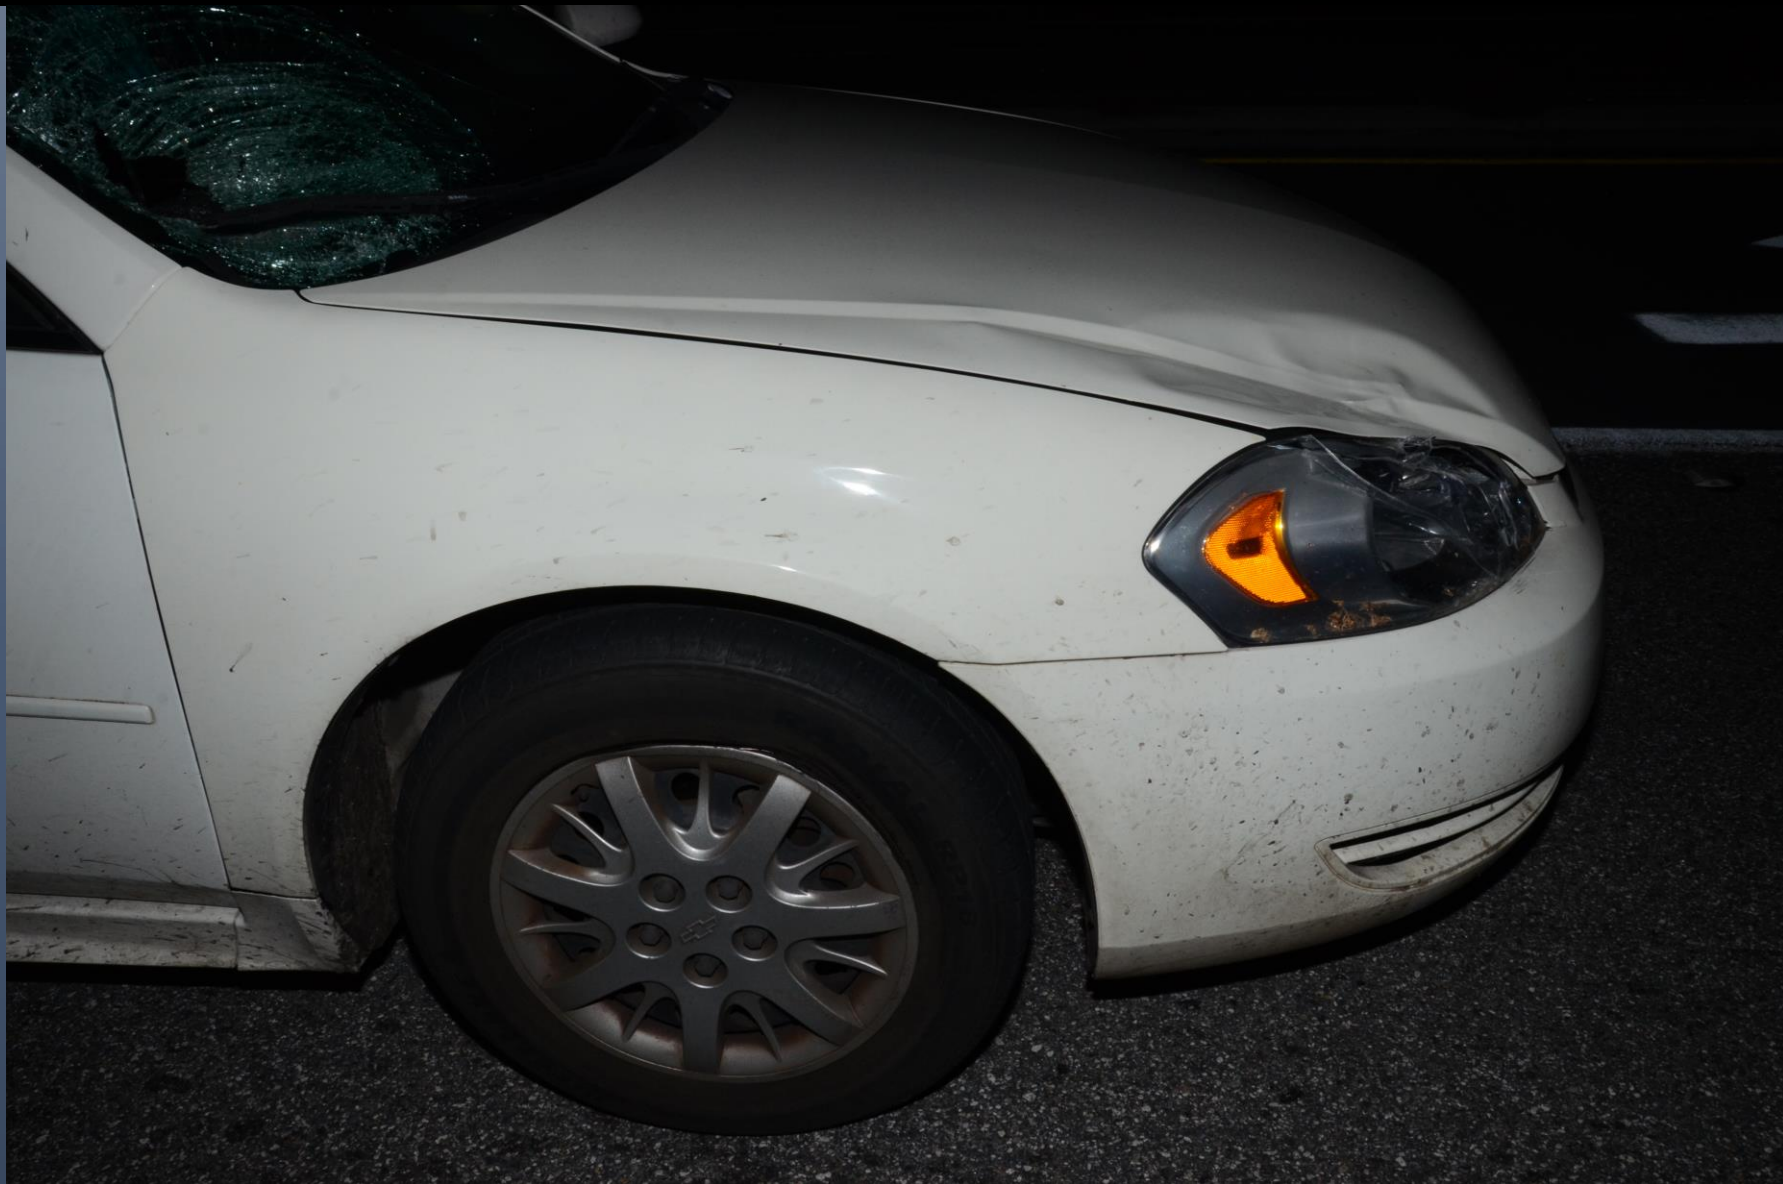
- Close-up of the dented hood above the right headlight.

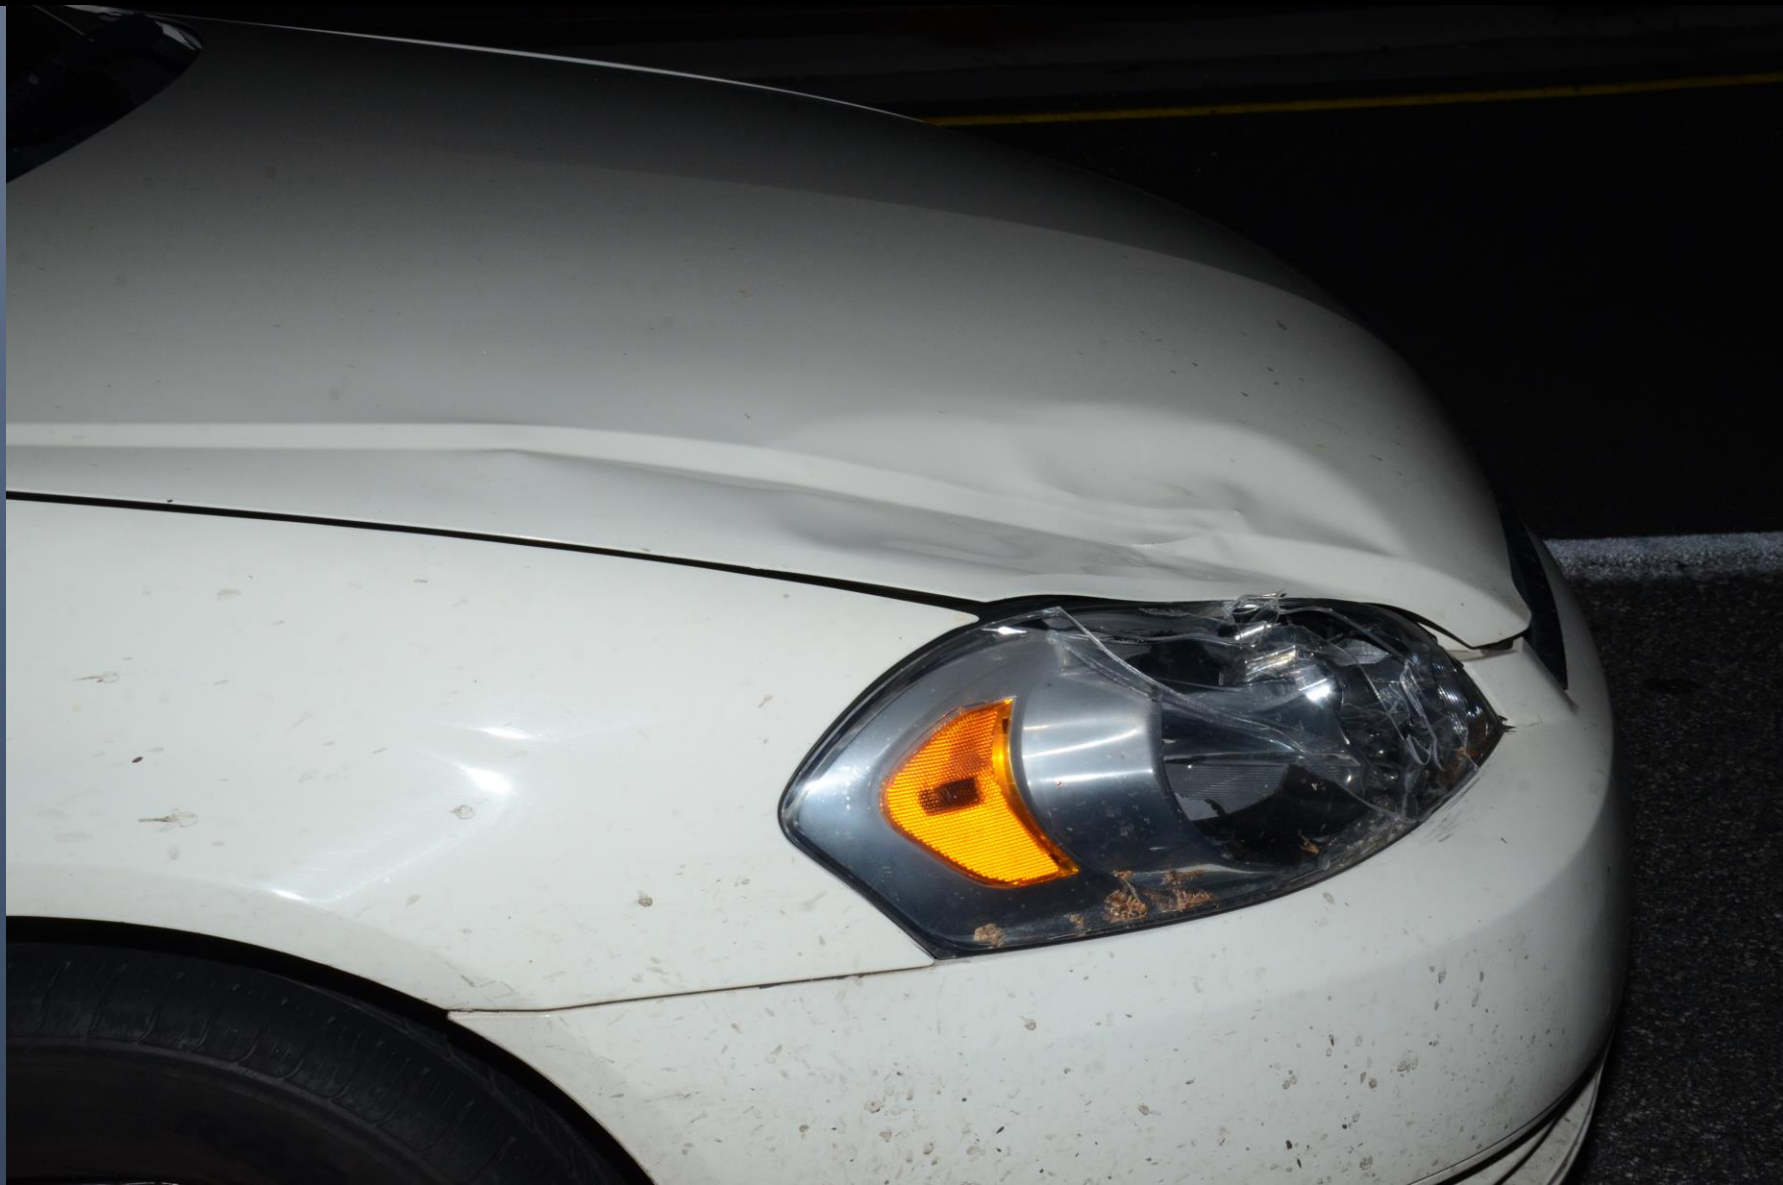
- Close-up of the dented hood above the right headlight.

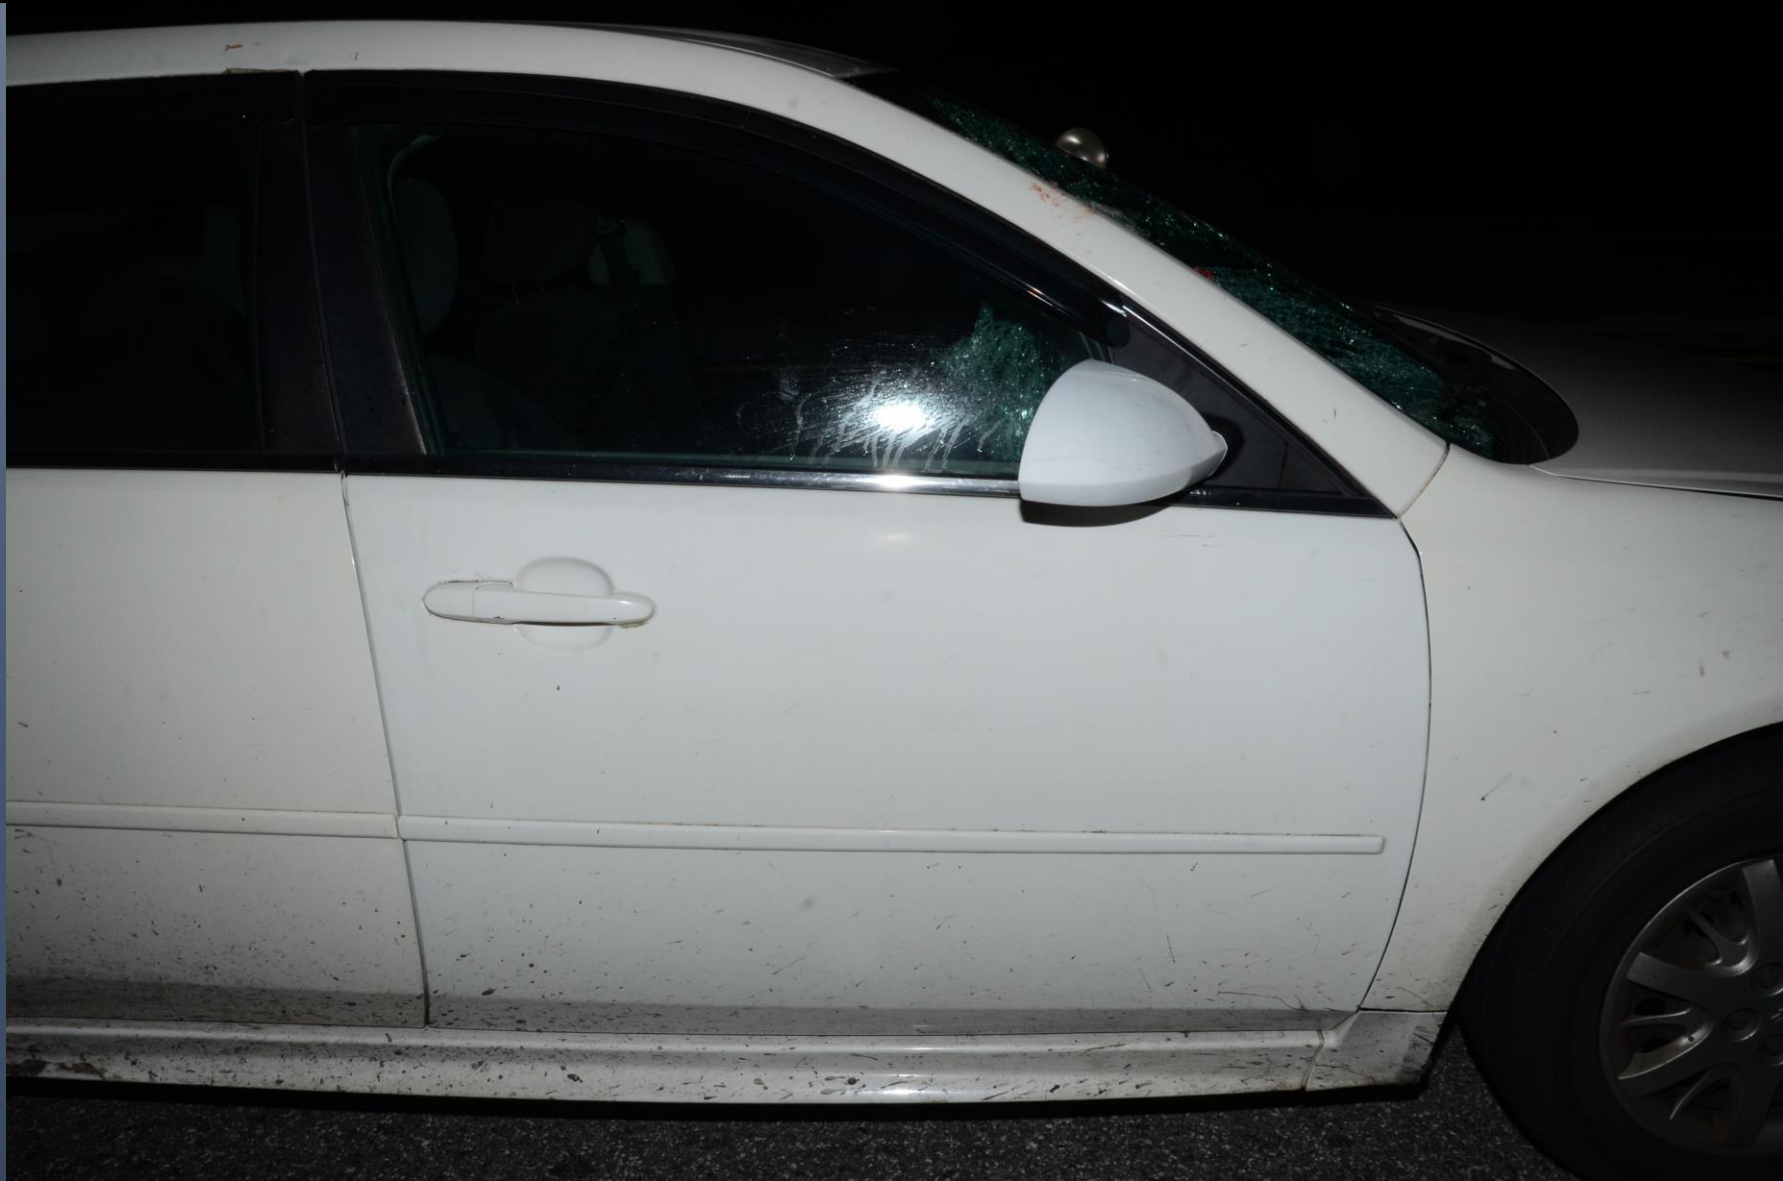
- Potential fluid marks on the passenger side window.
