Crash Reconstruction and Transportation Engineering Analysis

40-12724 (State v. Norris)

Kelly Palframan, Ph.D., P.E.

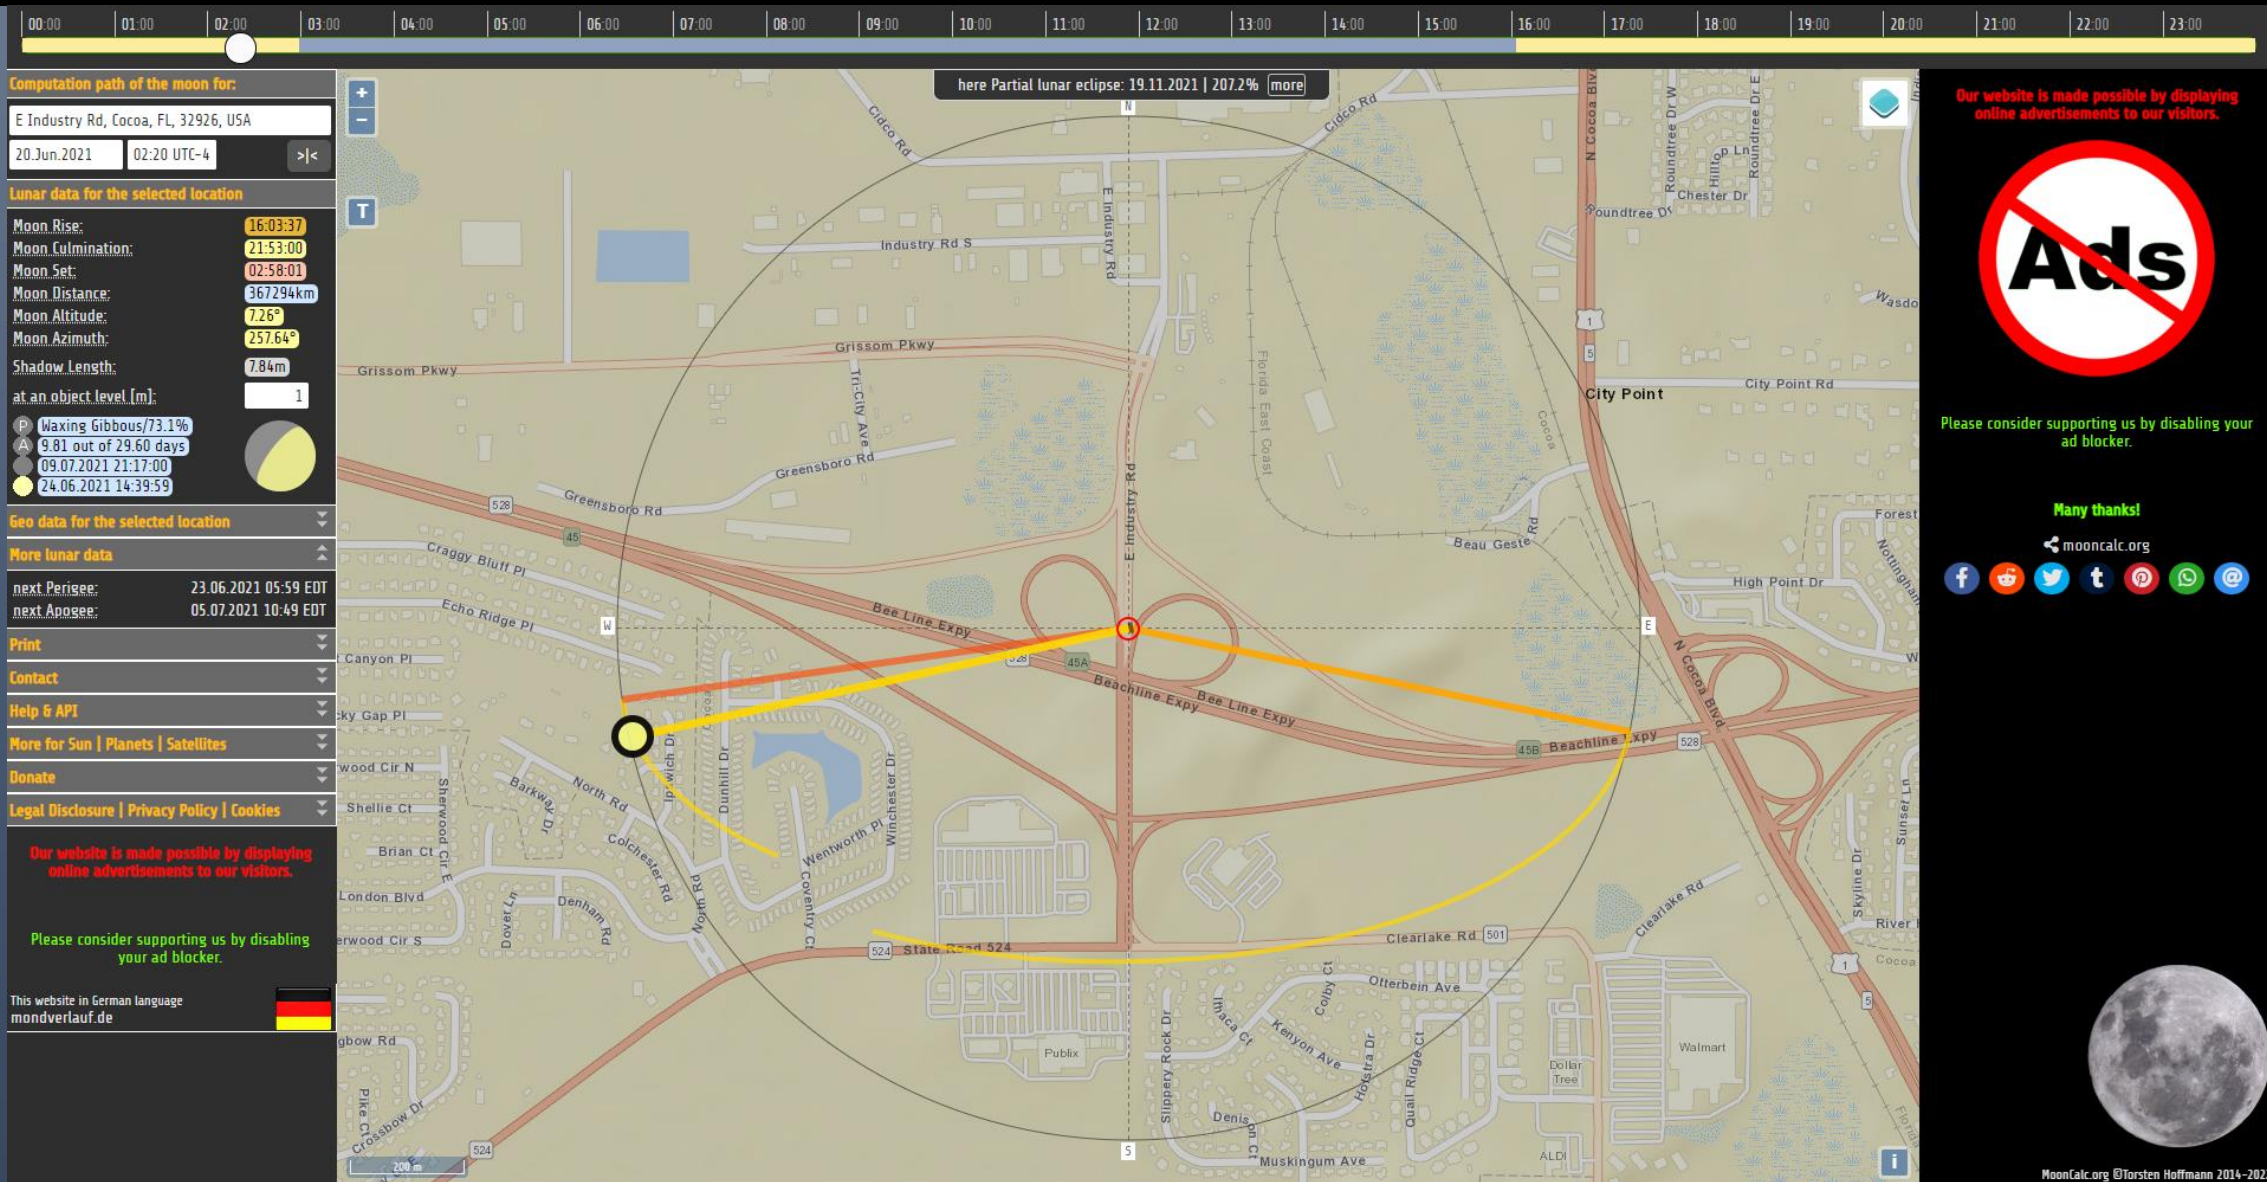
Moon Phase and Position

- The moon was nearly setting at the time of the crash. It's contribution to the available light would be negligible.

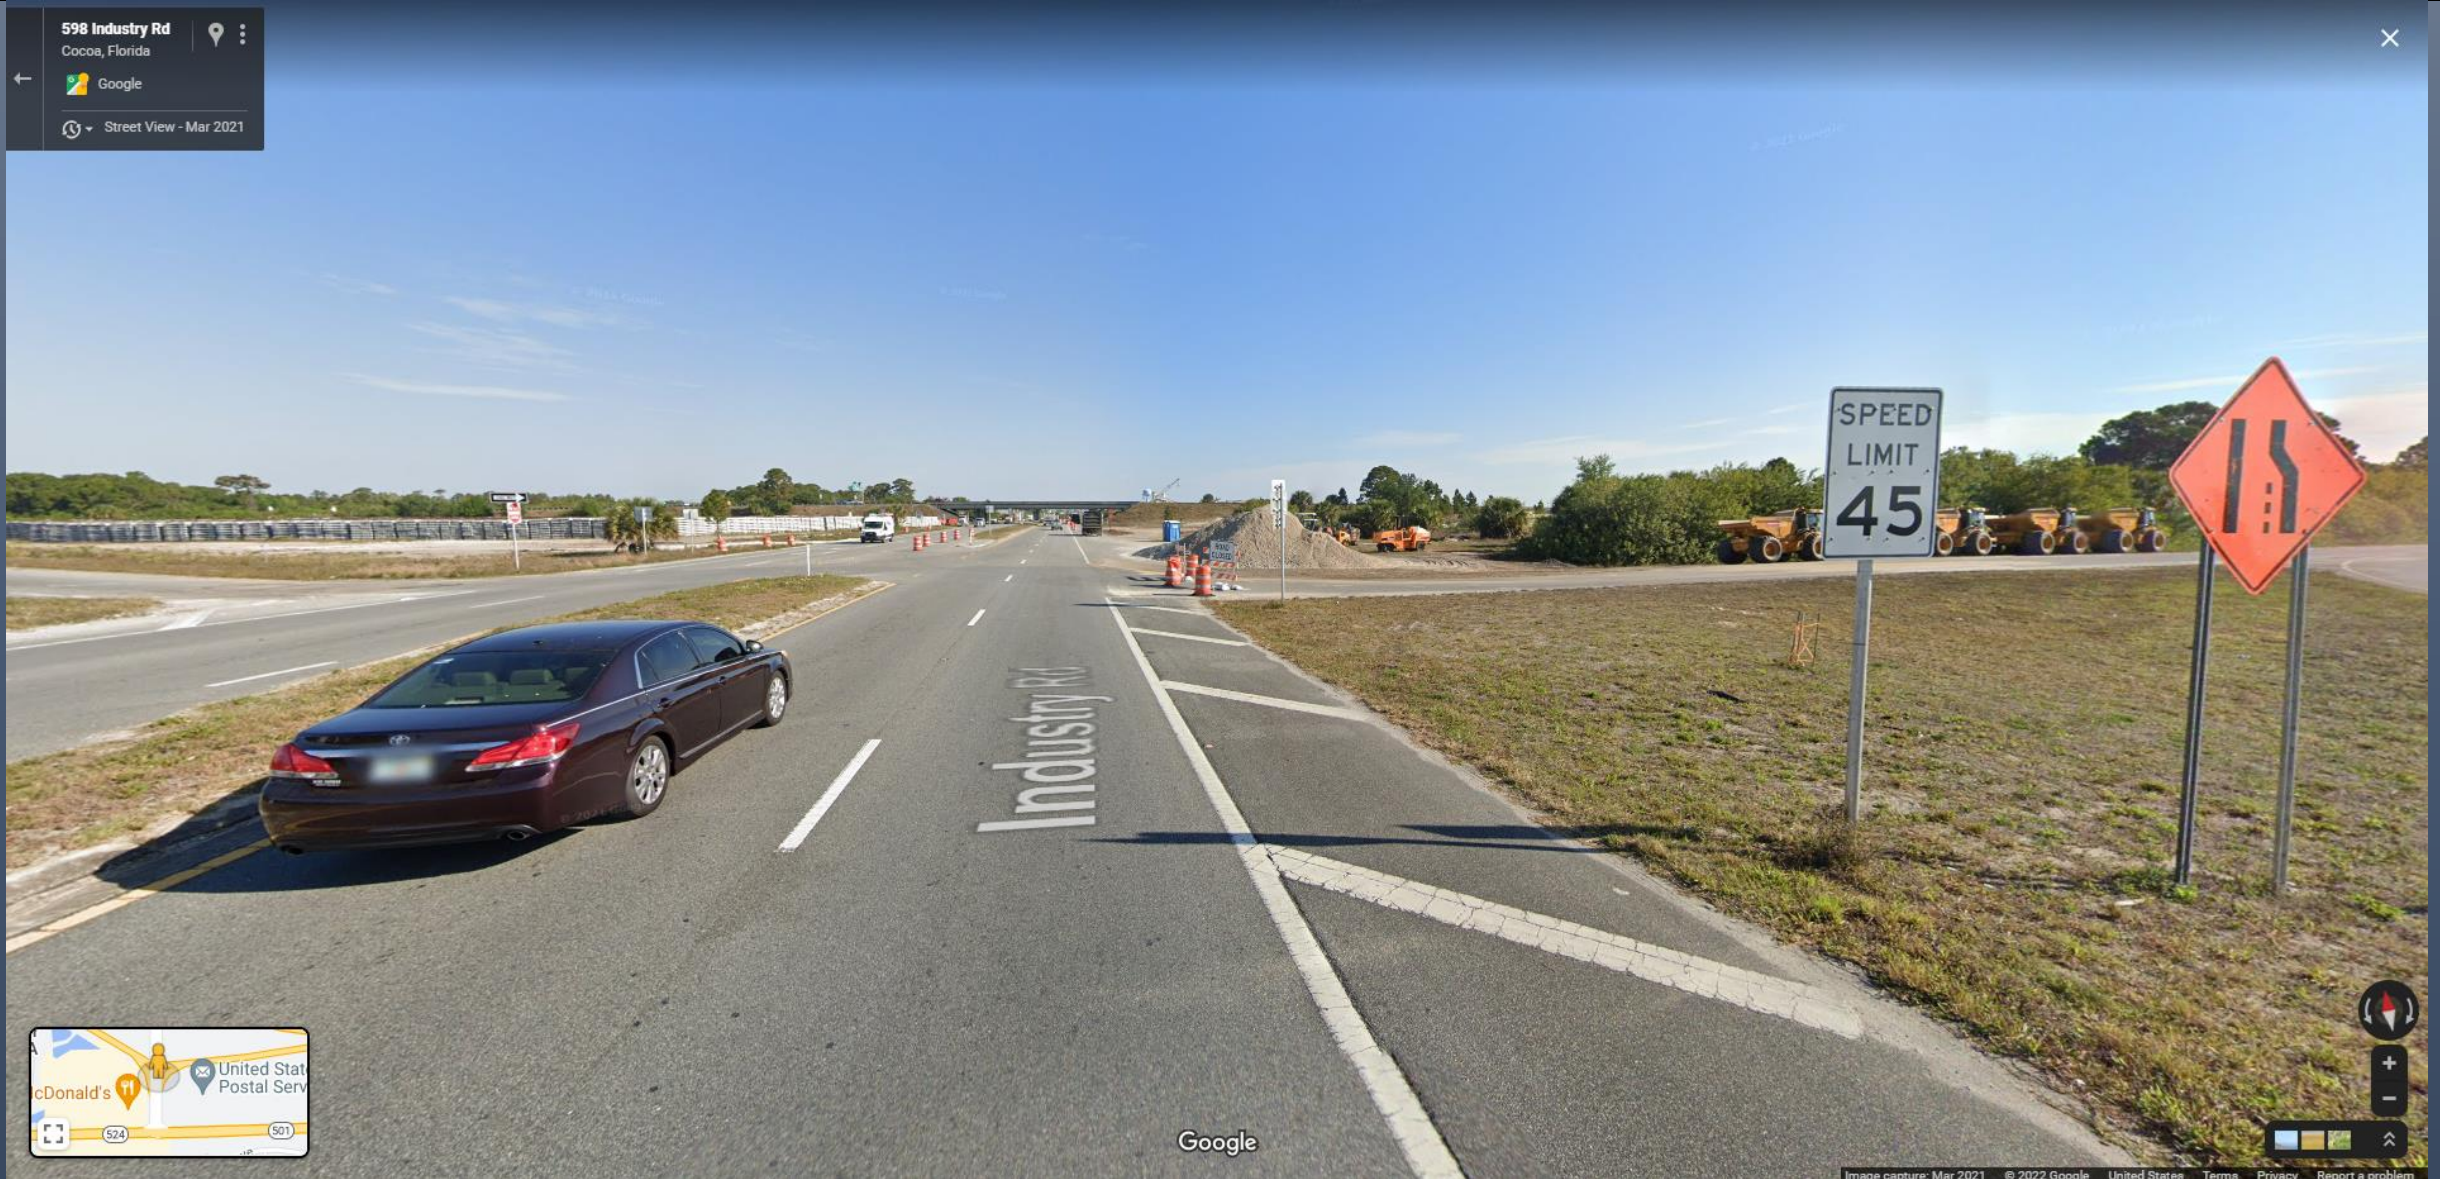
- The speed limit on Industry Road was 45 mph.
- The road was under construction at the time of the crash.

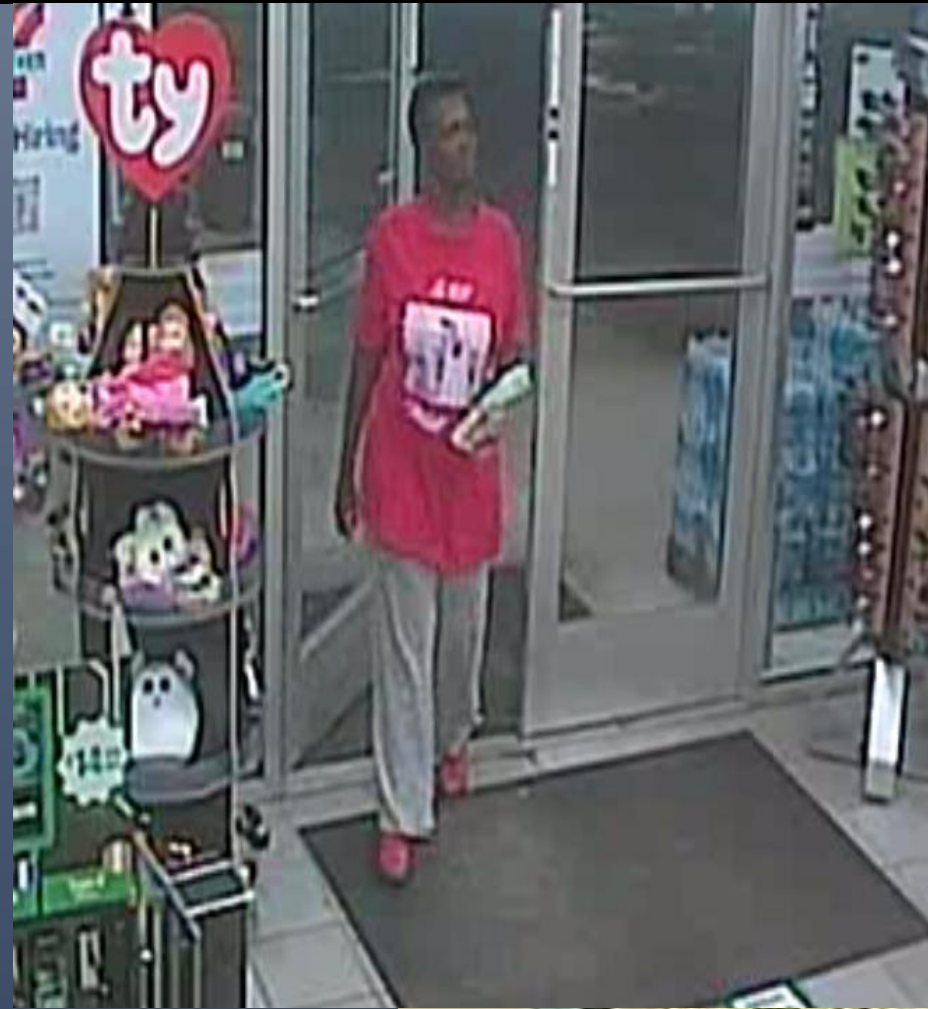
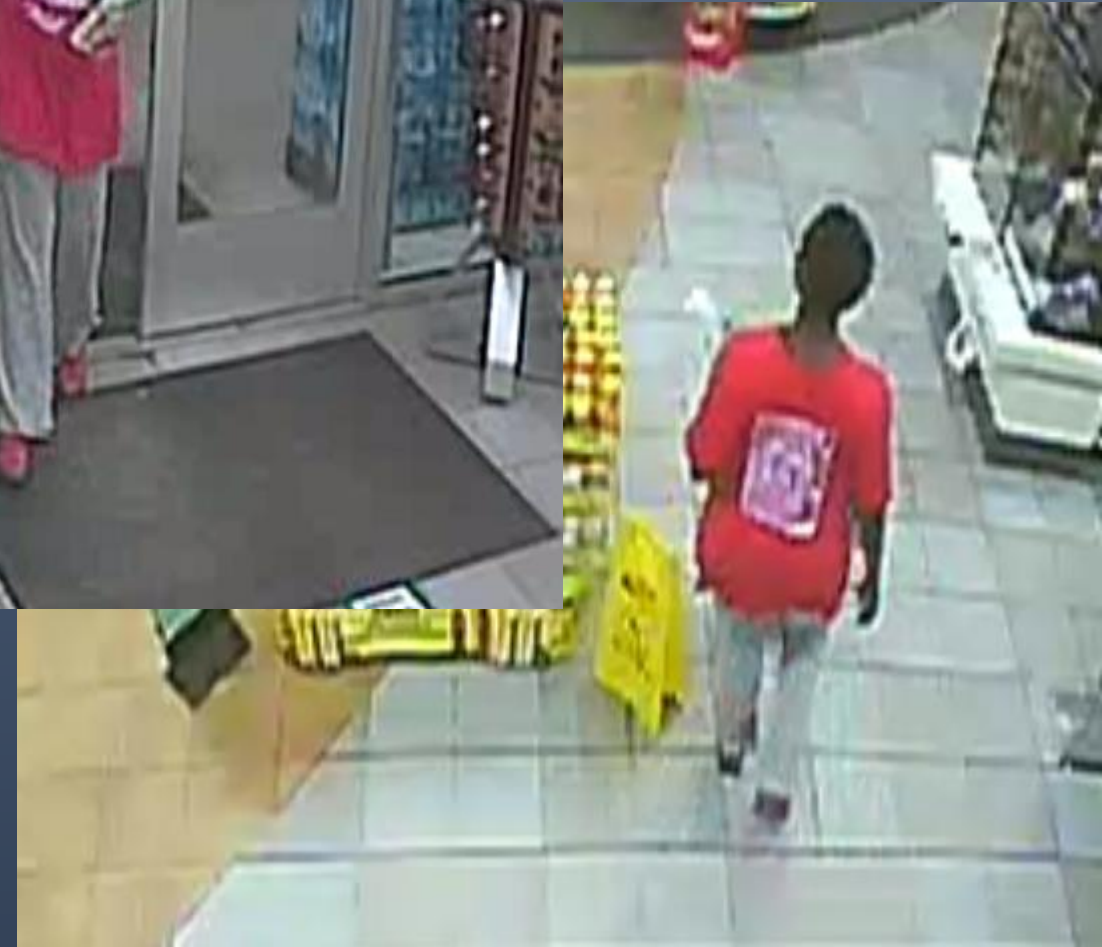
- Security footage captured just prior to the crash show Ms. Lucas wearing light colored pants and a red shirt.

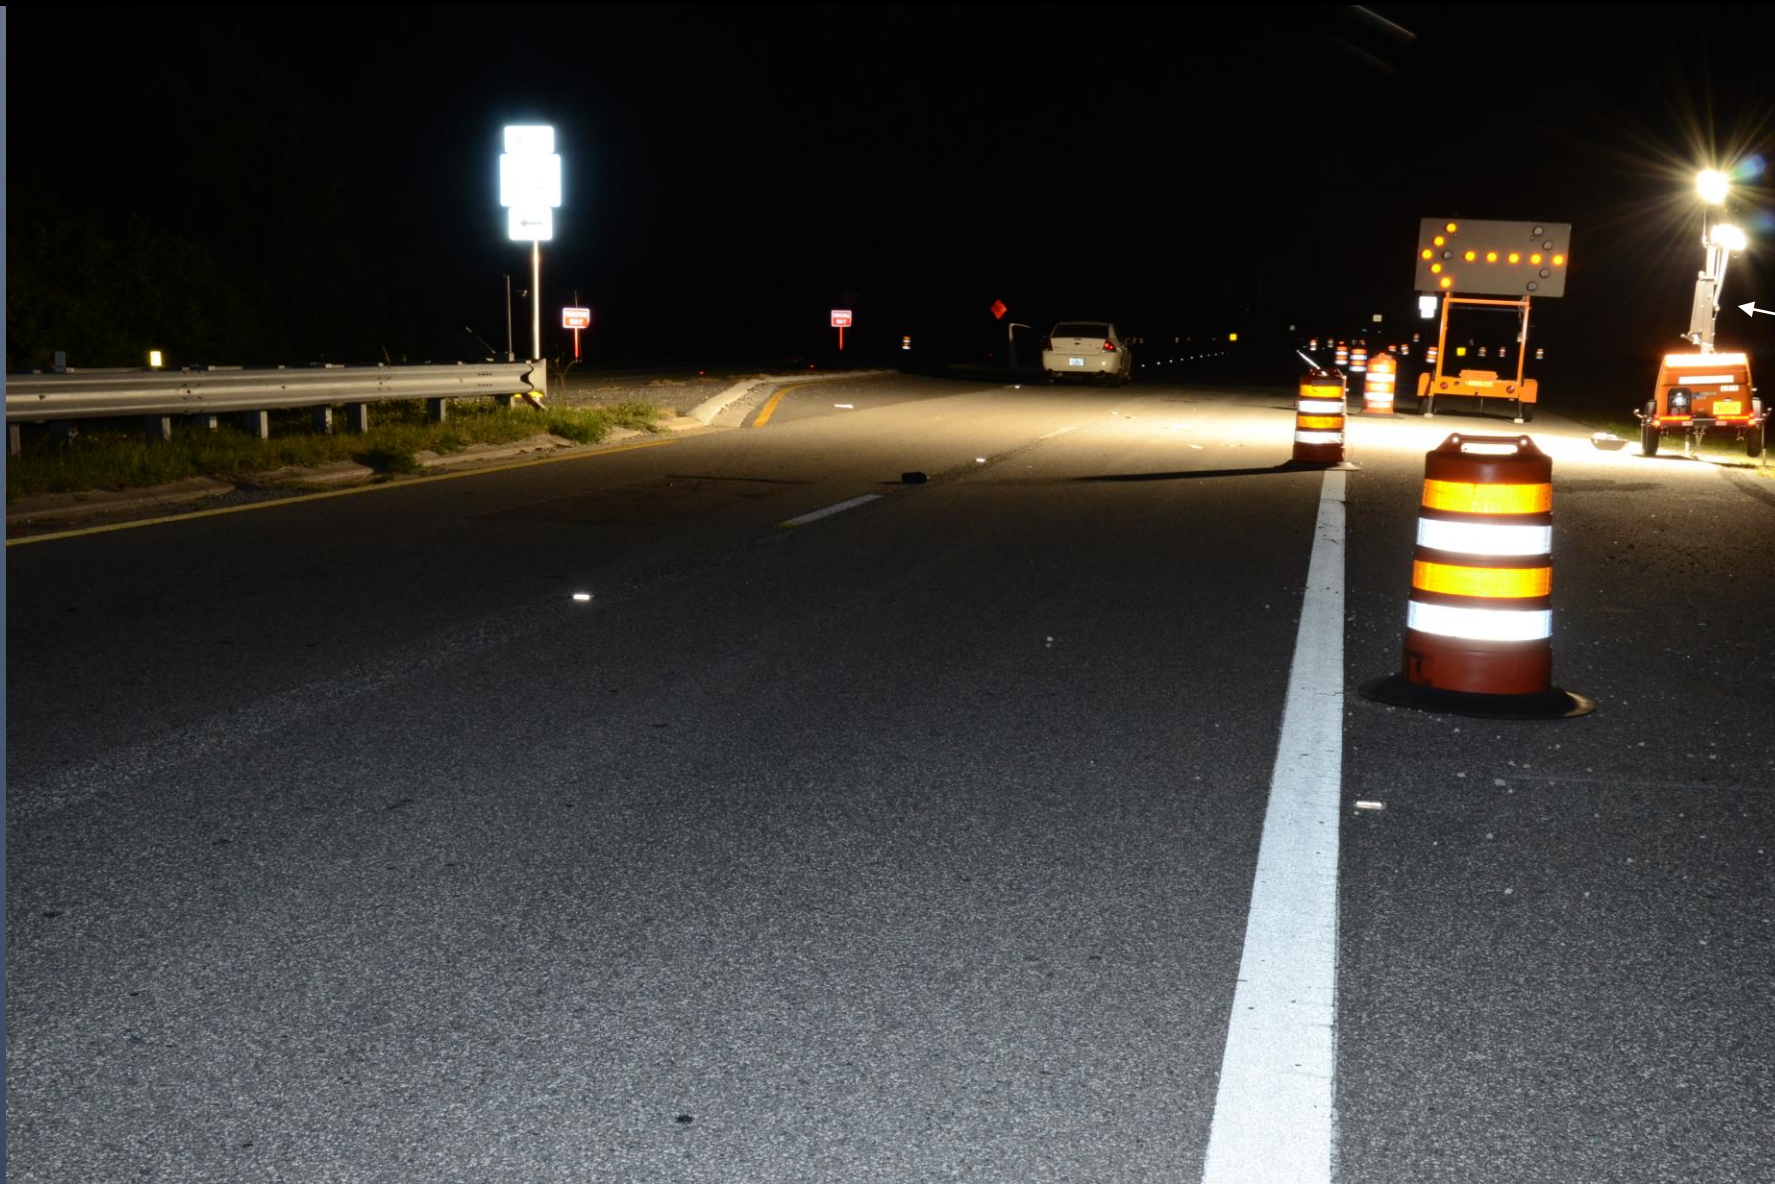
Portable
Light Source

- The police photographed the scene on the night of the crash.
- The police set up a portable light source to illuminate the scene during their investigation.

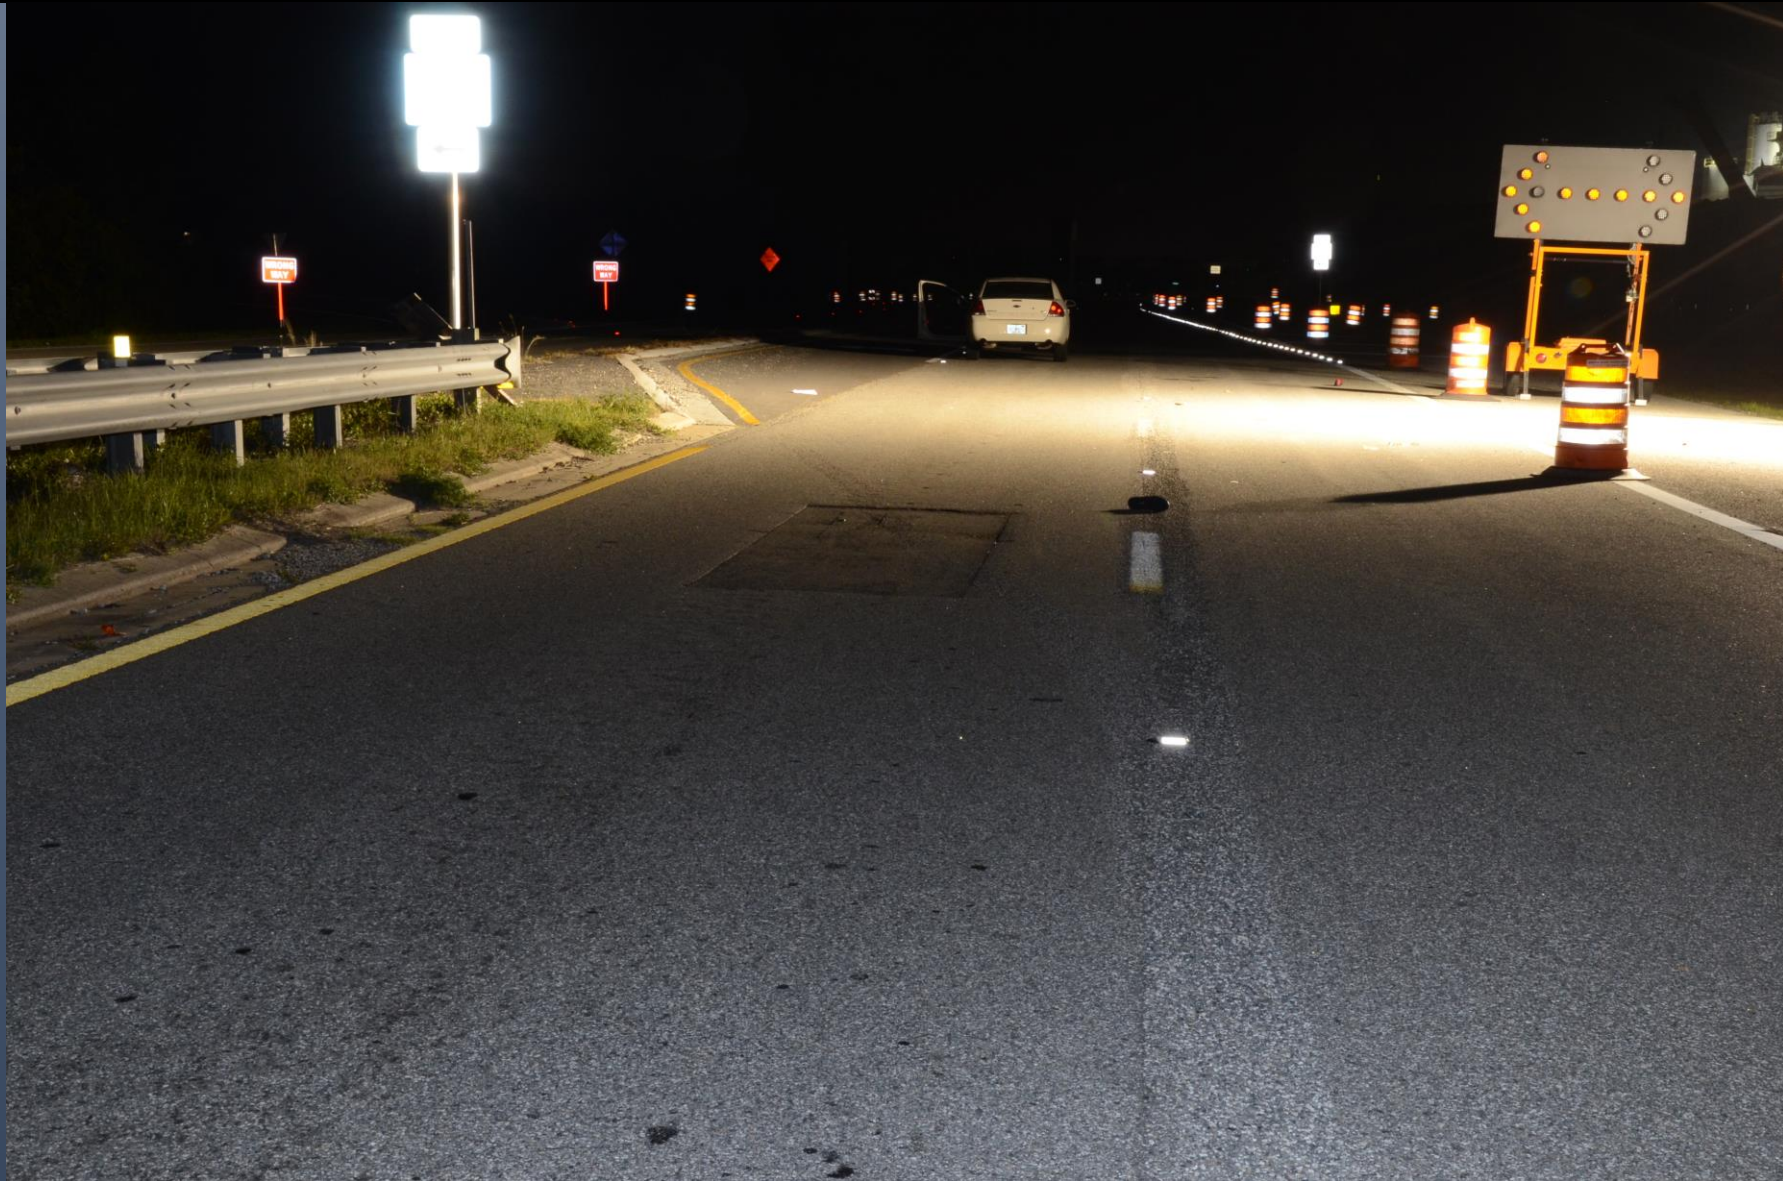
- Drums and a flashing arrow board were present on the night of the crash.
- The roadway was being narrowed from two northbound lanes to one northbound lane.

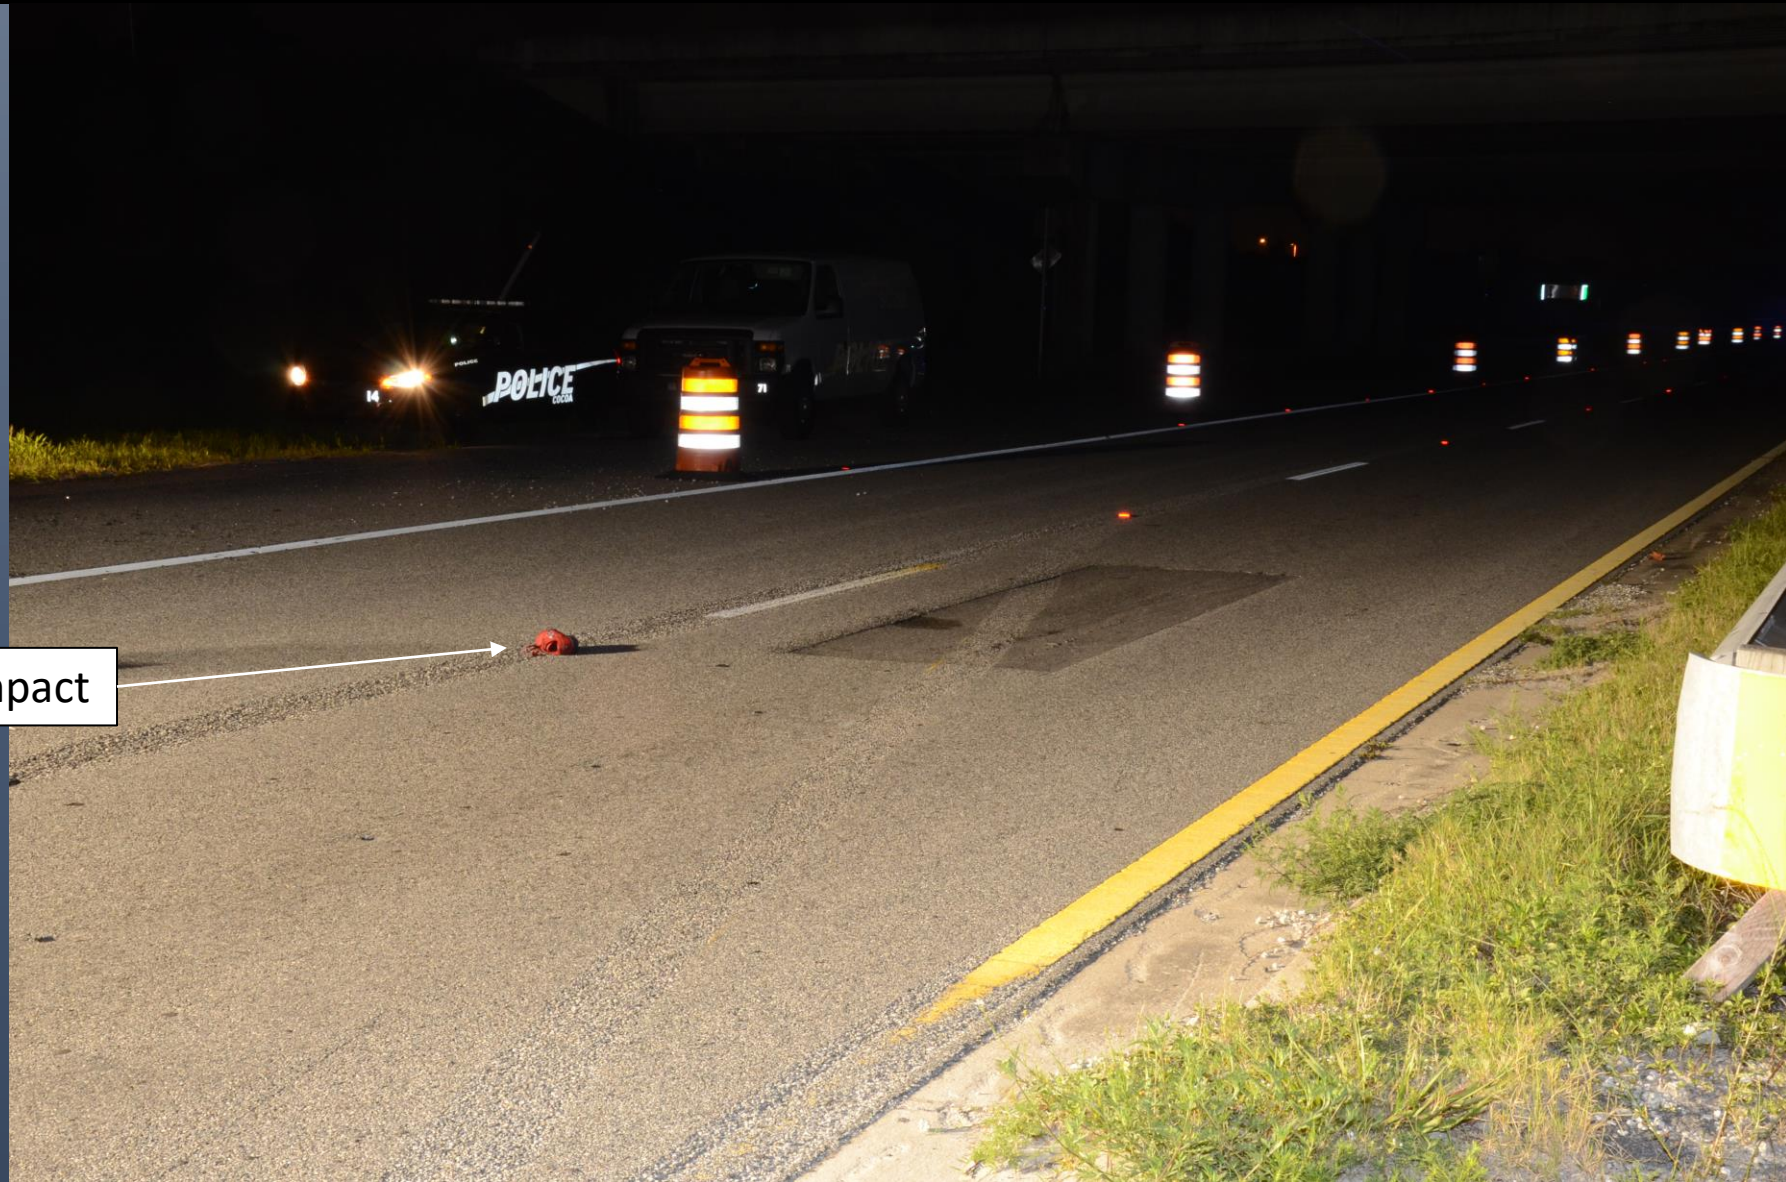
Evidence of Impact

- Looking backwards towards the point of impact.

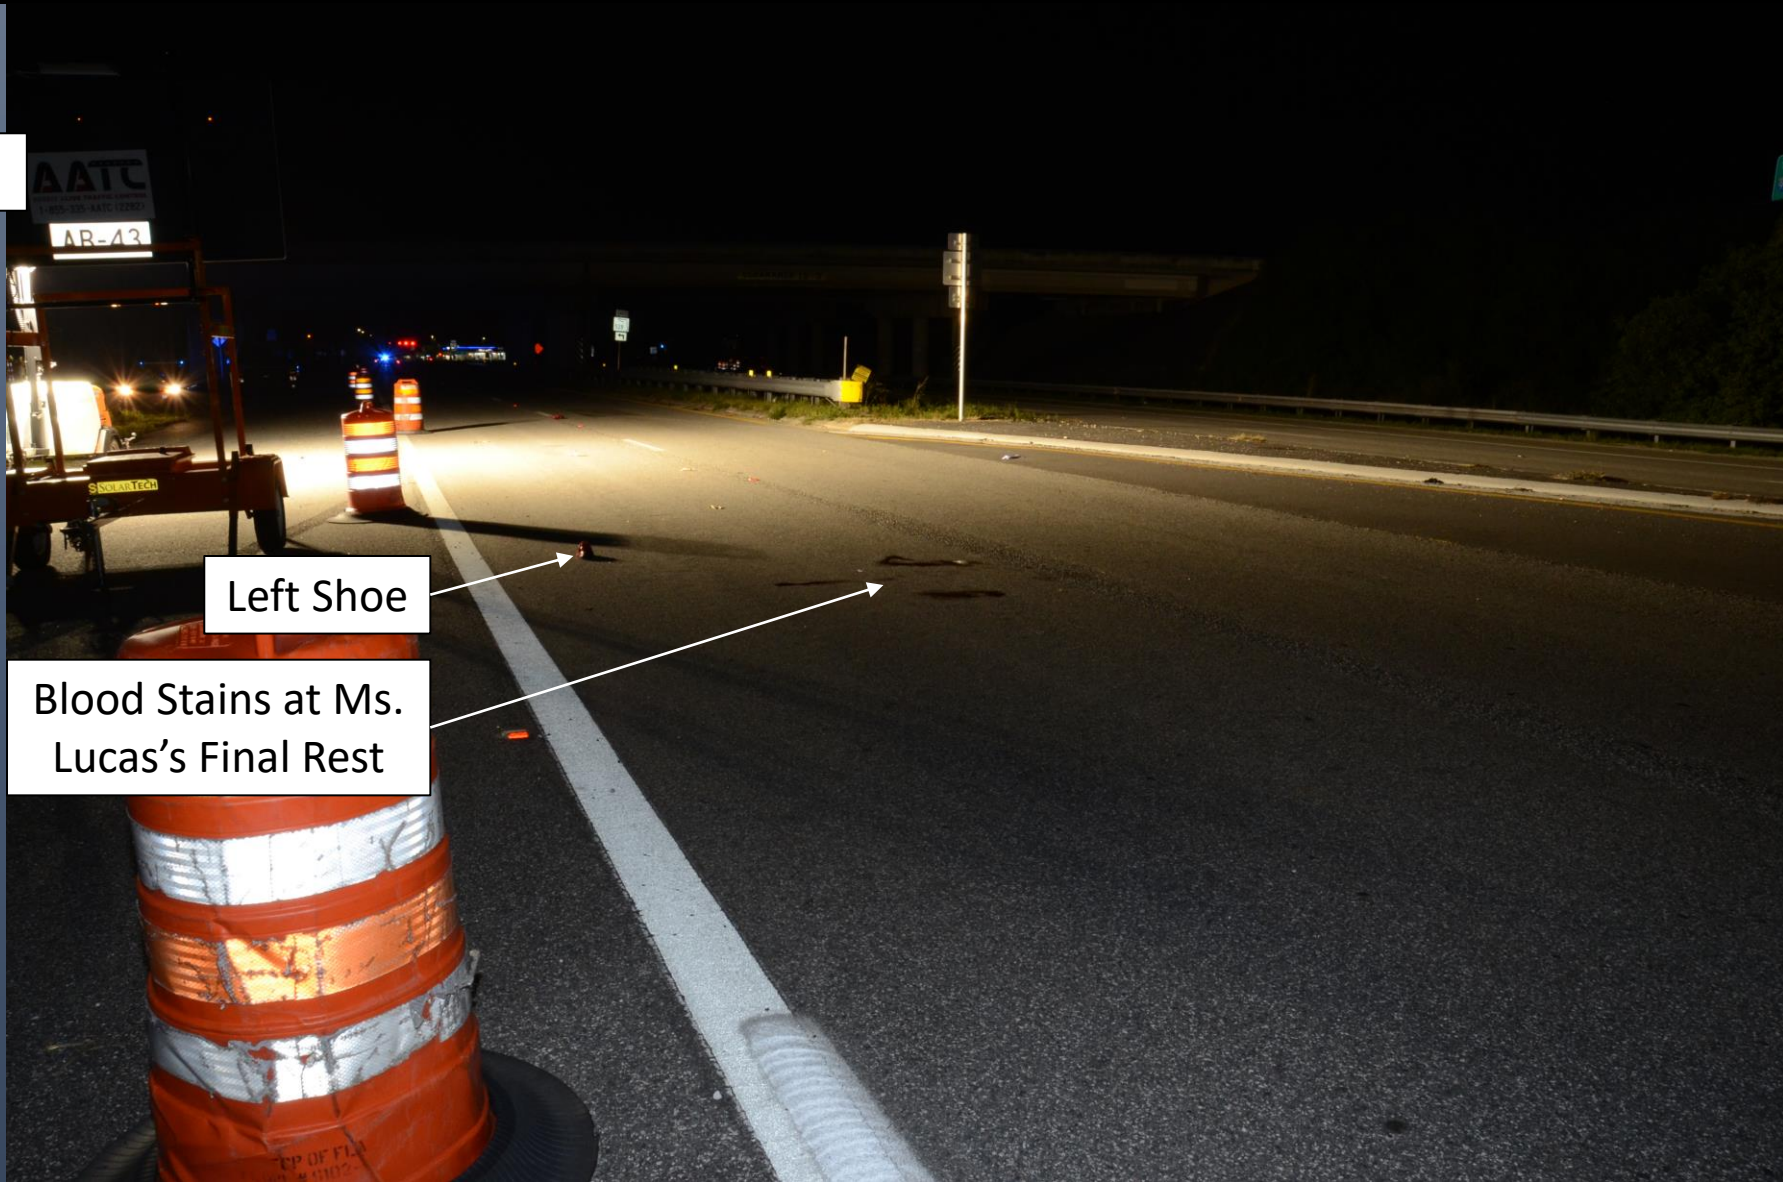
- Blood stains indicate that Ms. Lucas came to rest just north of the flashing arrow board.

- Looking backwards towards Ms. Lucas's final rest position.

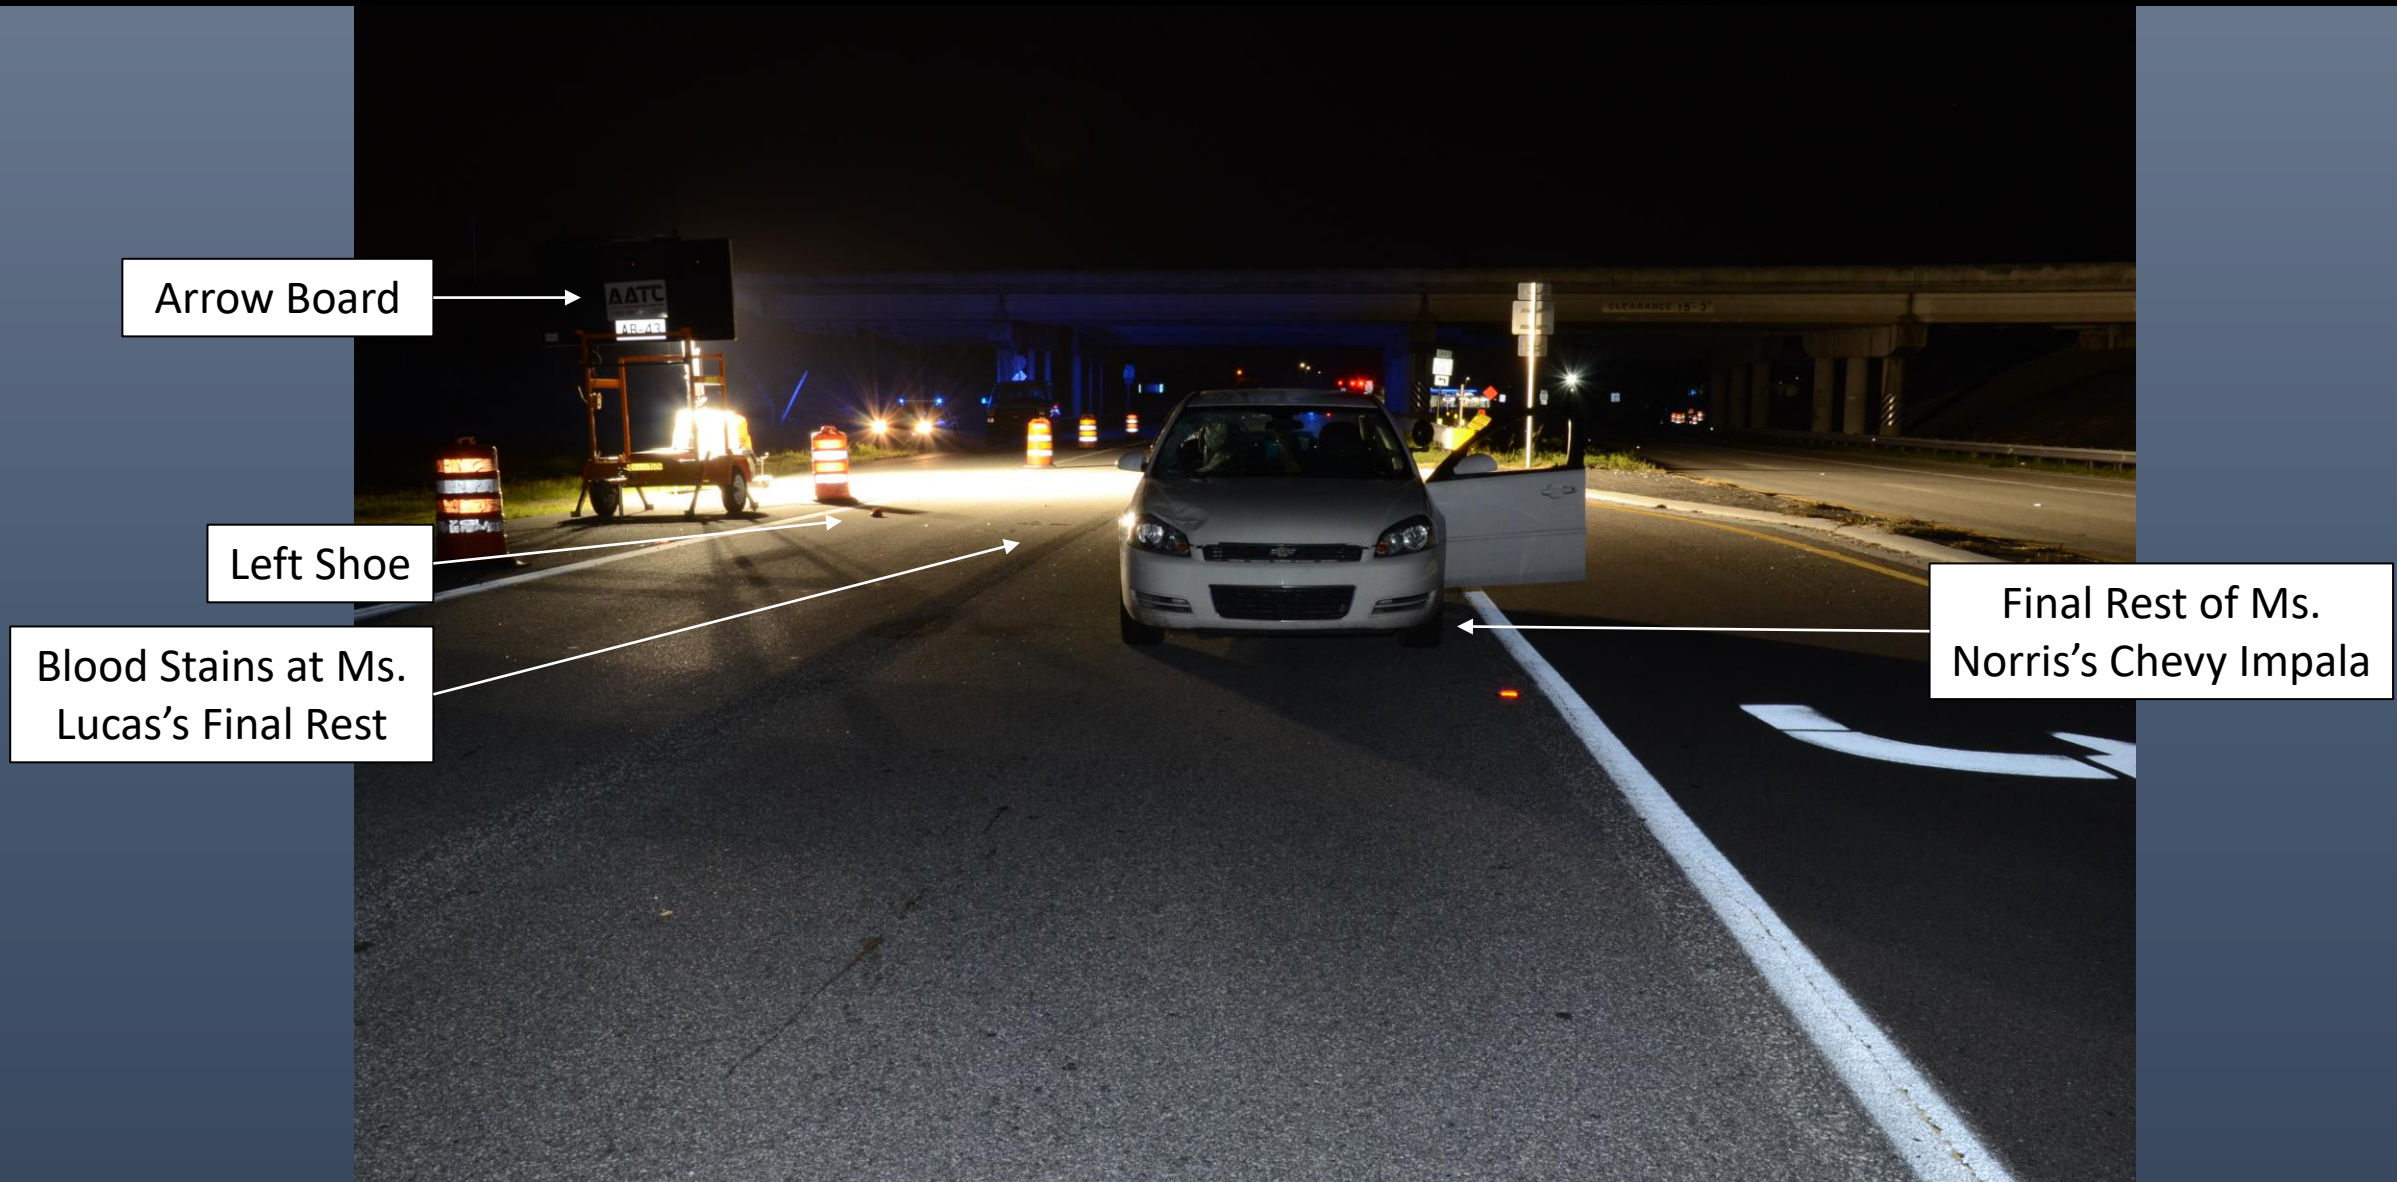
- Ms. Norris's vehicle in a stopped position at the scene of the crash.

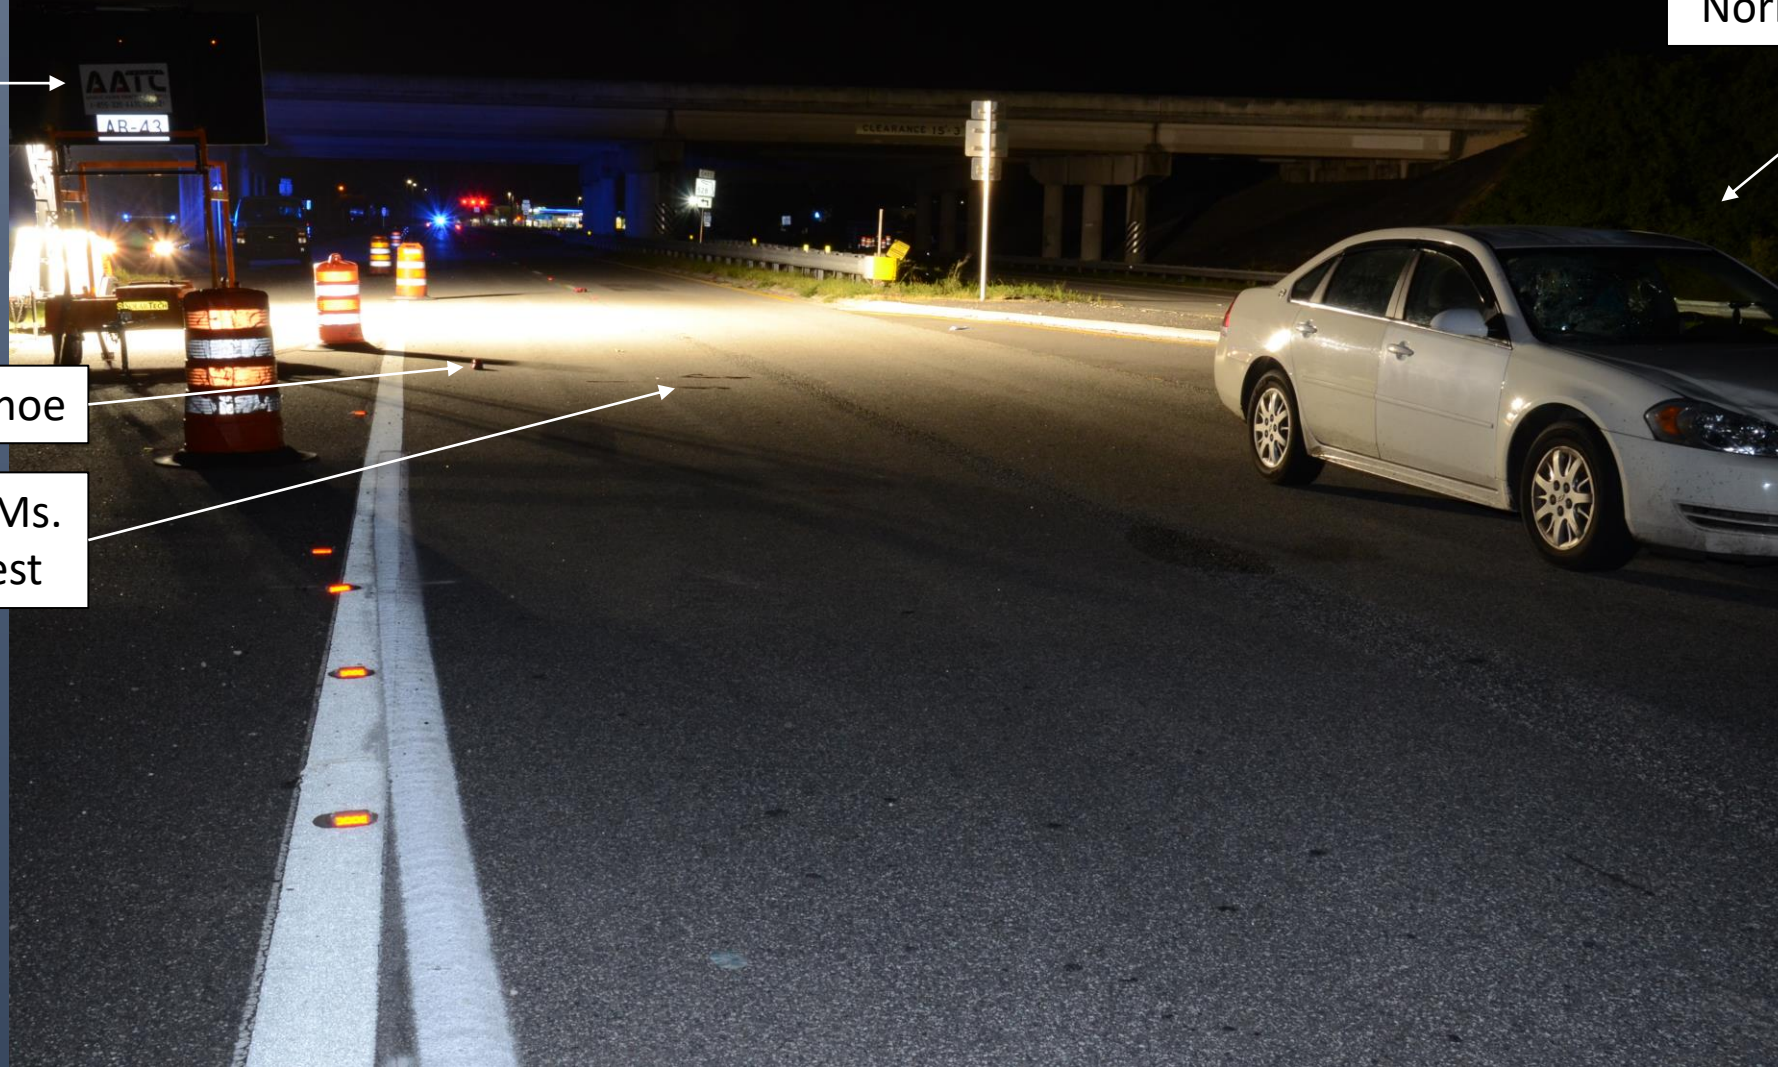
- Ms. Norris's vehicle relative to Ms. Lucas's final rest position.

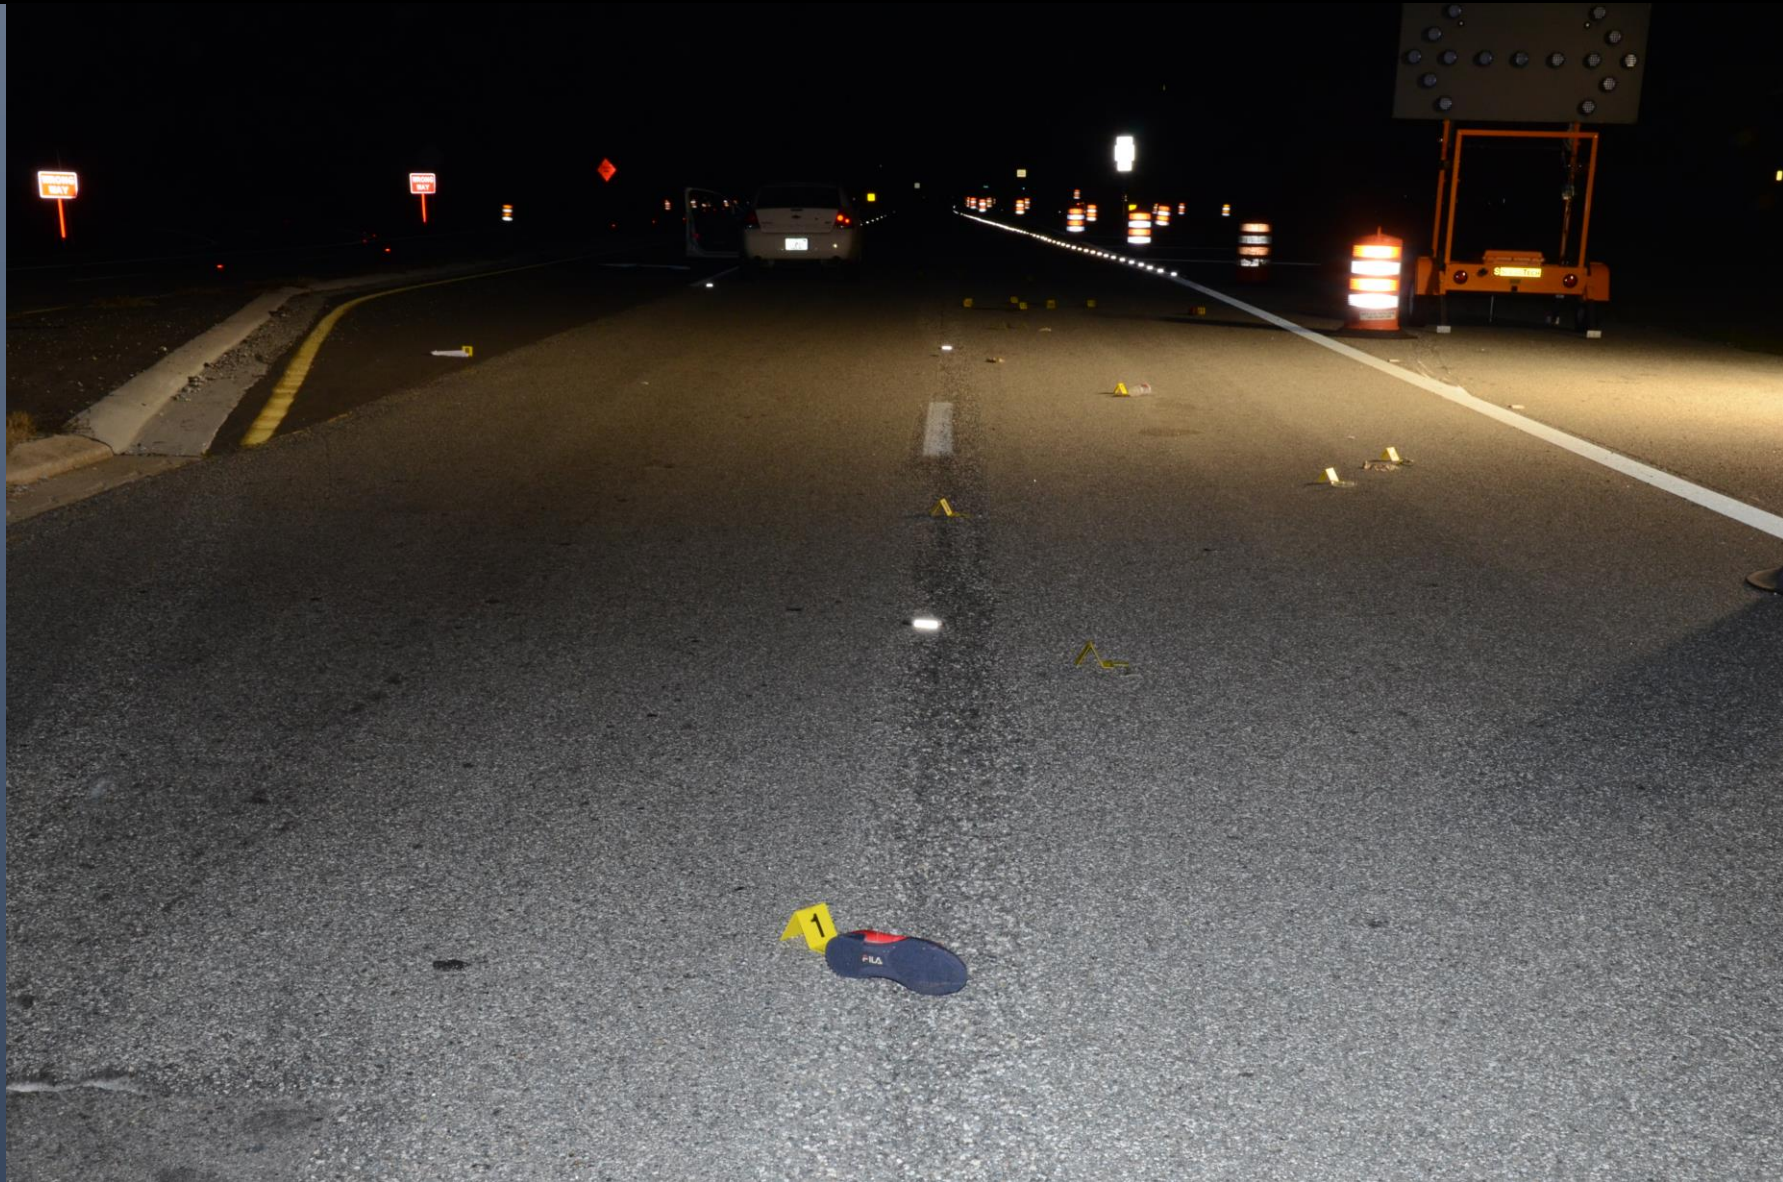
- Debris field marked with evidence markers.
