Crash Reconstruction and Transportation Engineering Analysis

40-12724 (State v. Norris)

Kelly Palframan, Ph.D., P.E.

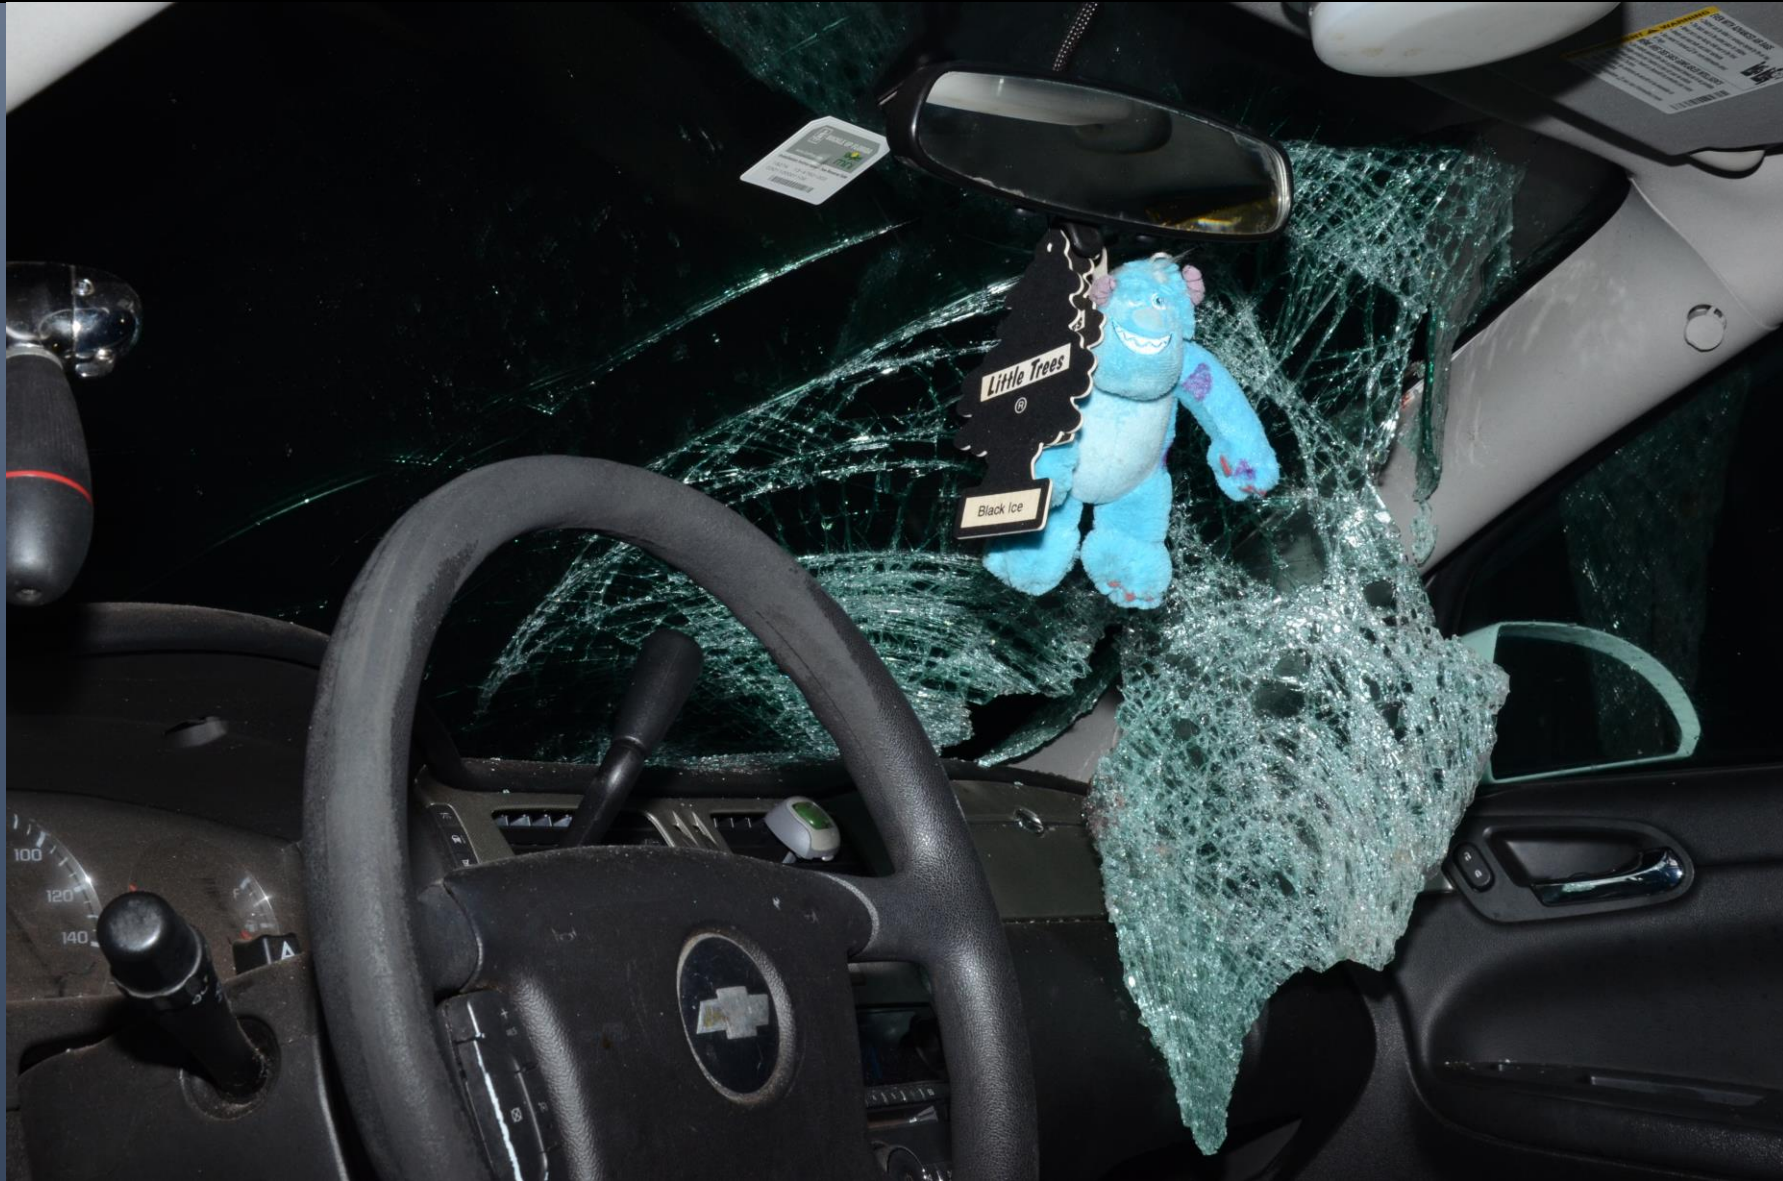
- Items hanging from rear view mirror.

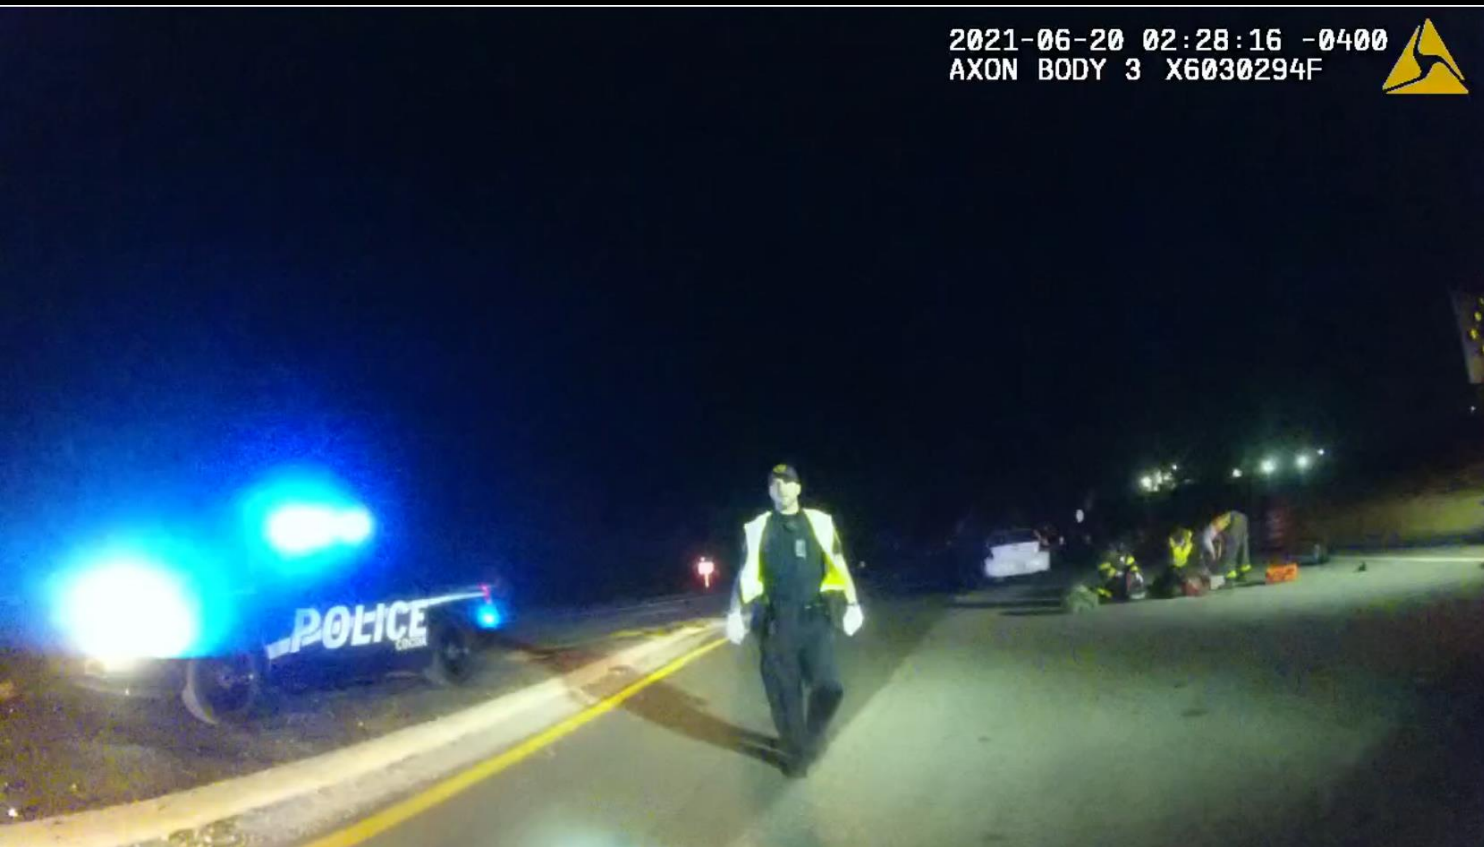
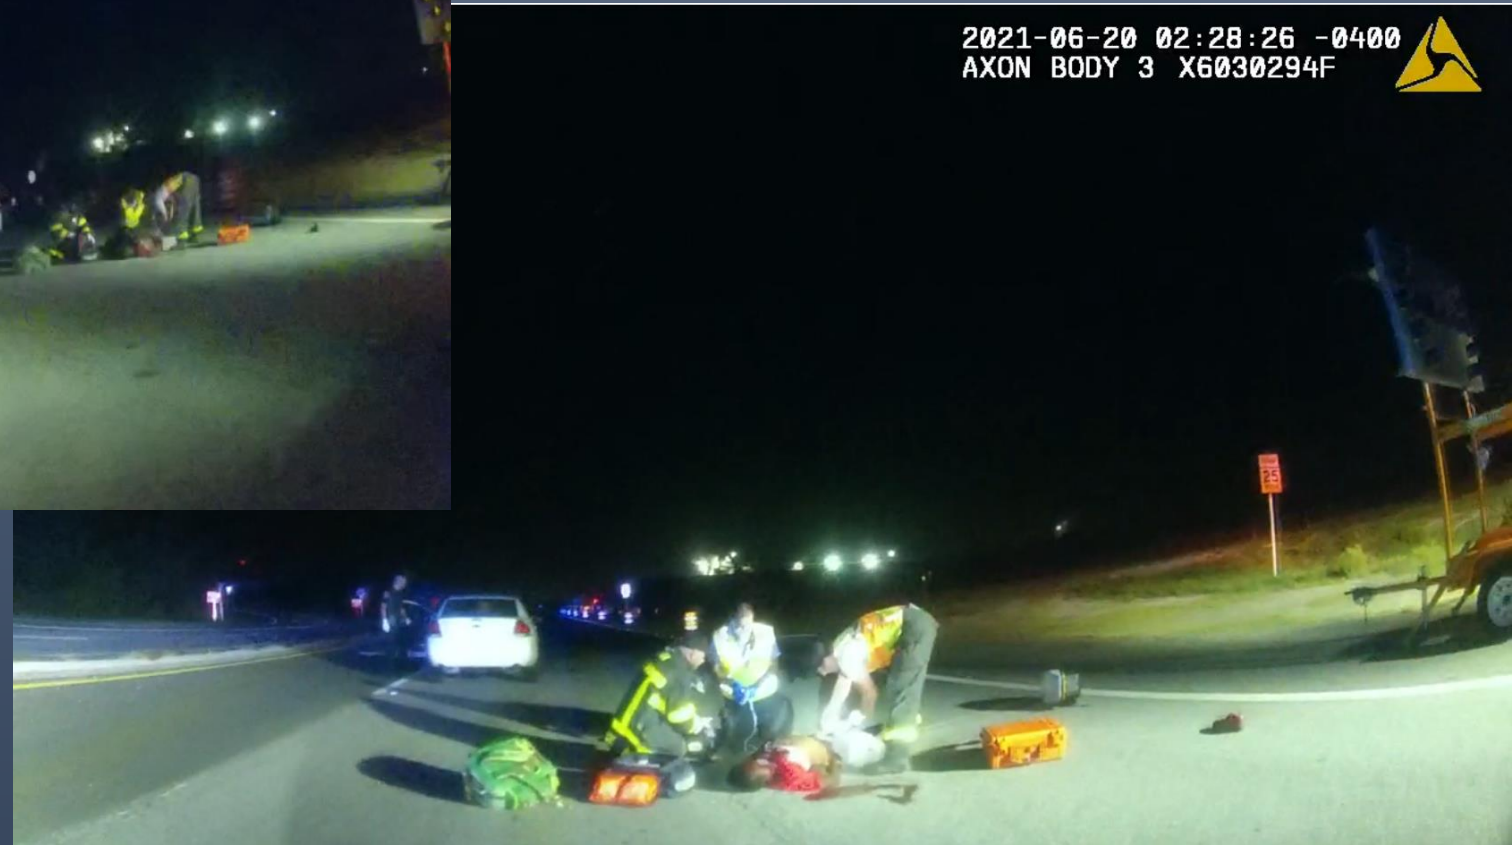
- Arrow board is illuminated in a flashing manner.

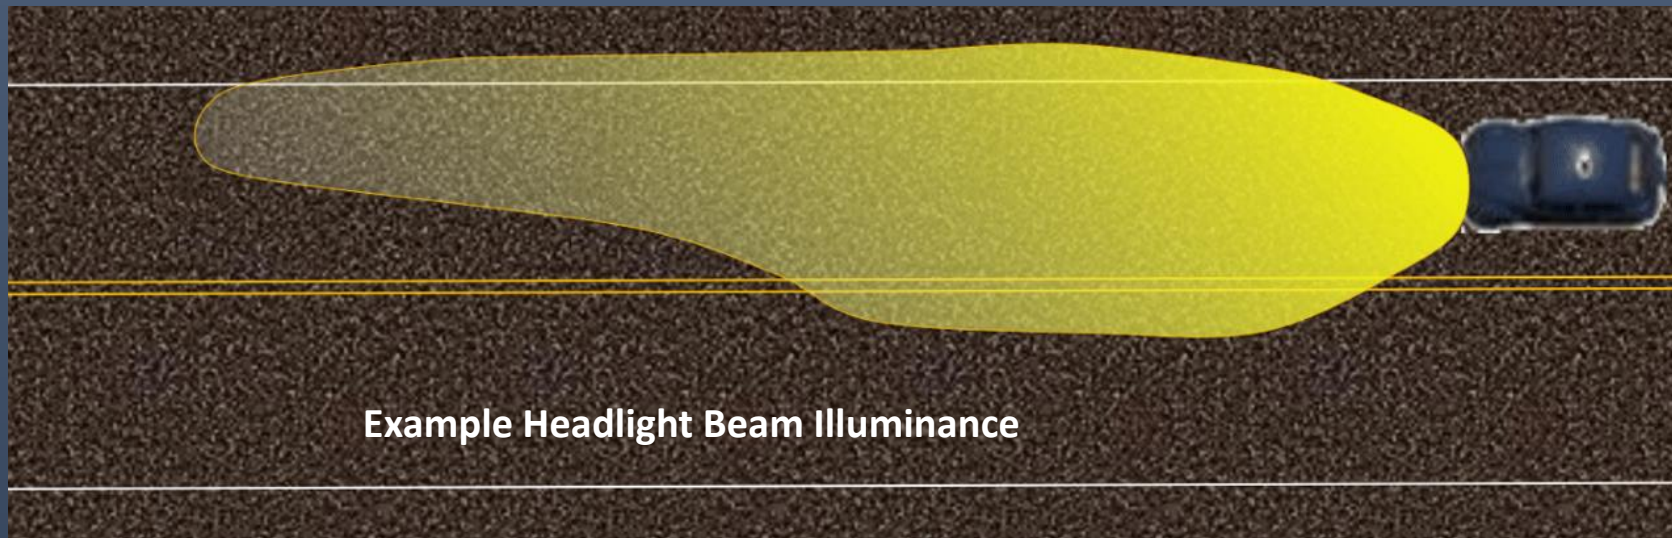
- Florida Statutes require 150 ft of illumination from a vehicle's low beam headlights. It does not require headlights to have symmetric light distribution.
- Pedestrians located on the driver's side of the vehicle are less illuminated than on the right side; therefore, they are more readily detectable right side vs. left side.

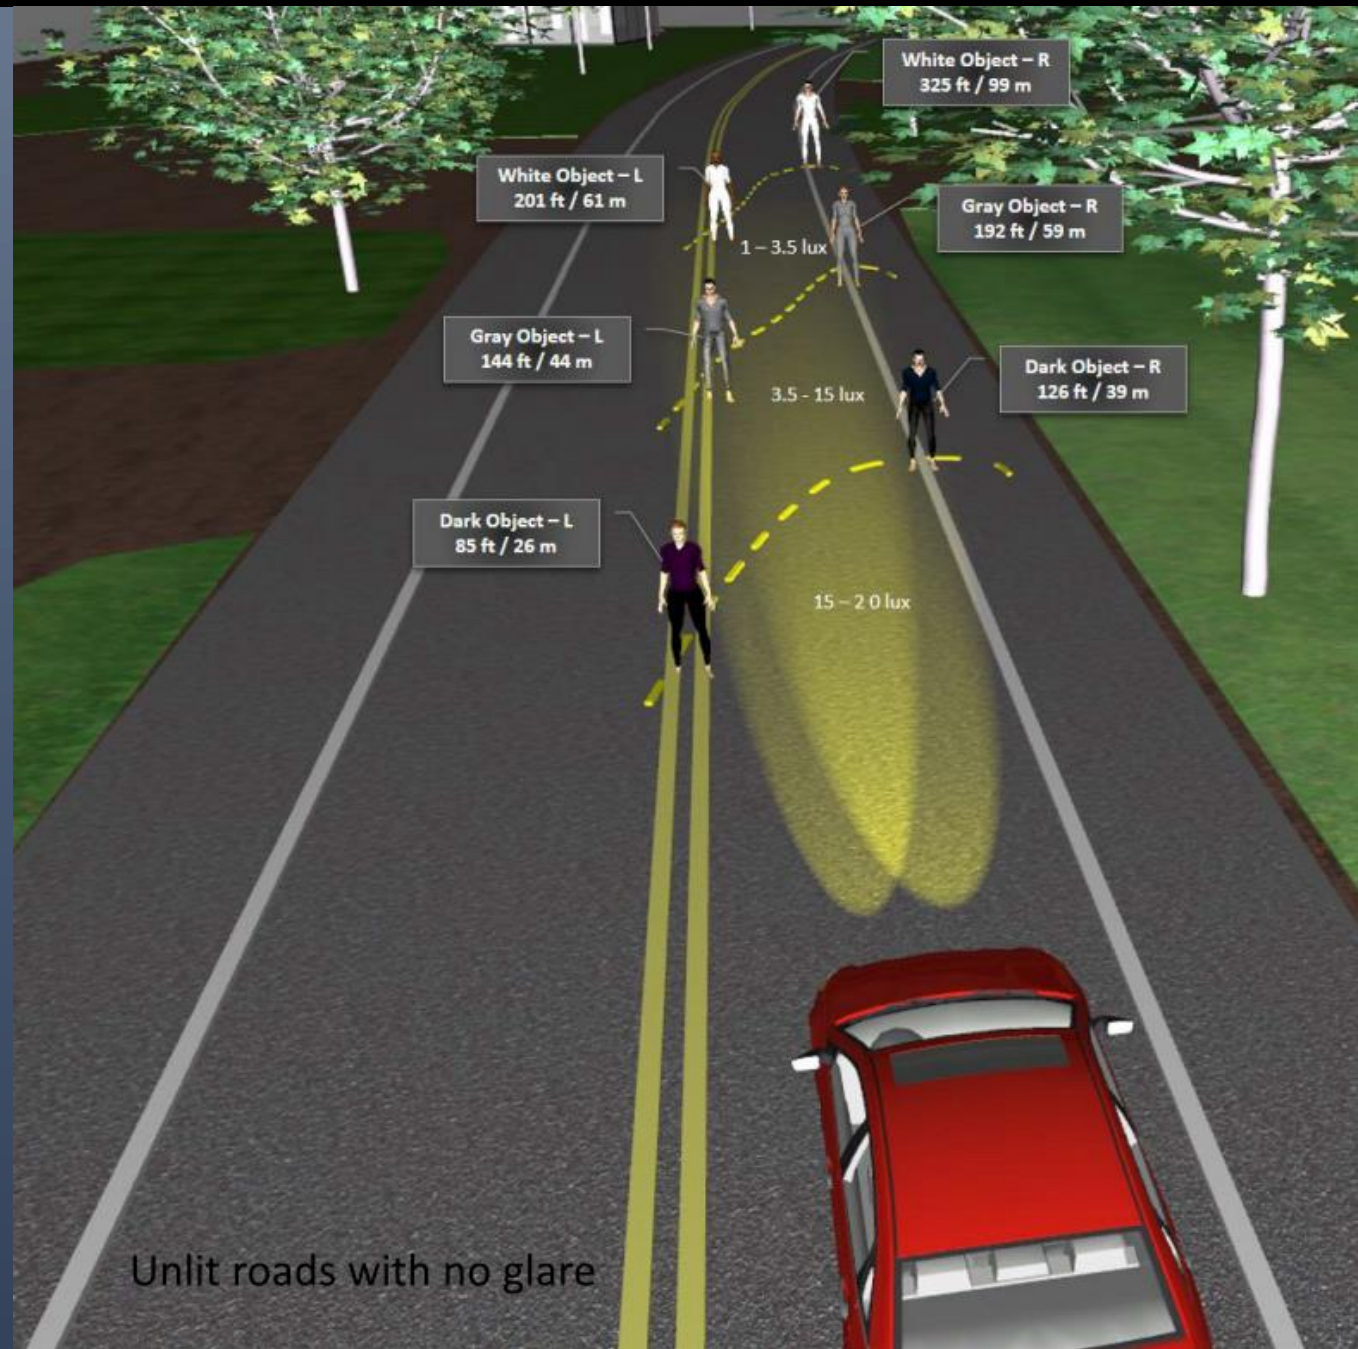
- Typical pedestrian visibility on dark unlit roads with no glare.
- Pedestrian clothing is averaged out into a grey-scale representation for the purposes of nighttime pedestrian visibility.
- A red shirt and light-colored pants would conservatively be considered a light grey object.

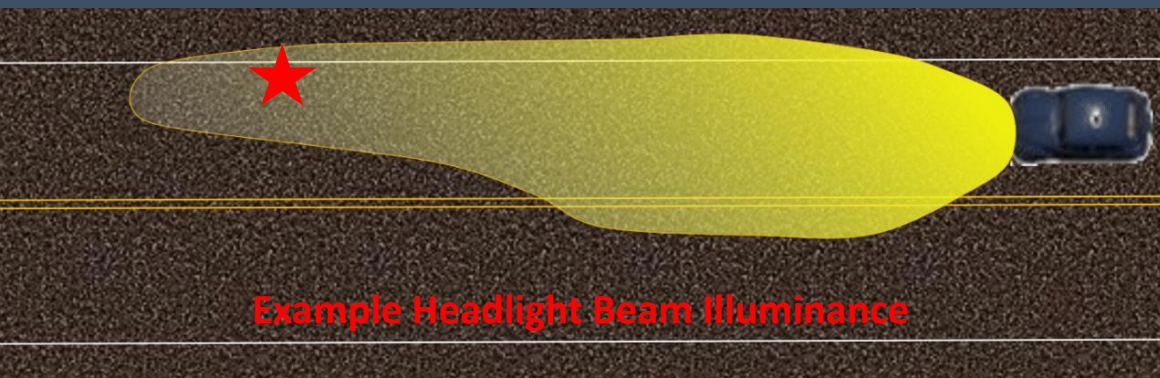
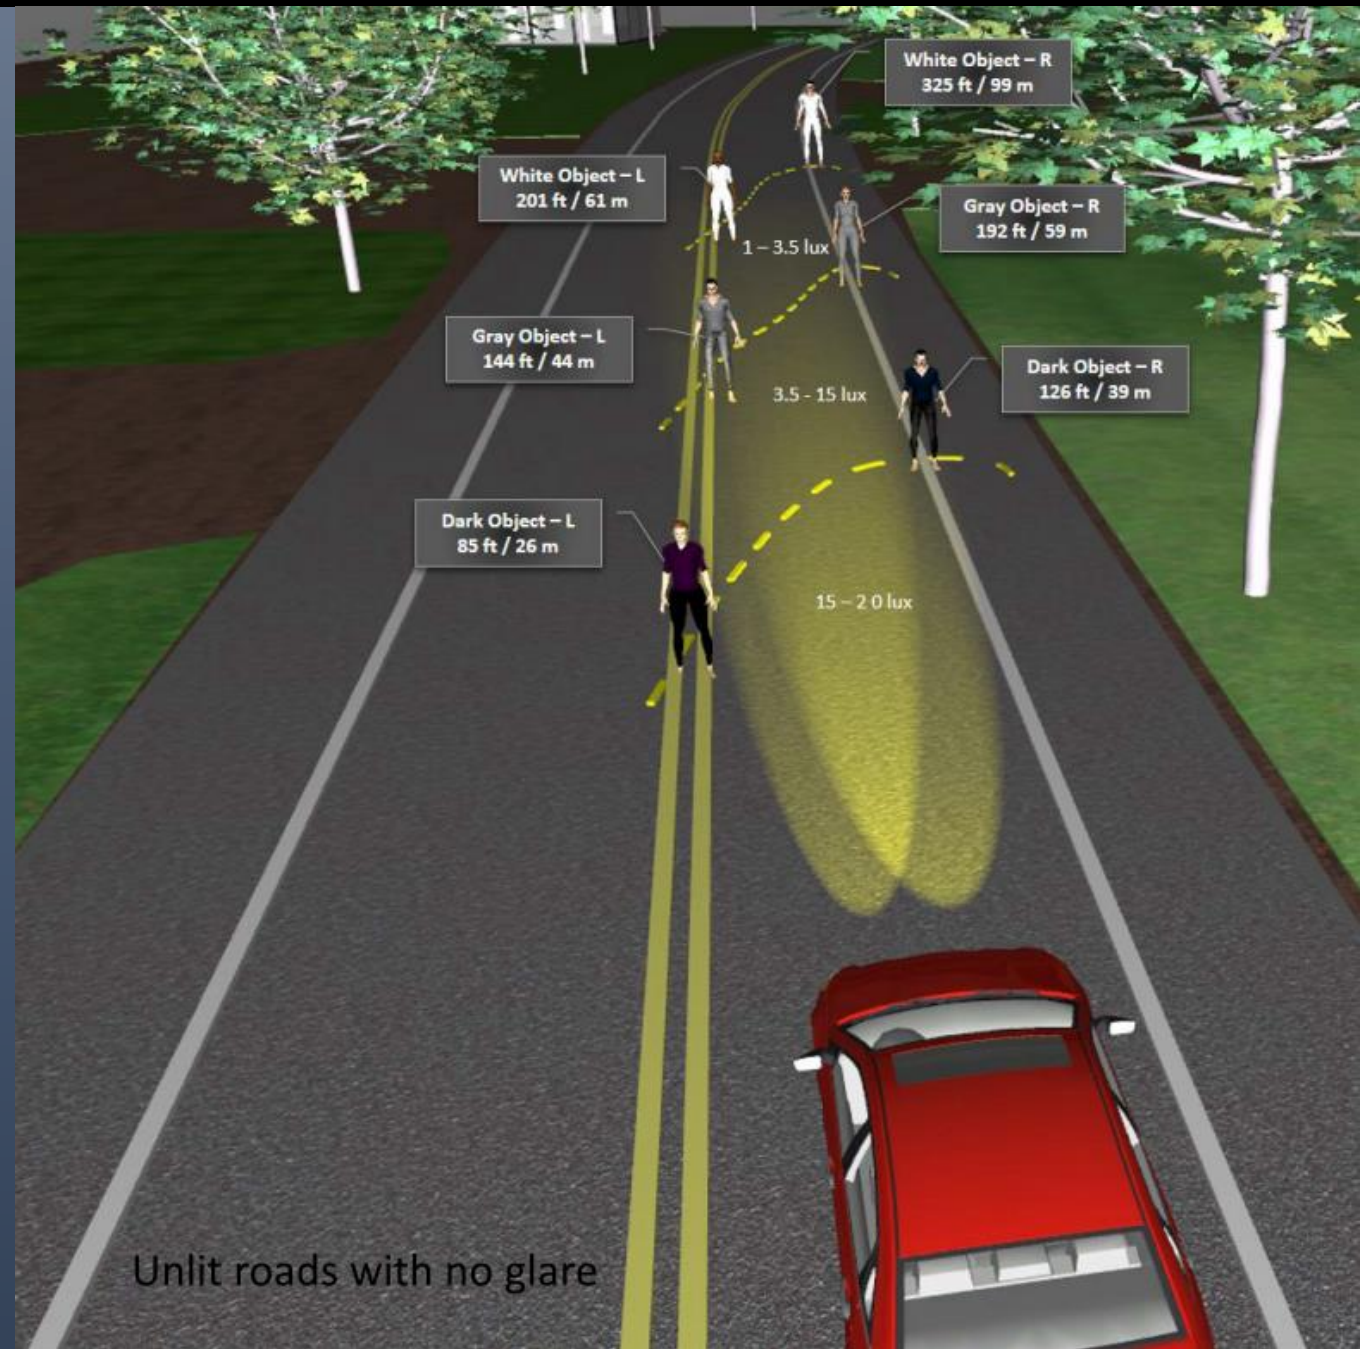
- Under the conditions presented in this case:
 - Given the age of the Chevrolet Impala's headlights and the relative position of Ms. Lucas within the headlight projection, the headlights would have provided 3 to 5 Lux of illumination onto Ms. Lucas beginning when the Chevrolet was 180 to 226 feet prior to impact, with increasing illumination as the vehicle drew closer.

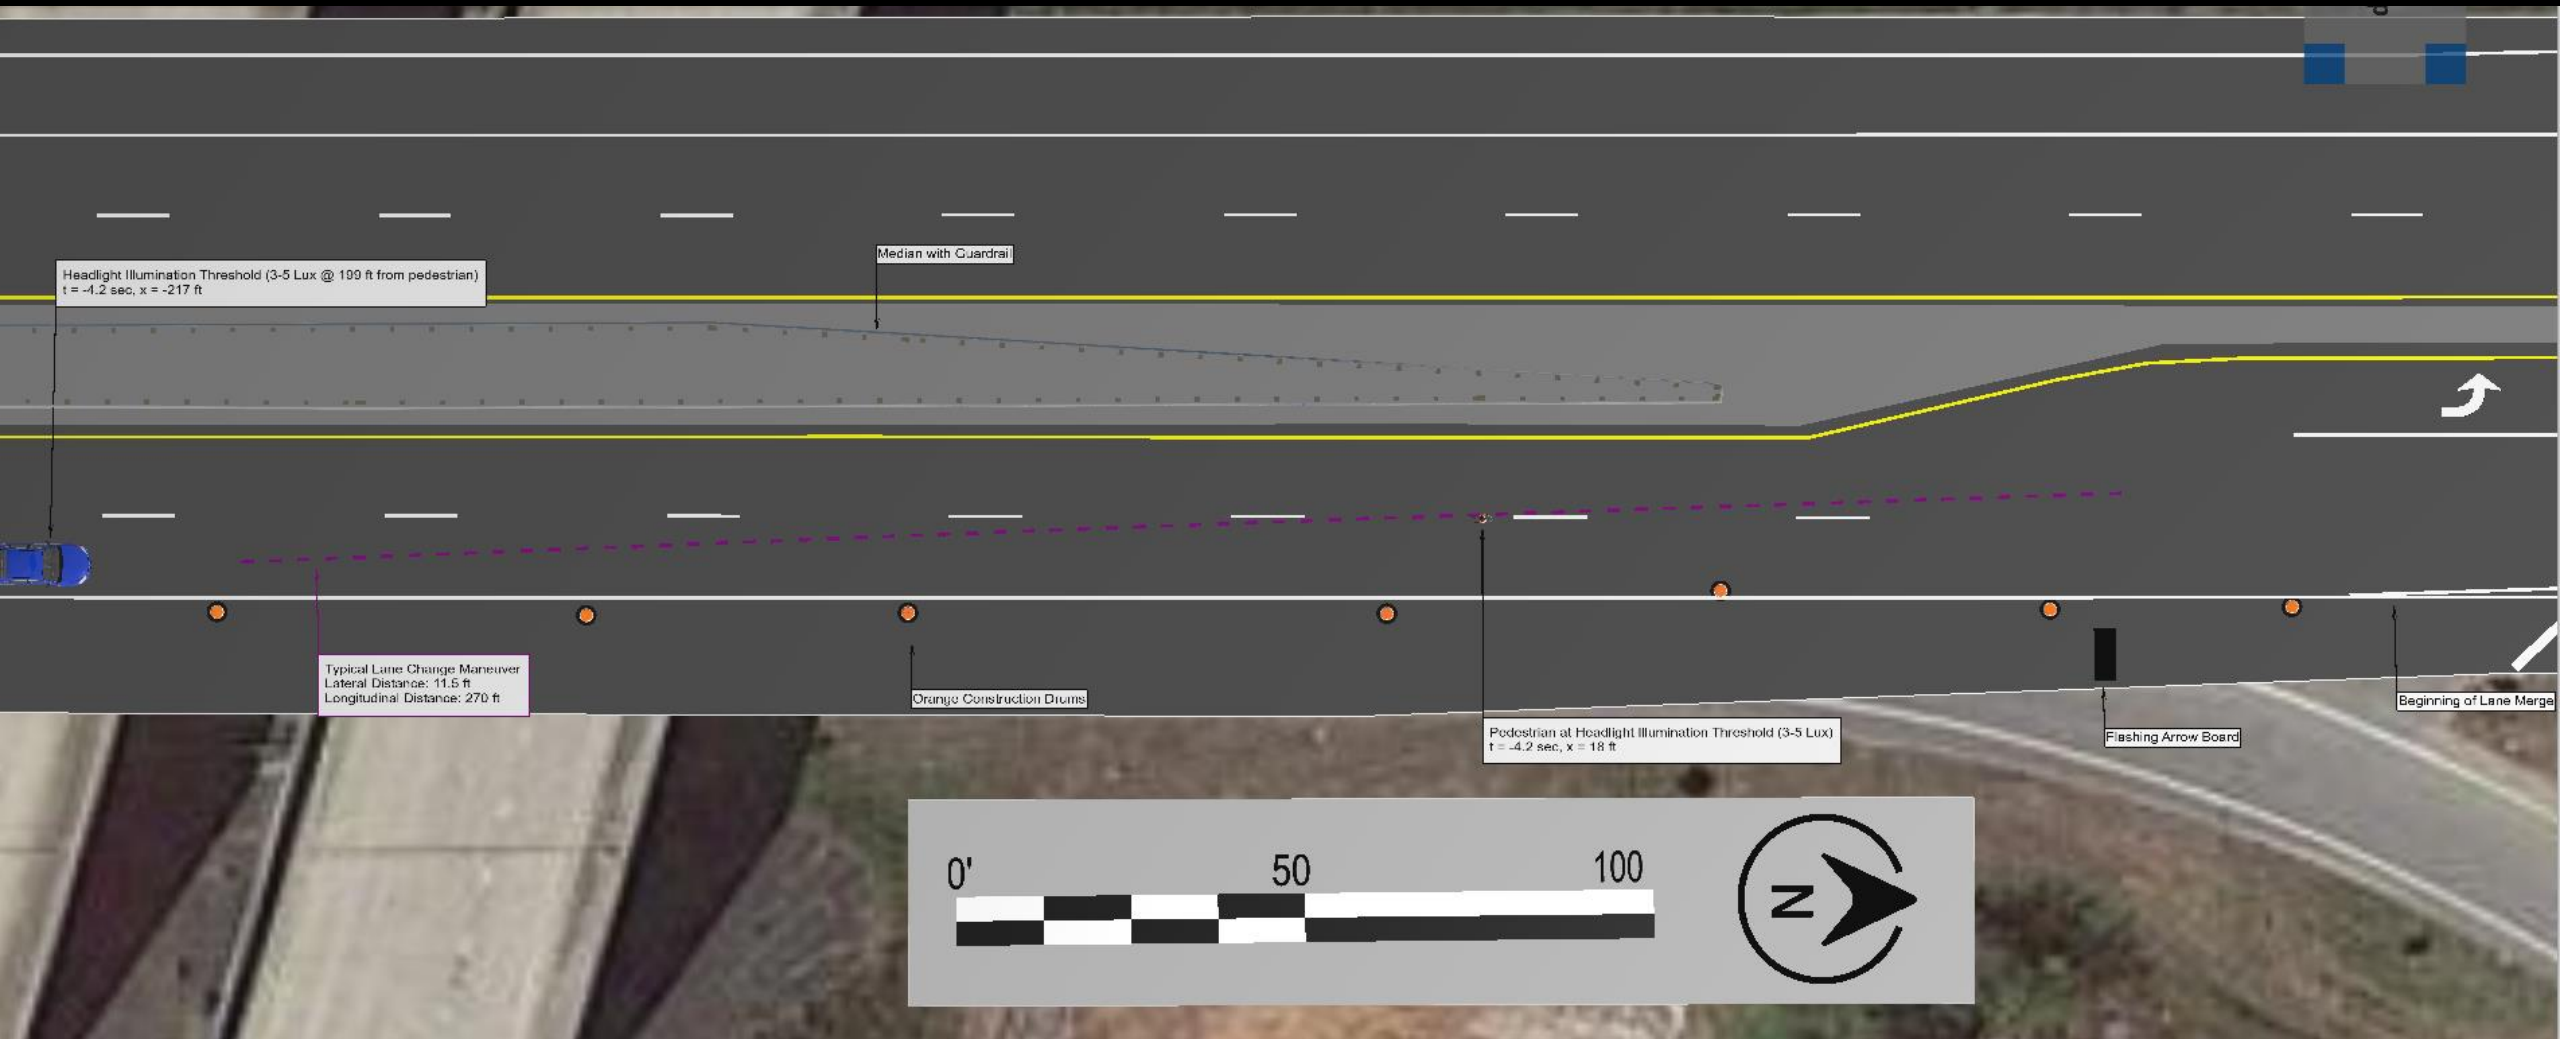
- The above diagram demonstrates the sequence of events with the vehicle traveling at a constant speed of 35 mph (middle of the 31-39 mph range) prior to impact. The pedestrian is modeled as walking 4.2 ft/s which is typical for a 37 year old female pedestrian.
- A typical, attentive and unimpaired driver would be able to see and detect a pedestrian walking in the roadway wearing light colored clothing when the pedestrian is 199 feet ahead of the vehicle.

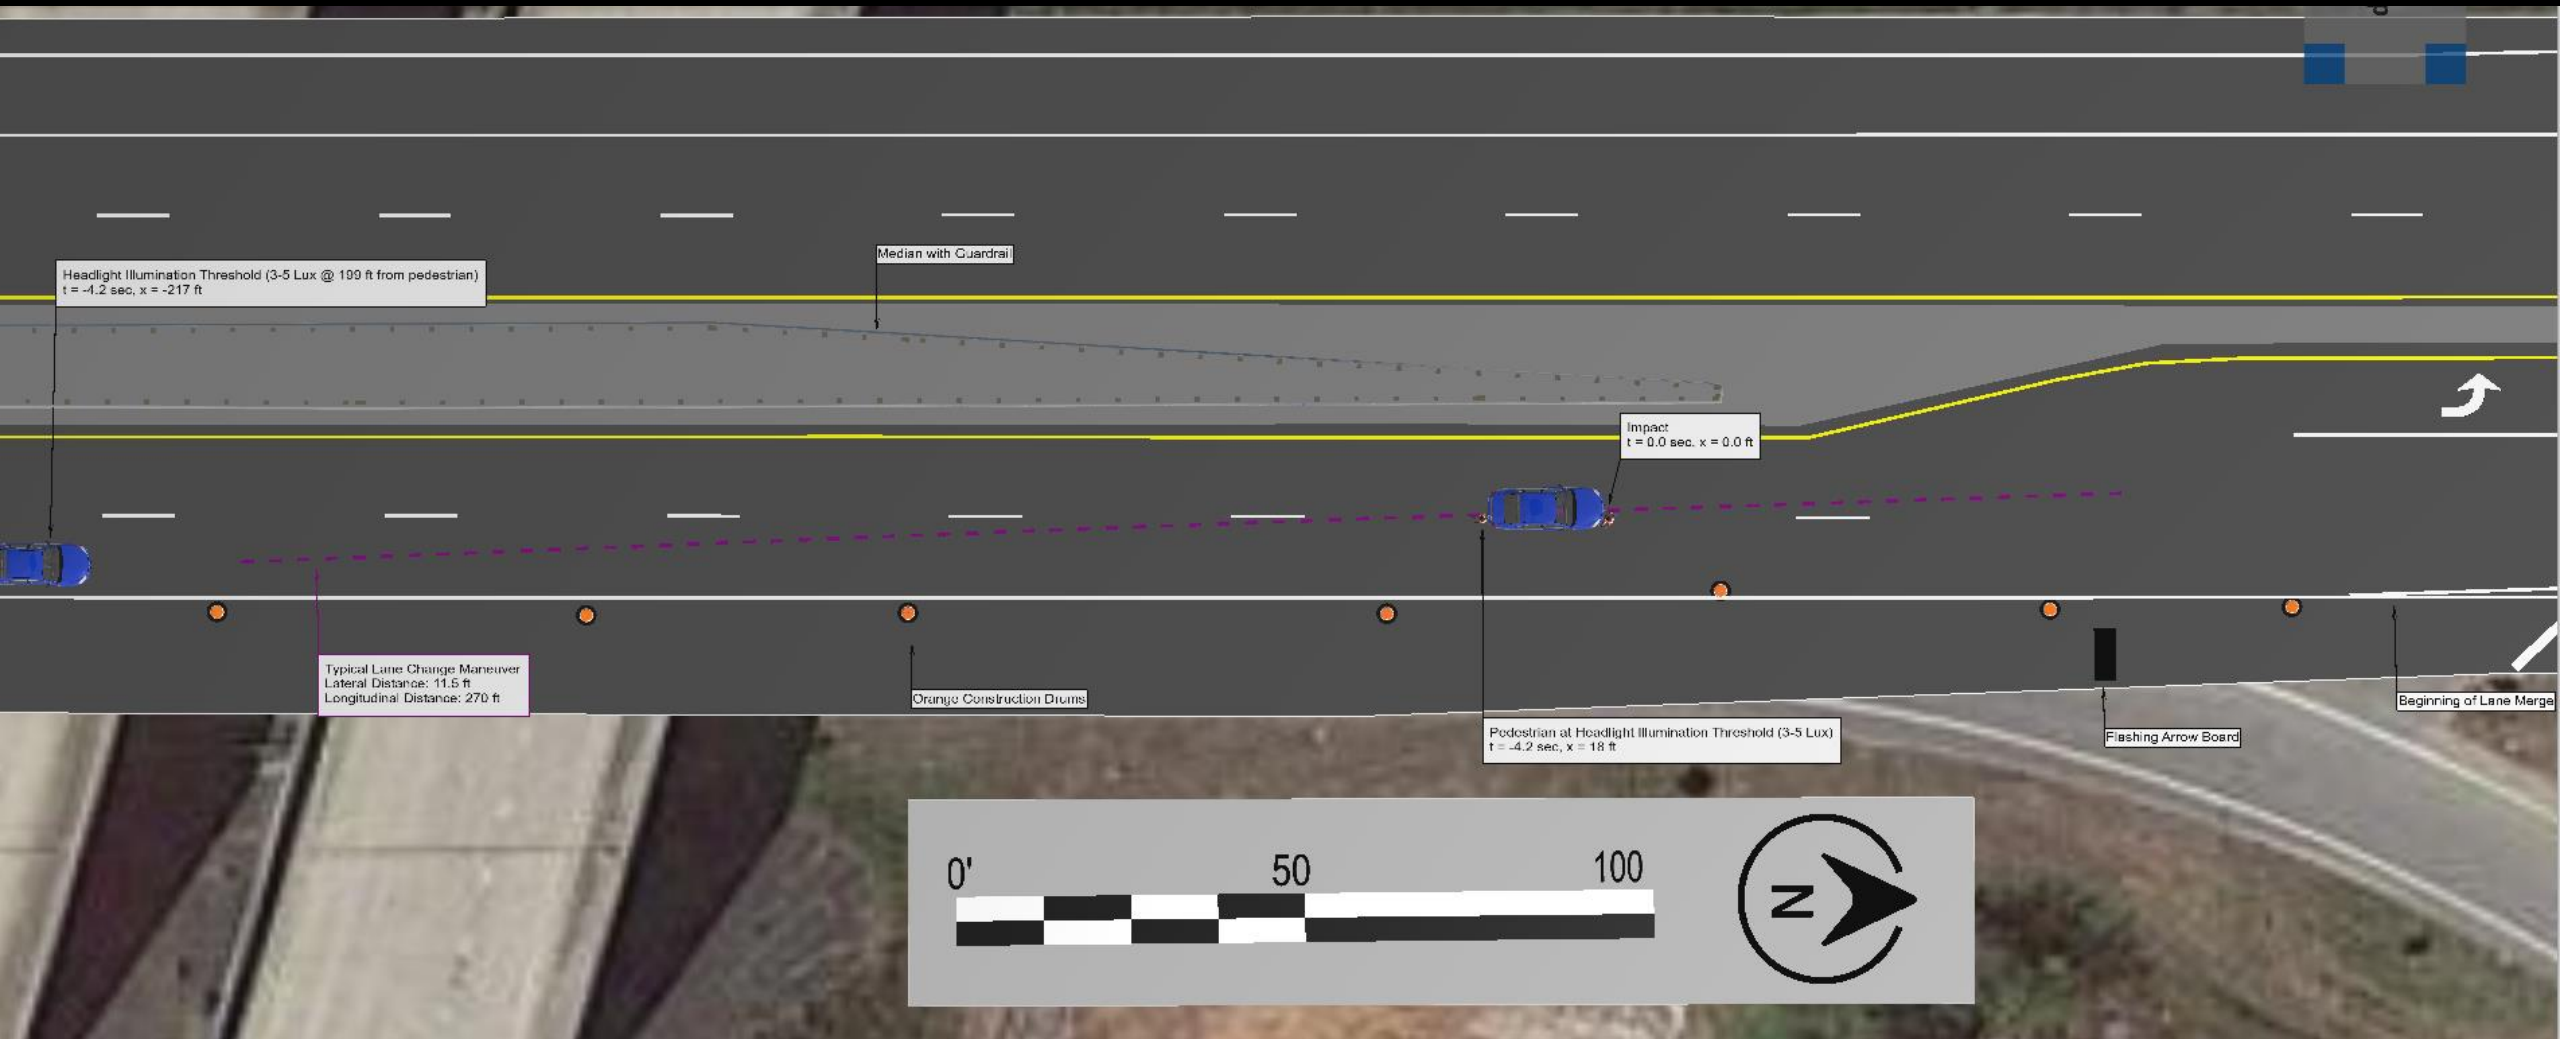
- Impact occurred when the vehicle and pedestrian were both straddling the skip line between the two travel lanes. This is consistent with a casual lane change in response to a lane merge ahead.

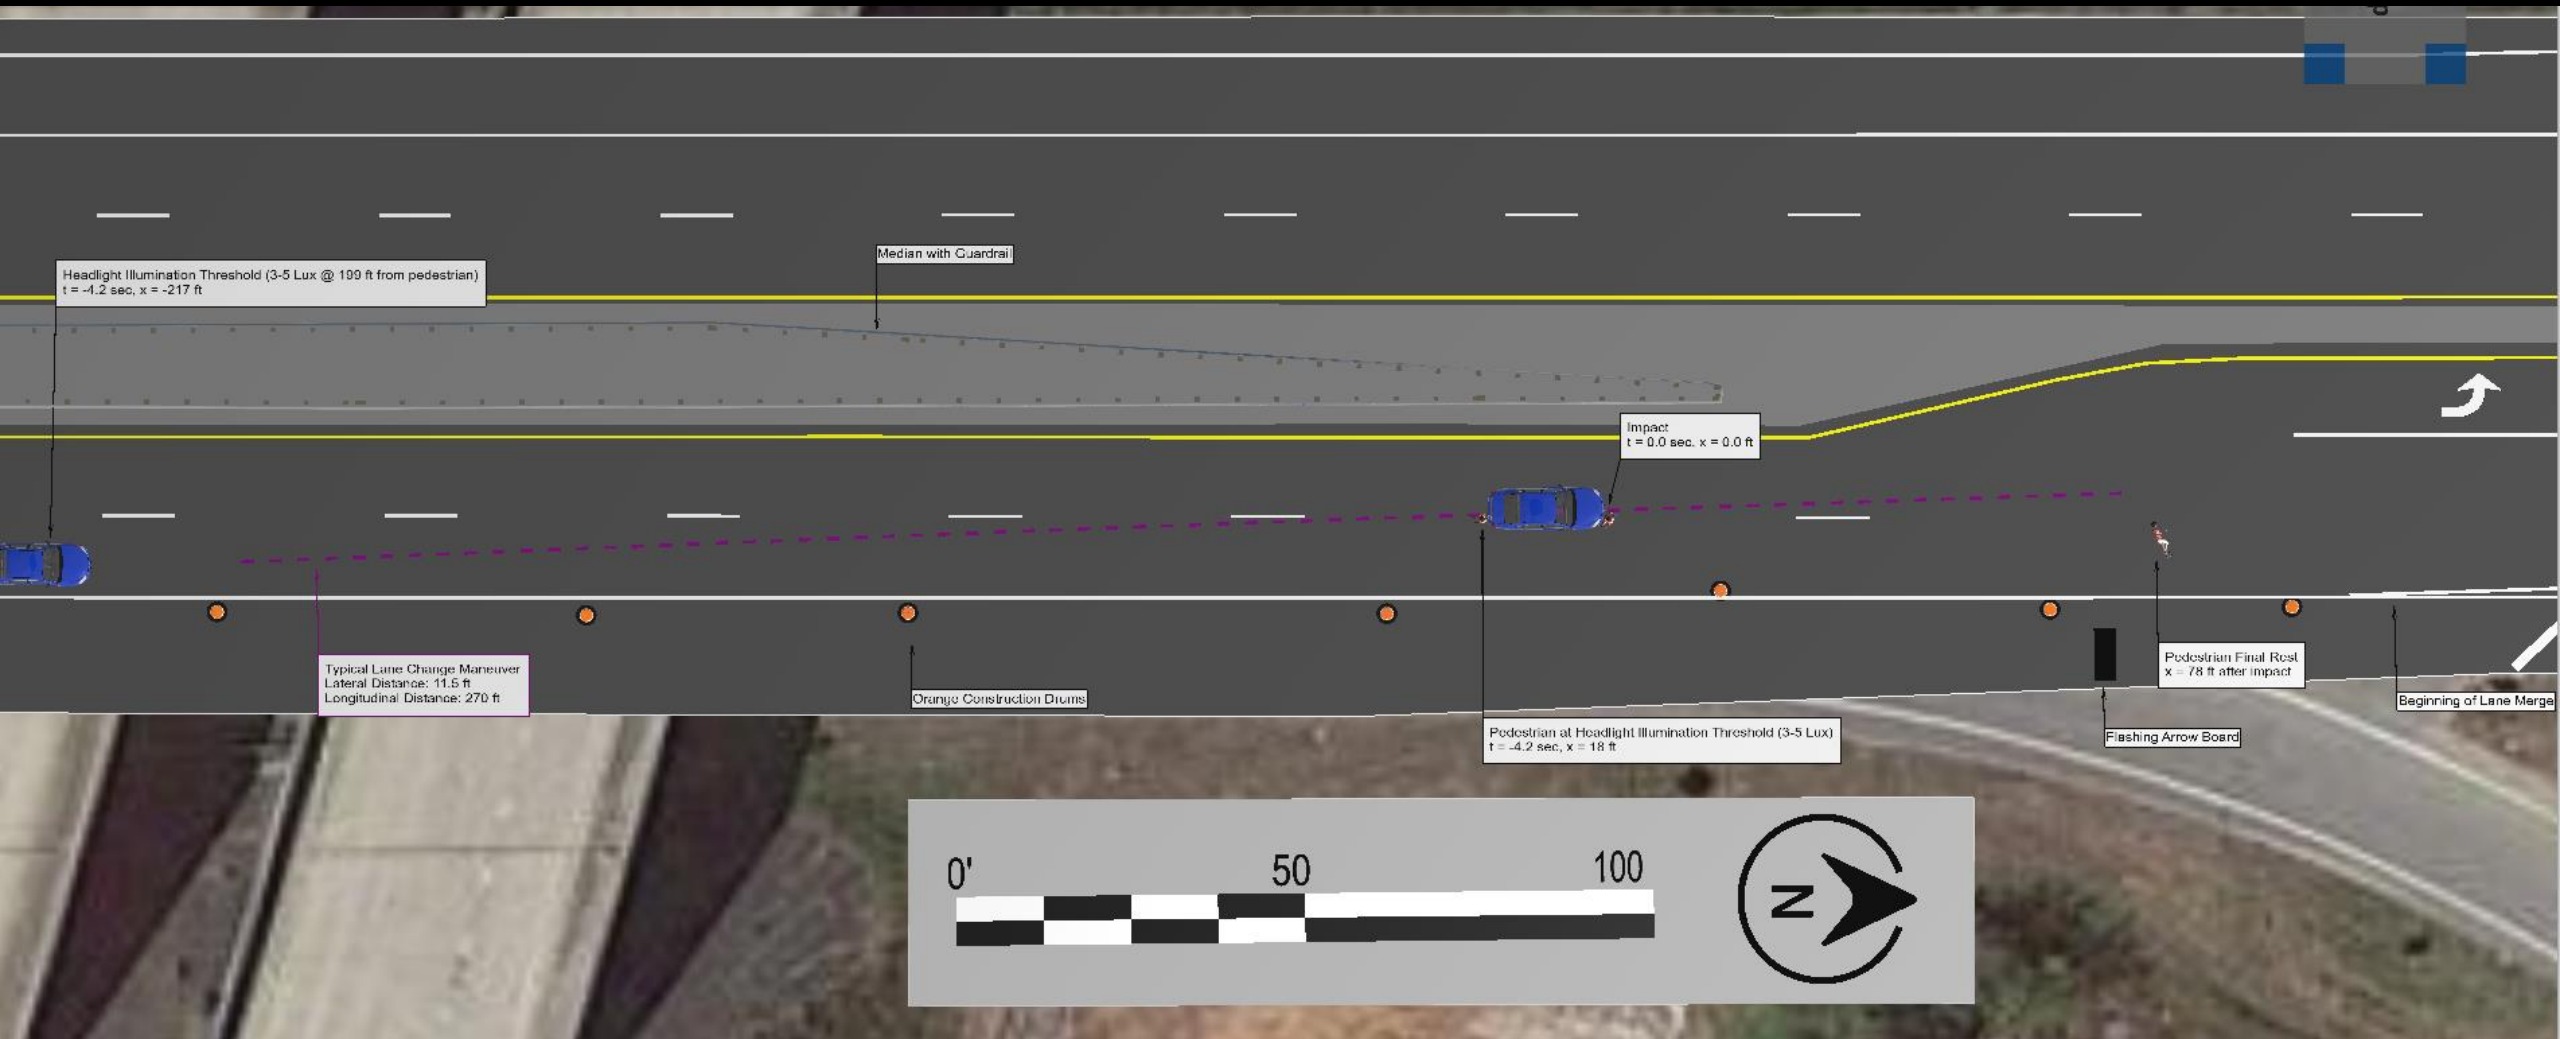
Reconstruction

- The pedestrian came to rest approximately 78 ft after impact.

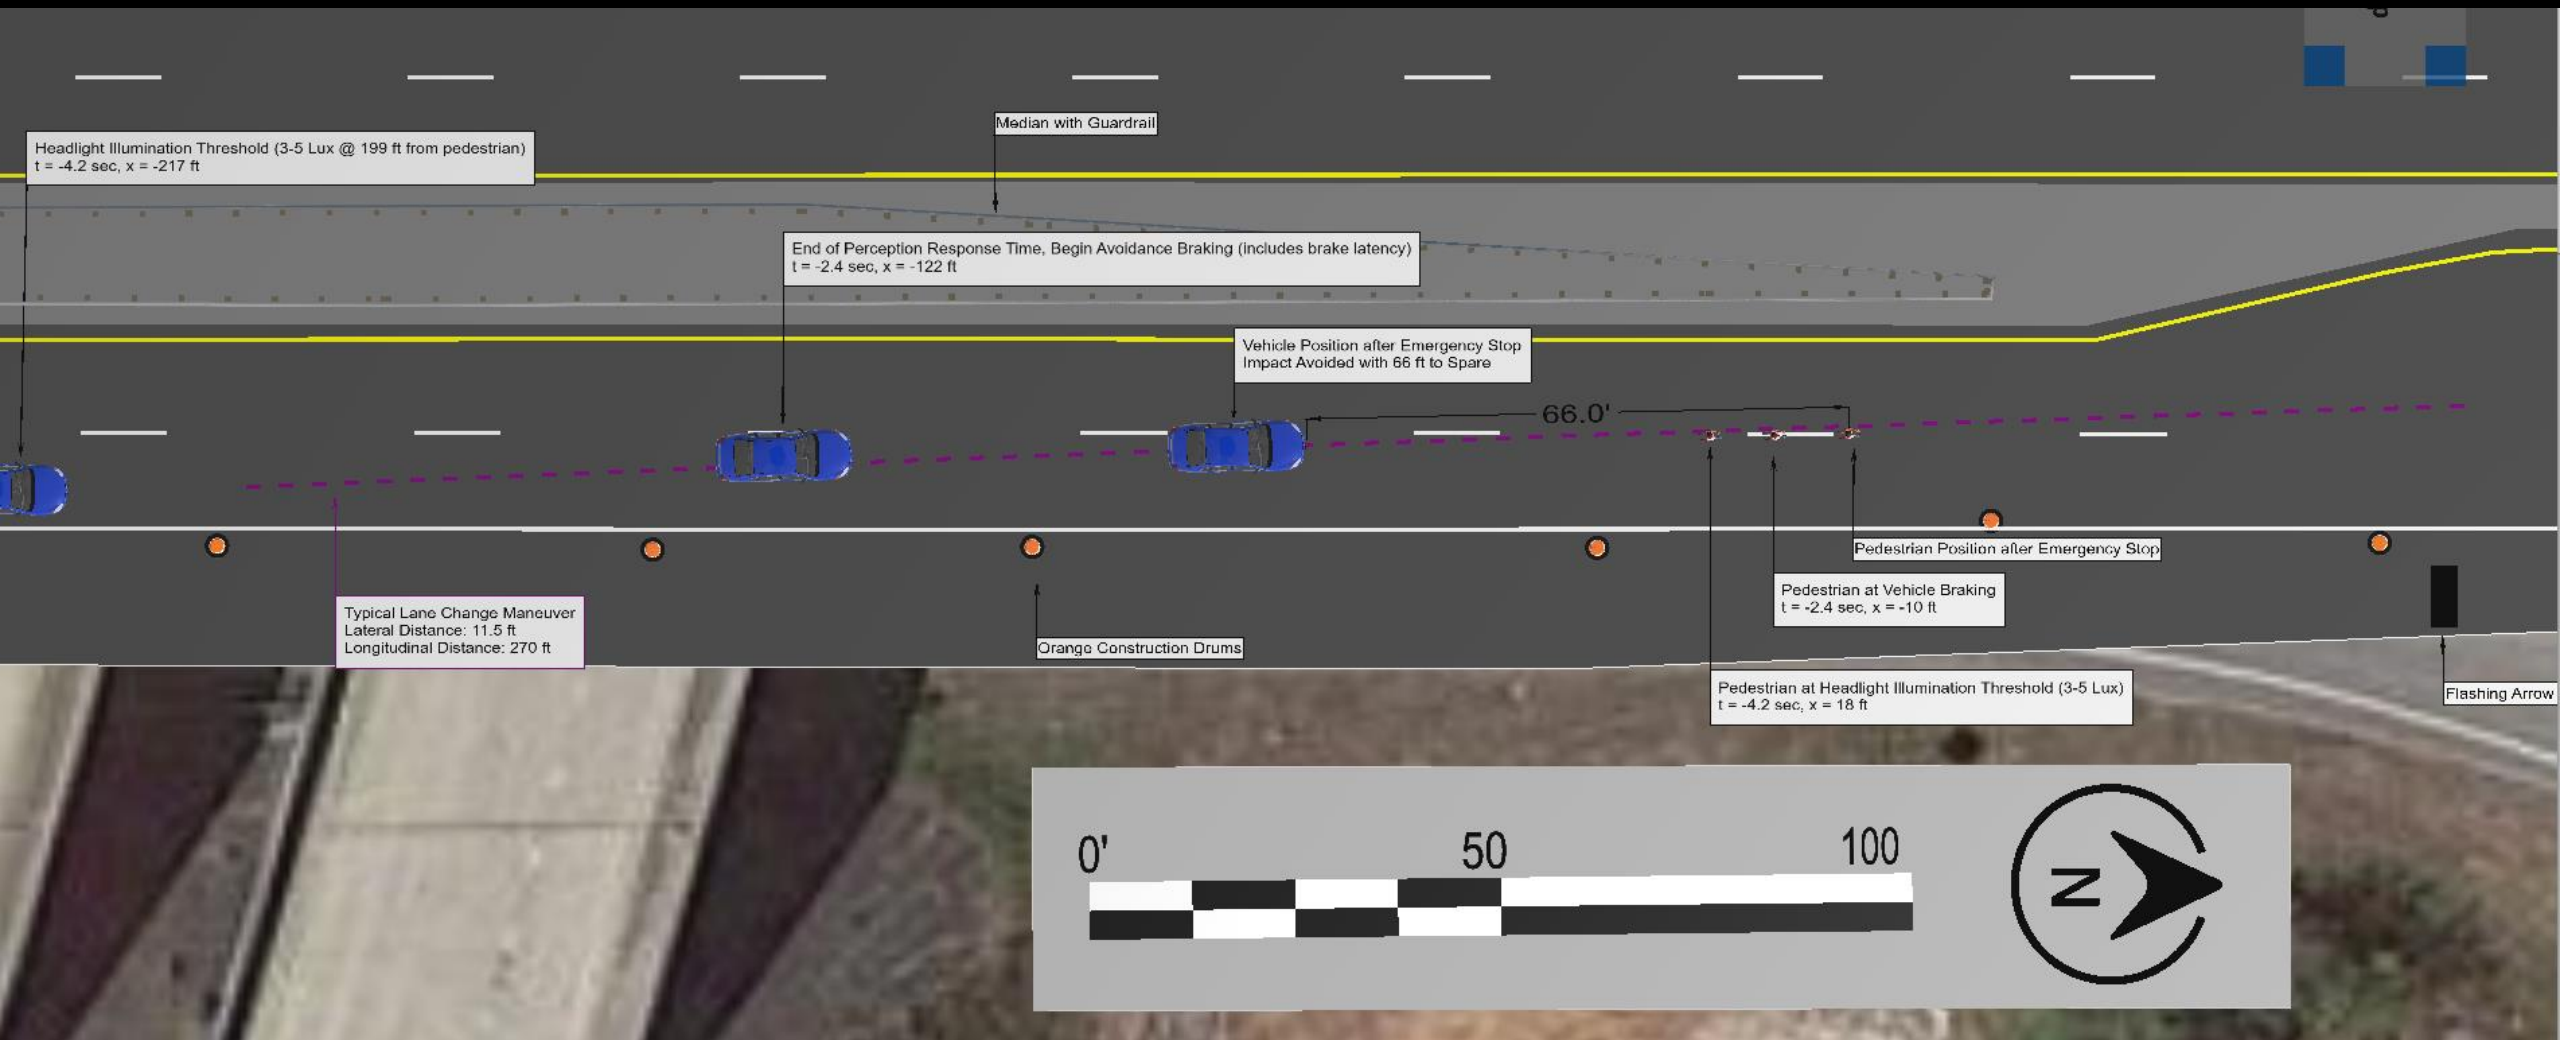
Reconstruction – Stopping Avoidance

- The above diagram demonstrates the sequence of events with the vehicle traveling at a constant speed of 35 mph (middle of the 31-39 mph range) prior to impact. The pedestrian is modeled as walking 4.2 ft/s.
- A typical, attentive and unimpaired driver would be able to:
 - See and detect a pedestrian walking in the roadway wearing light-colored clothing when the pedestrian is 199 feet ahead of the vehicle.
 - Perceive and initiate a hard braking response to an emergency hazard within 95 ft of detecting the pedestrian.
 - Brake to a stop within 150 ft of detecting the pedestrian (leaving 66 ft to spare between the vehicle and the pedestrian).
