Crash Reconstruction and Transportation Engineering Analysis

40-12724 (State v. Norris)

Kelly Palframan, Ph.D., P.E.

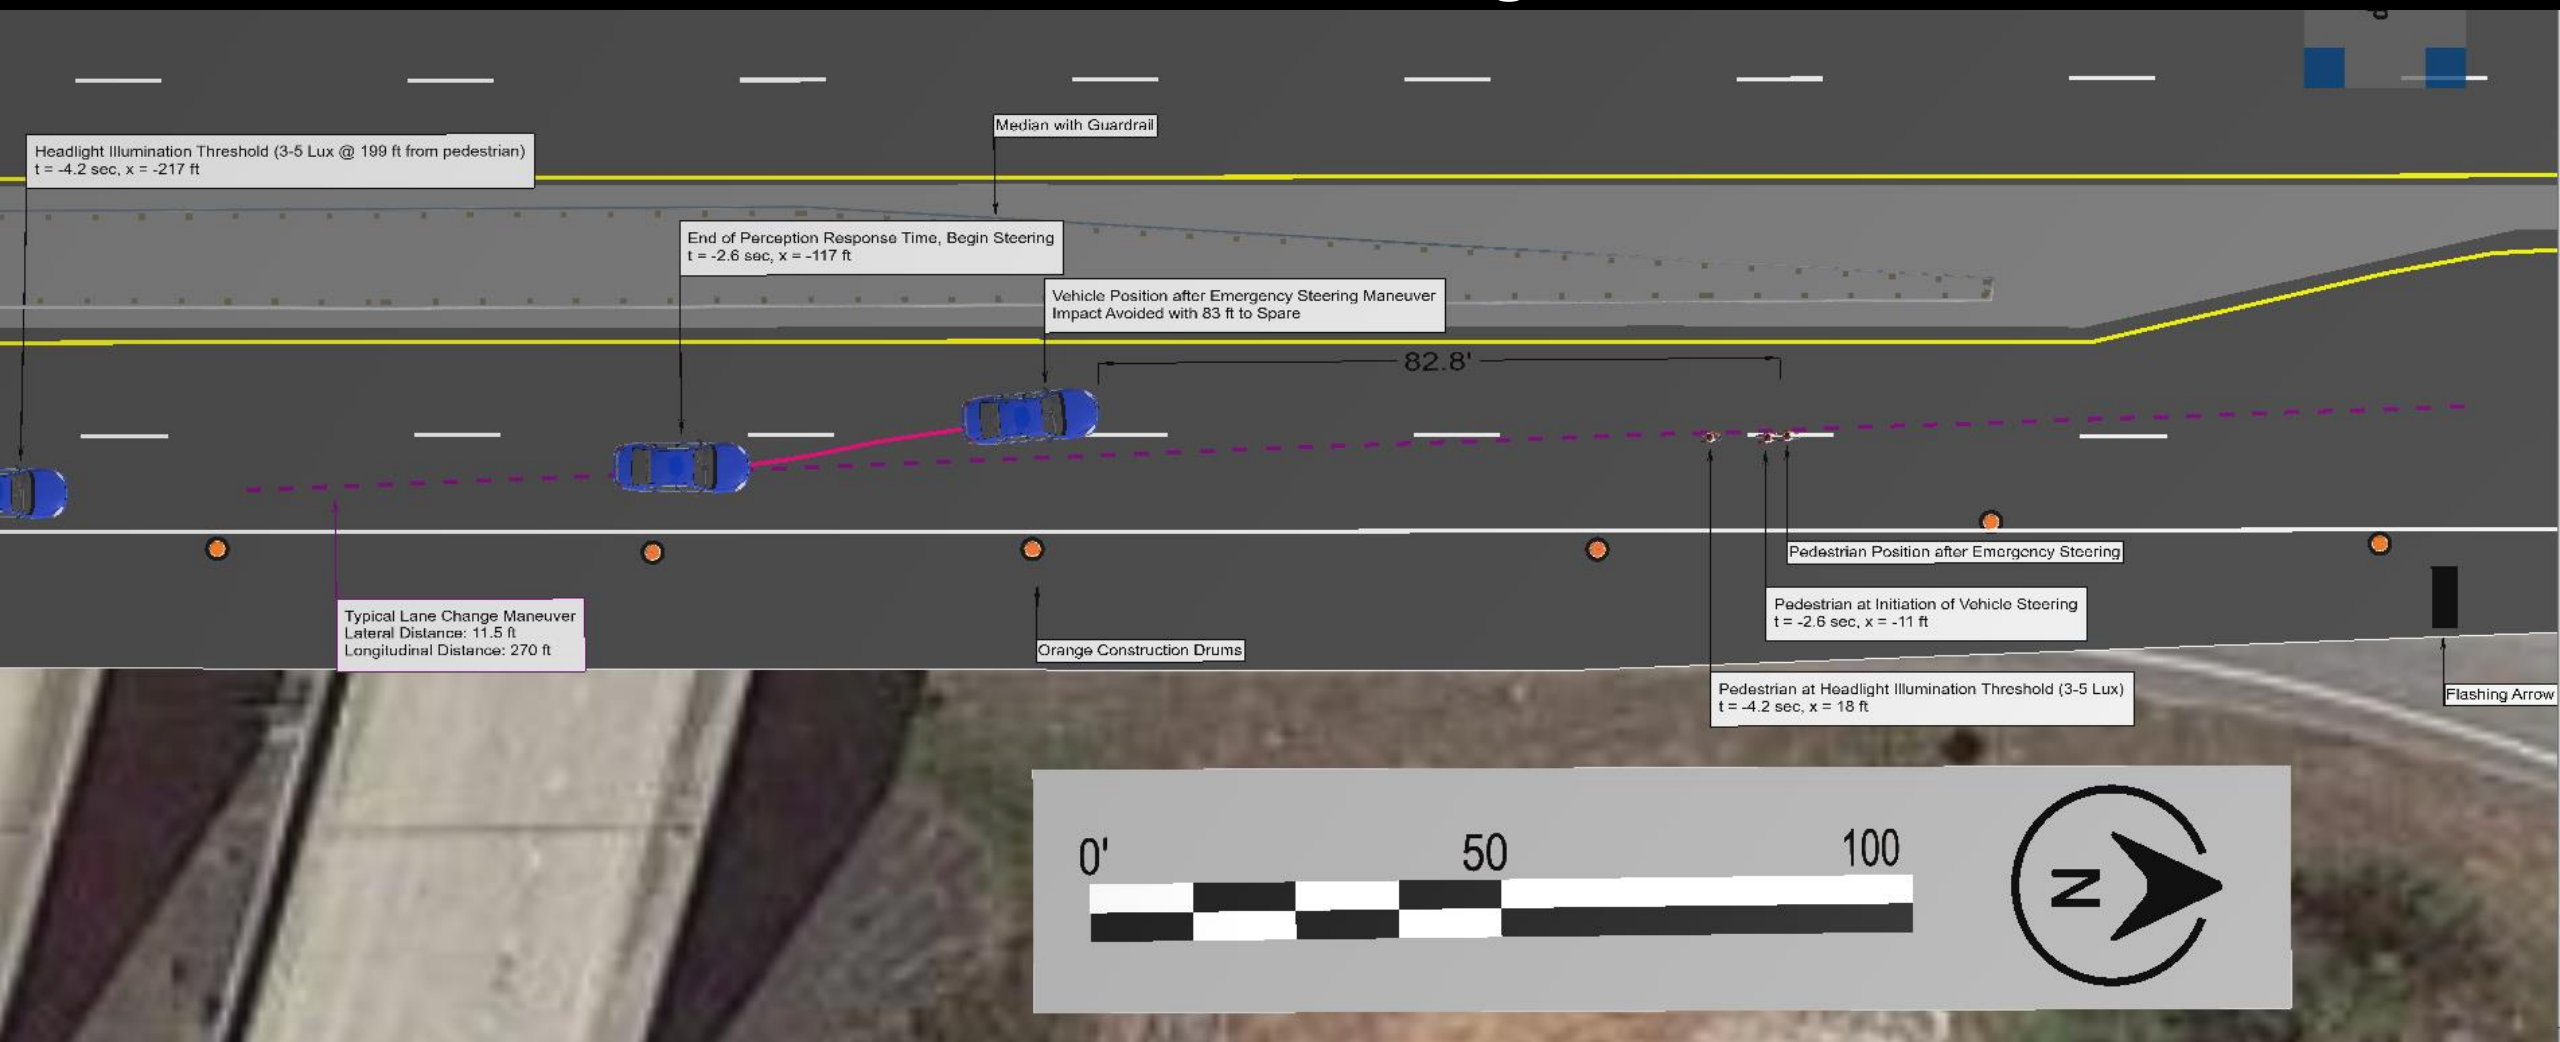
Reconstruction – Steering Avoidance

- The above diagram demonstrates the sequence of events with the vehicle traveling at a constant speed of 35 mph (middle of the 31-39 mph range) prior to impact. The pedestrian is modeled as walking 4.2 ft/s.
- A typical, attentive and unimpaired driver would be able to:
 - See and detect a pedestrian walking in the roadway wearing light-colored clothing when the pedestrian is 199 feet ahead of the vehicle.
 - Perceive and initiate a steering response to move the vehicle 2-3 ft laterally in response to an emergency hazard within 82.5 ft of detecting the pedestrian.
 - Execute an emergency steering maneuver within 127 ft of detecting the pedestrian (leaving 83 ft to spare between the vehicle and the pedestrian).

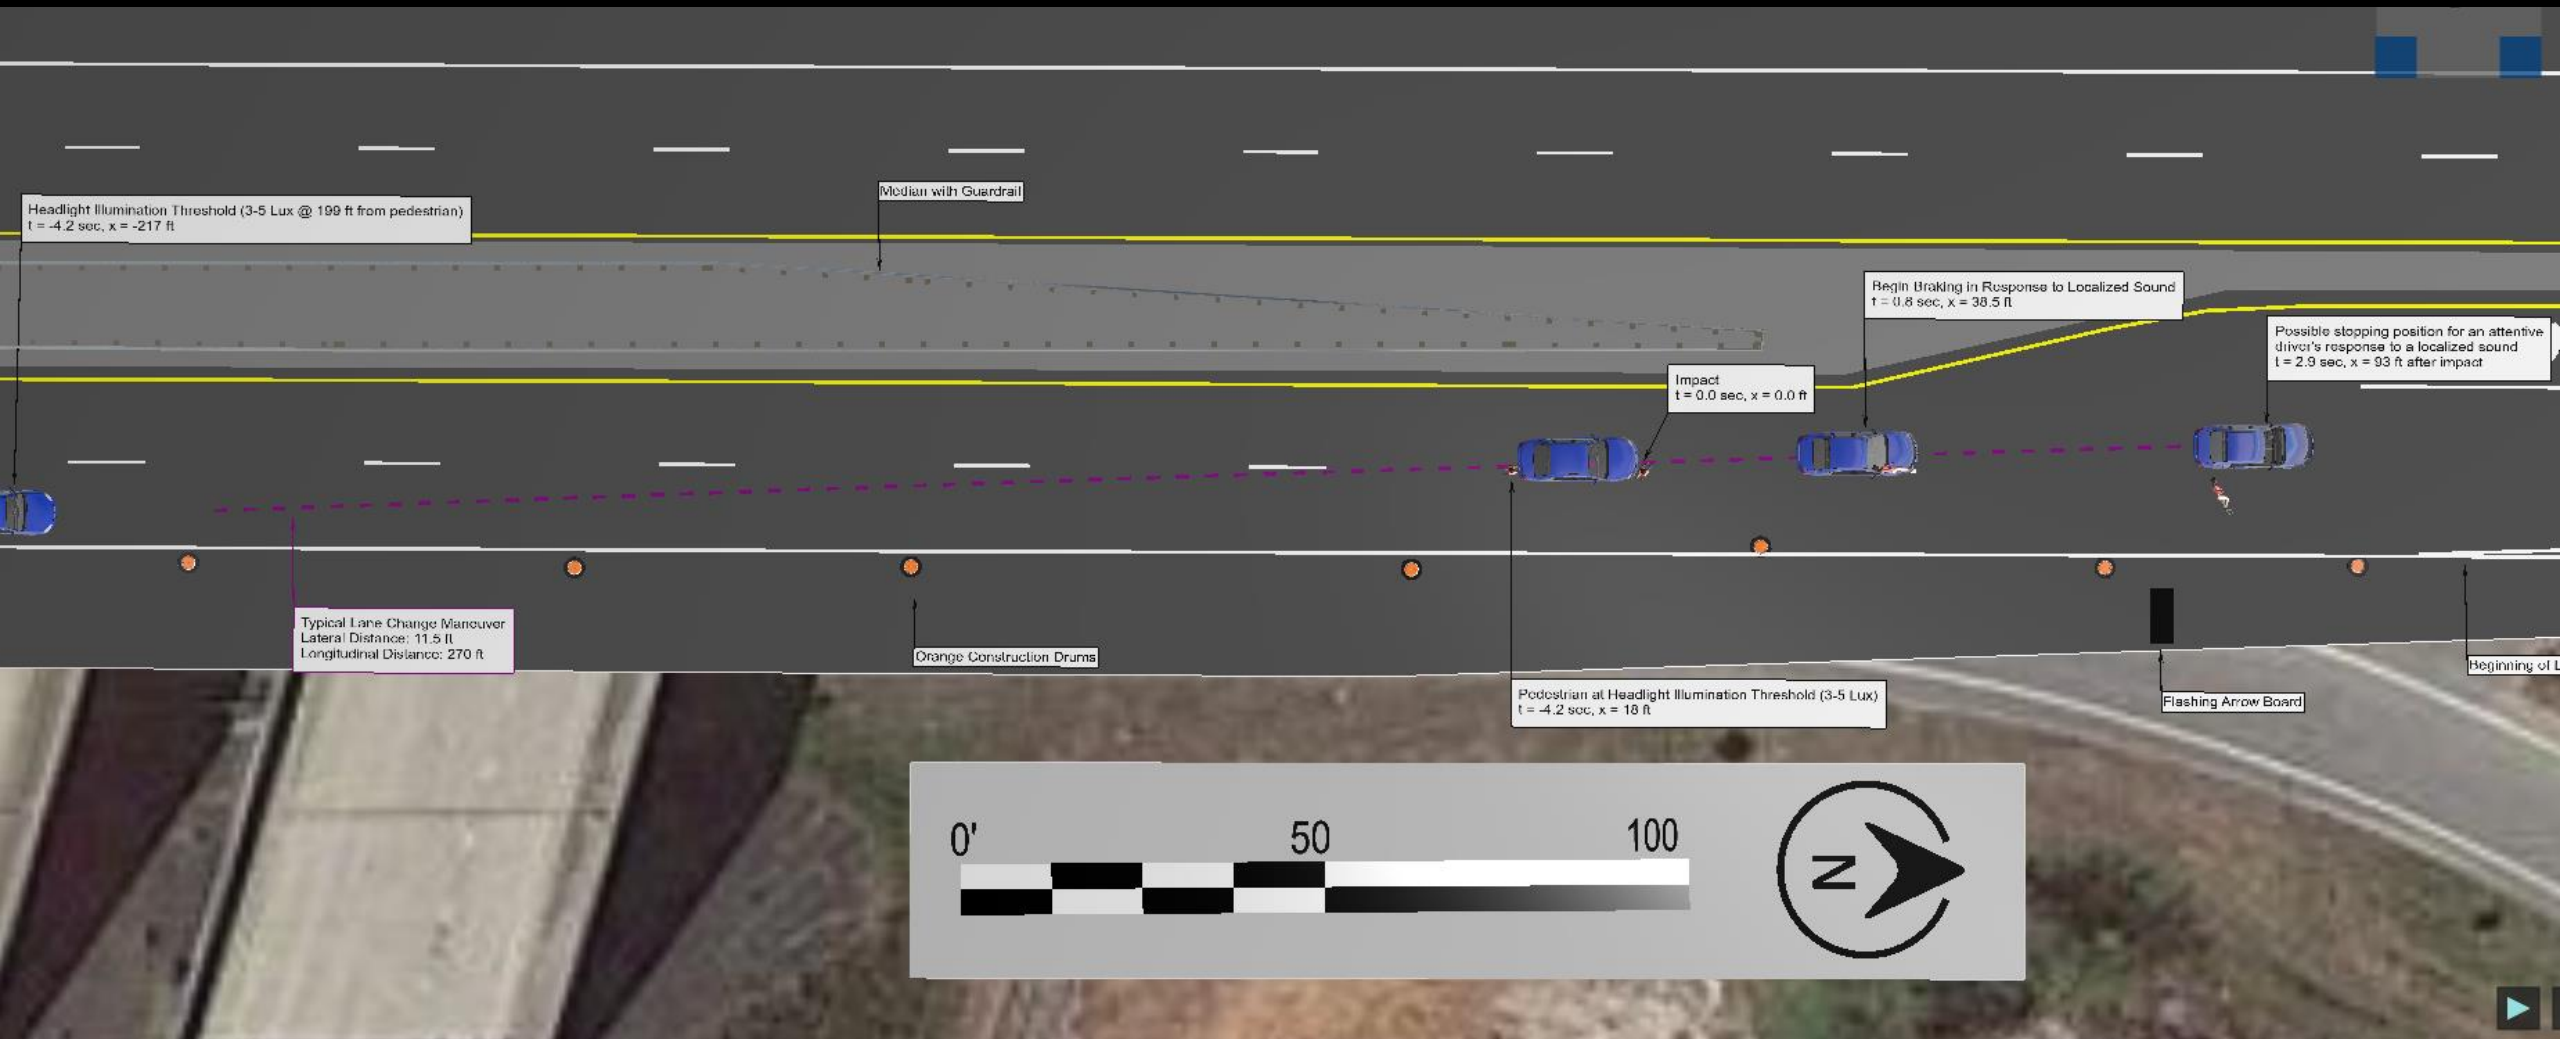
Reconstruction – Response to a Localized Sound

- The above diagram demonstrates the sequence of events with the vehicle traveling at a constant speed of 35 mph (middle of the 31-39 mph range) prior to impact. The pedestrian is modeled as walking 4.2 ft/s.
- A typical, attentive and unimpaired driver would be able to:
 - See and detect a pedestrian walking in the roadway wearing light colored clothing when the pedestrian is 199 feet ahead of the vehicle.
- A typical, unimpaired driver would respond to a localized sound within 0.5 seconds of the sound. Braking would take effect approximately 0.25 seconds later. A vehicle traveling 35 mph would come to a complete hard stop approximately 93 ft after impact.

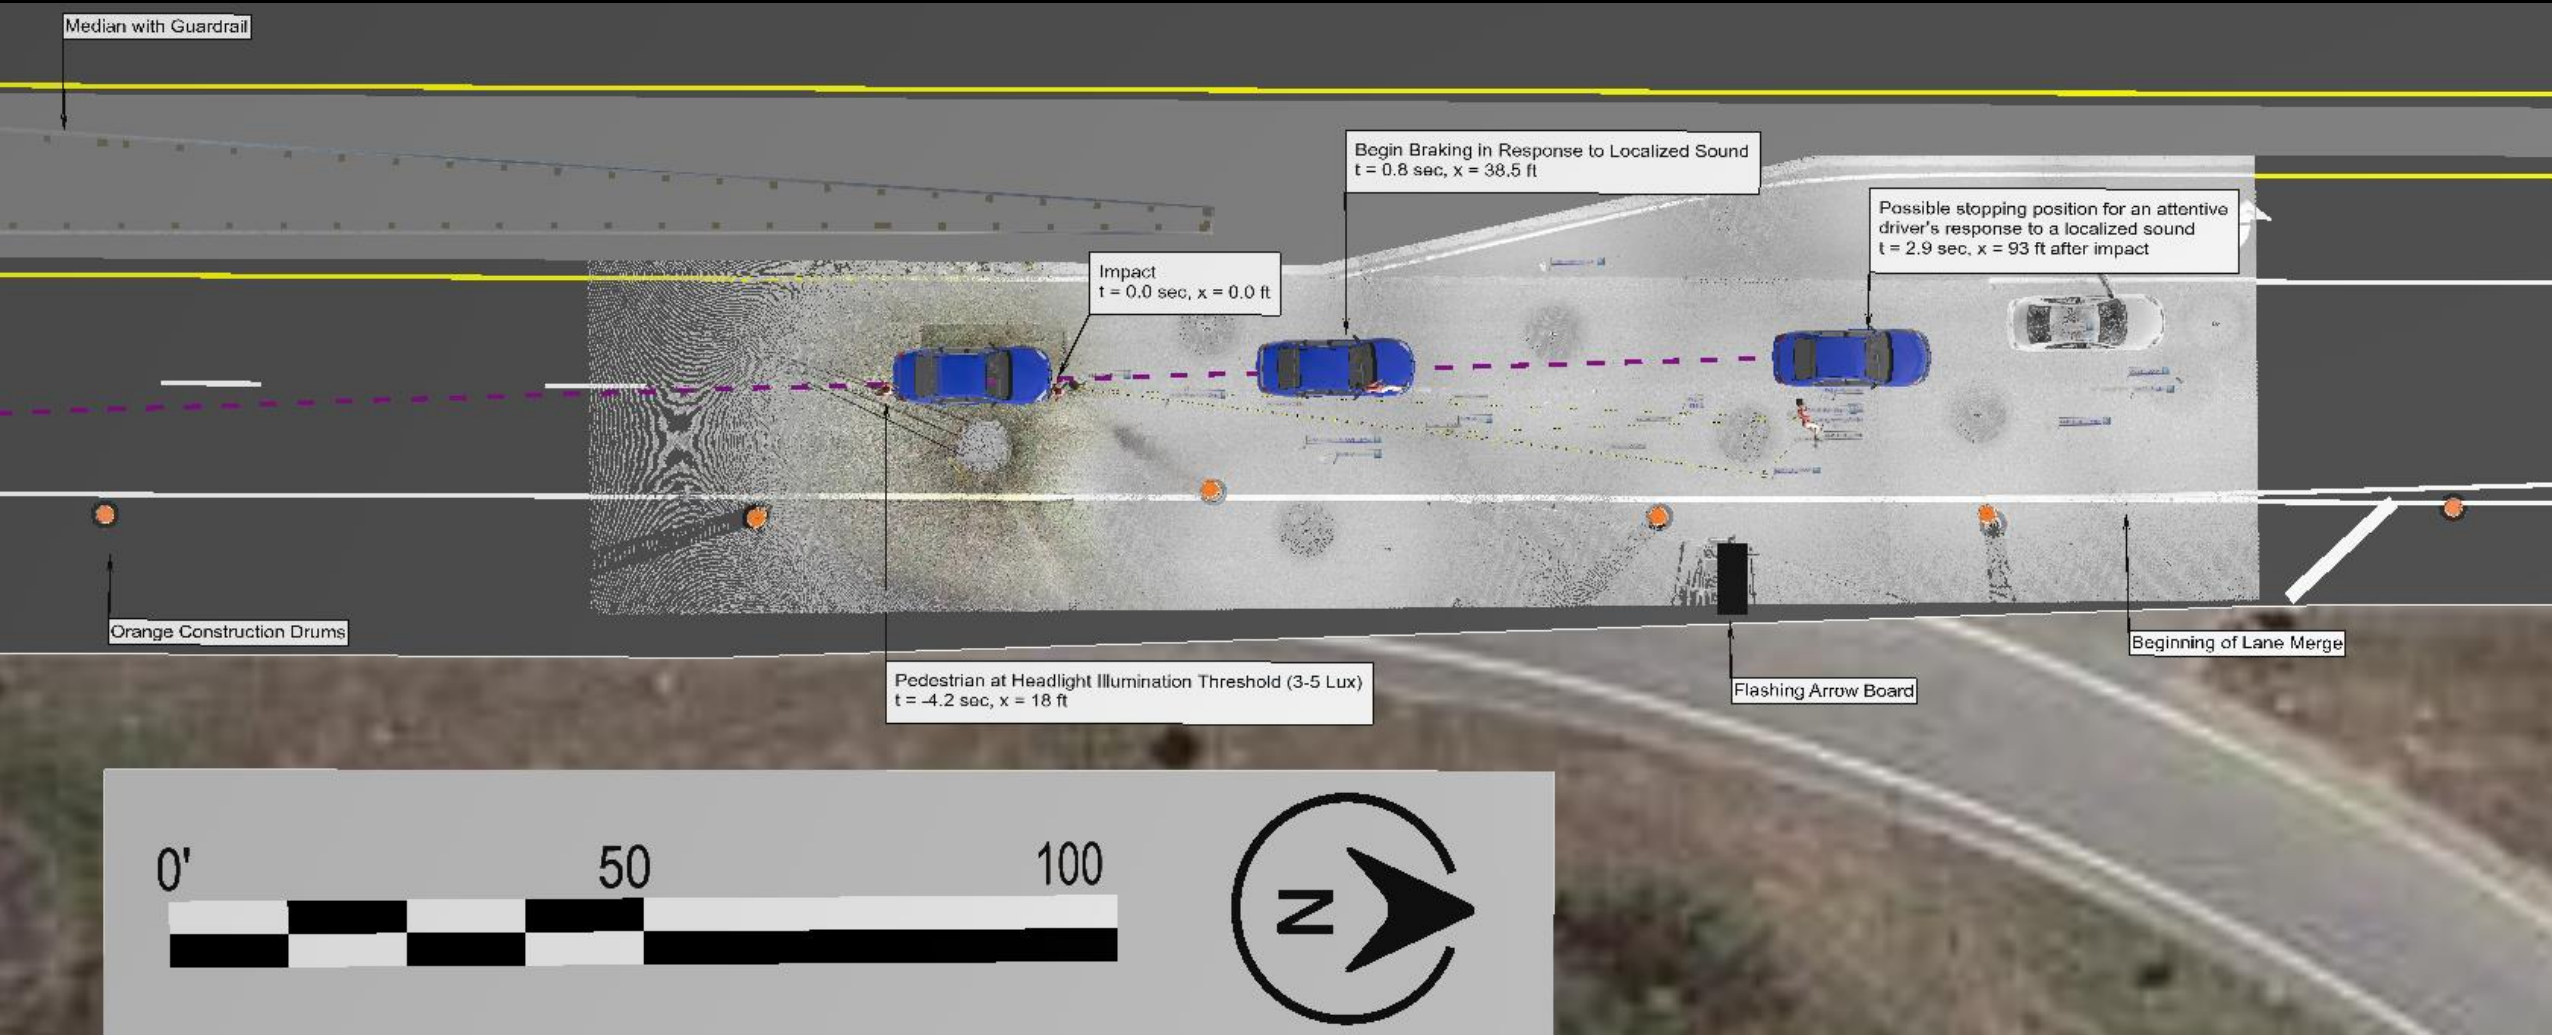
Reconstruction – Response to a Localized Sound

- The above diagram demonstrates the sequence of events with the vehicle traveling at a constant speed of 35 mph (middle of the 31-39 mph range) prior to impact. The pedestrian is modeled as walking 4.2 ft/s.
- The documented stopped position of Ms. Norris's vehicle is further downstream than would be expected for a driver responding to a localized sound.

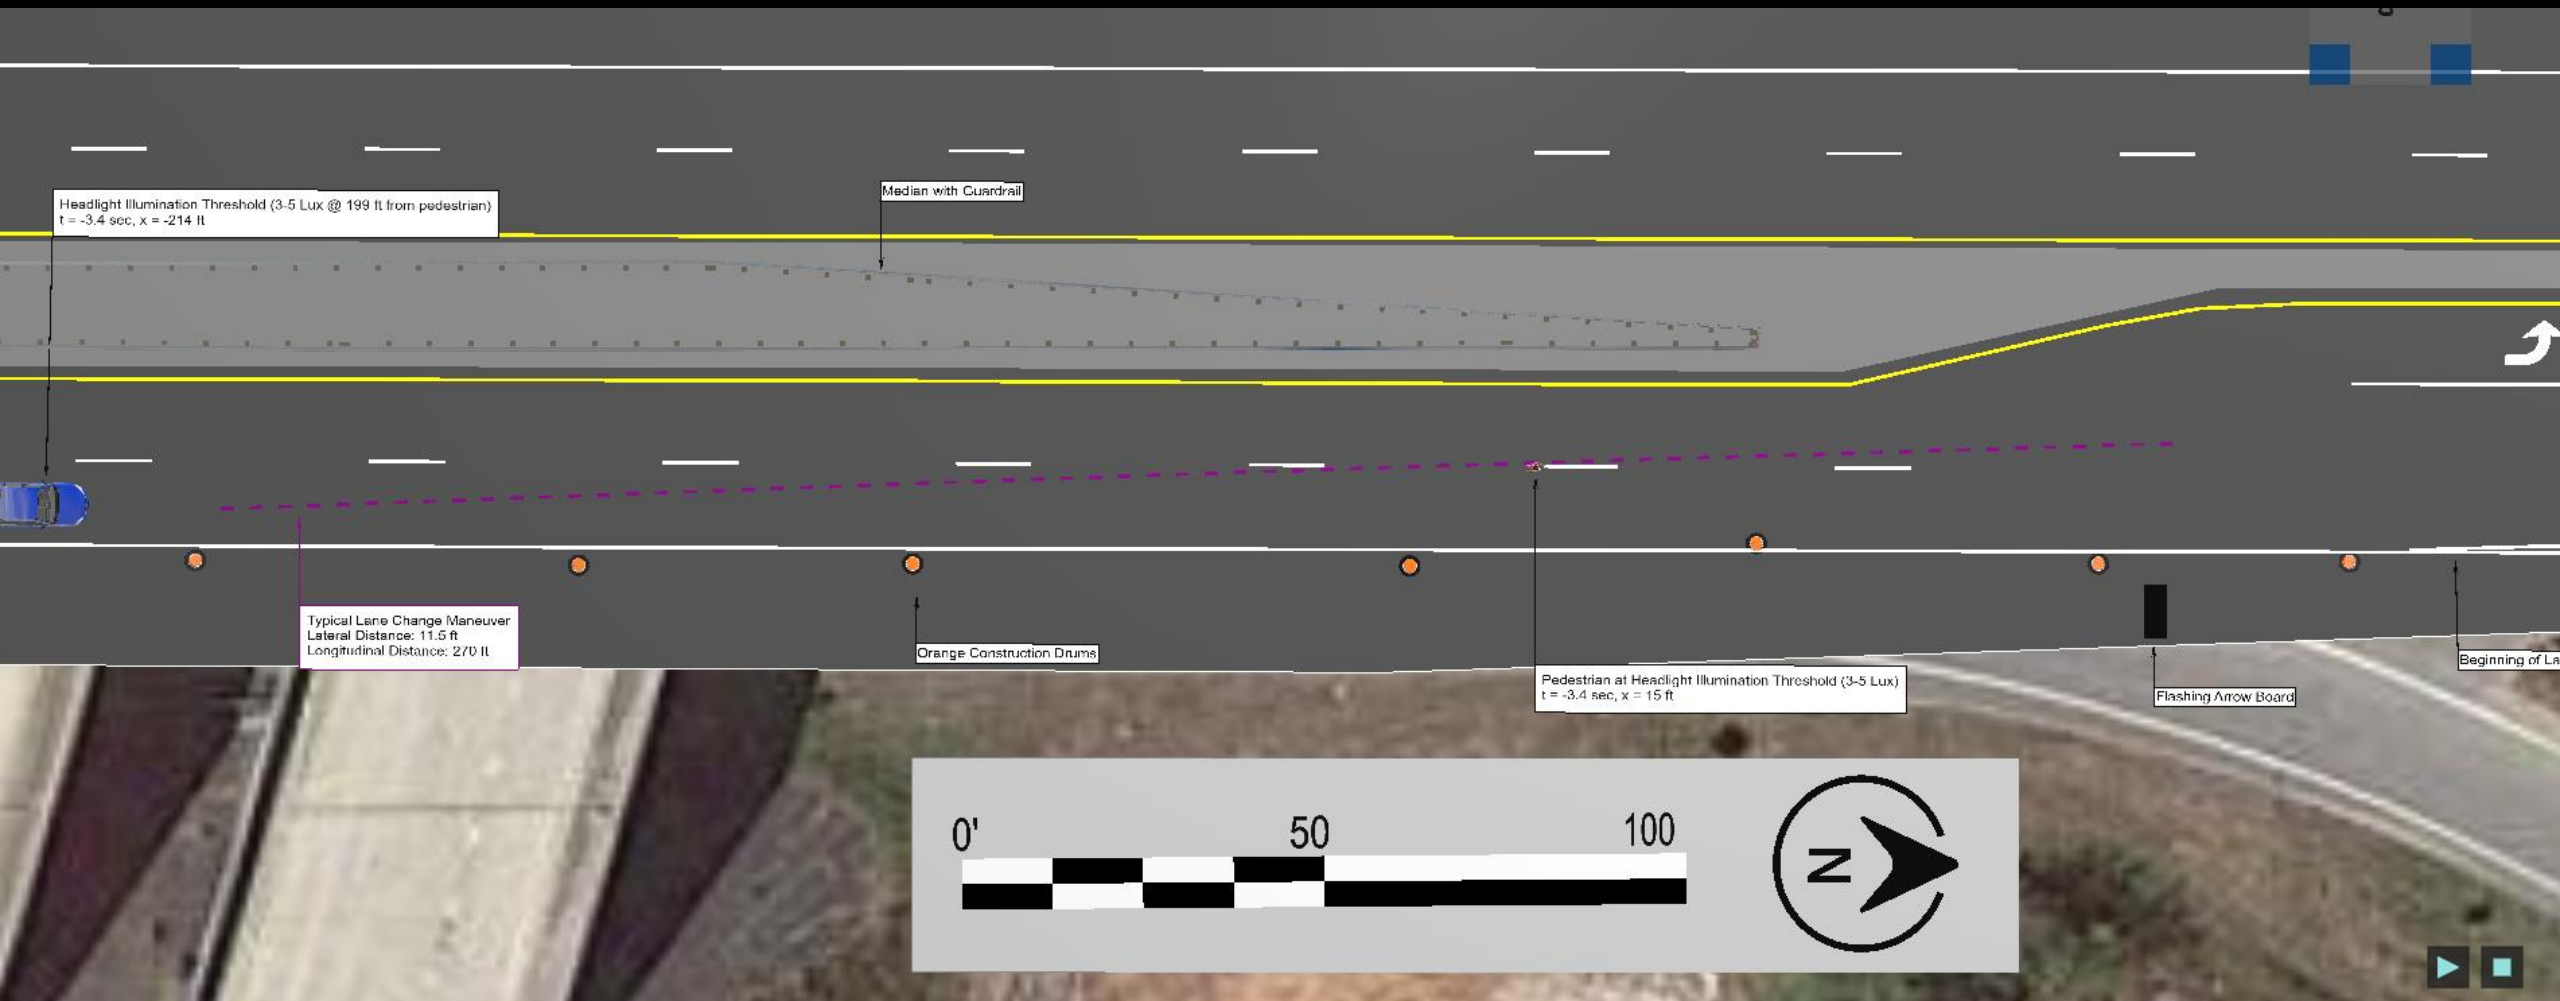
Reconstruction Hypothetical

- The above diagram demonstrates the sequence of events with the vehicle traveling at an initial speed of 42.5 mph (middle of the 40-45 mph range) prior to impact. The pedestrian is modeled as walking 4.2 ft/s.
- A typical, unimpaired driver would be able to:
 - See and detect a pedestrian walking in the roadway wearing light colored clothing when the pedestrian is 199 feet ahead of the vehicle.

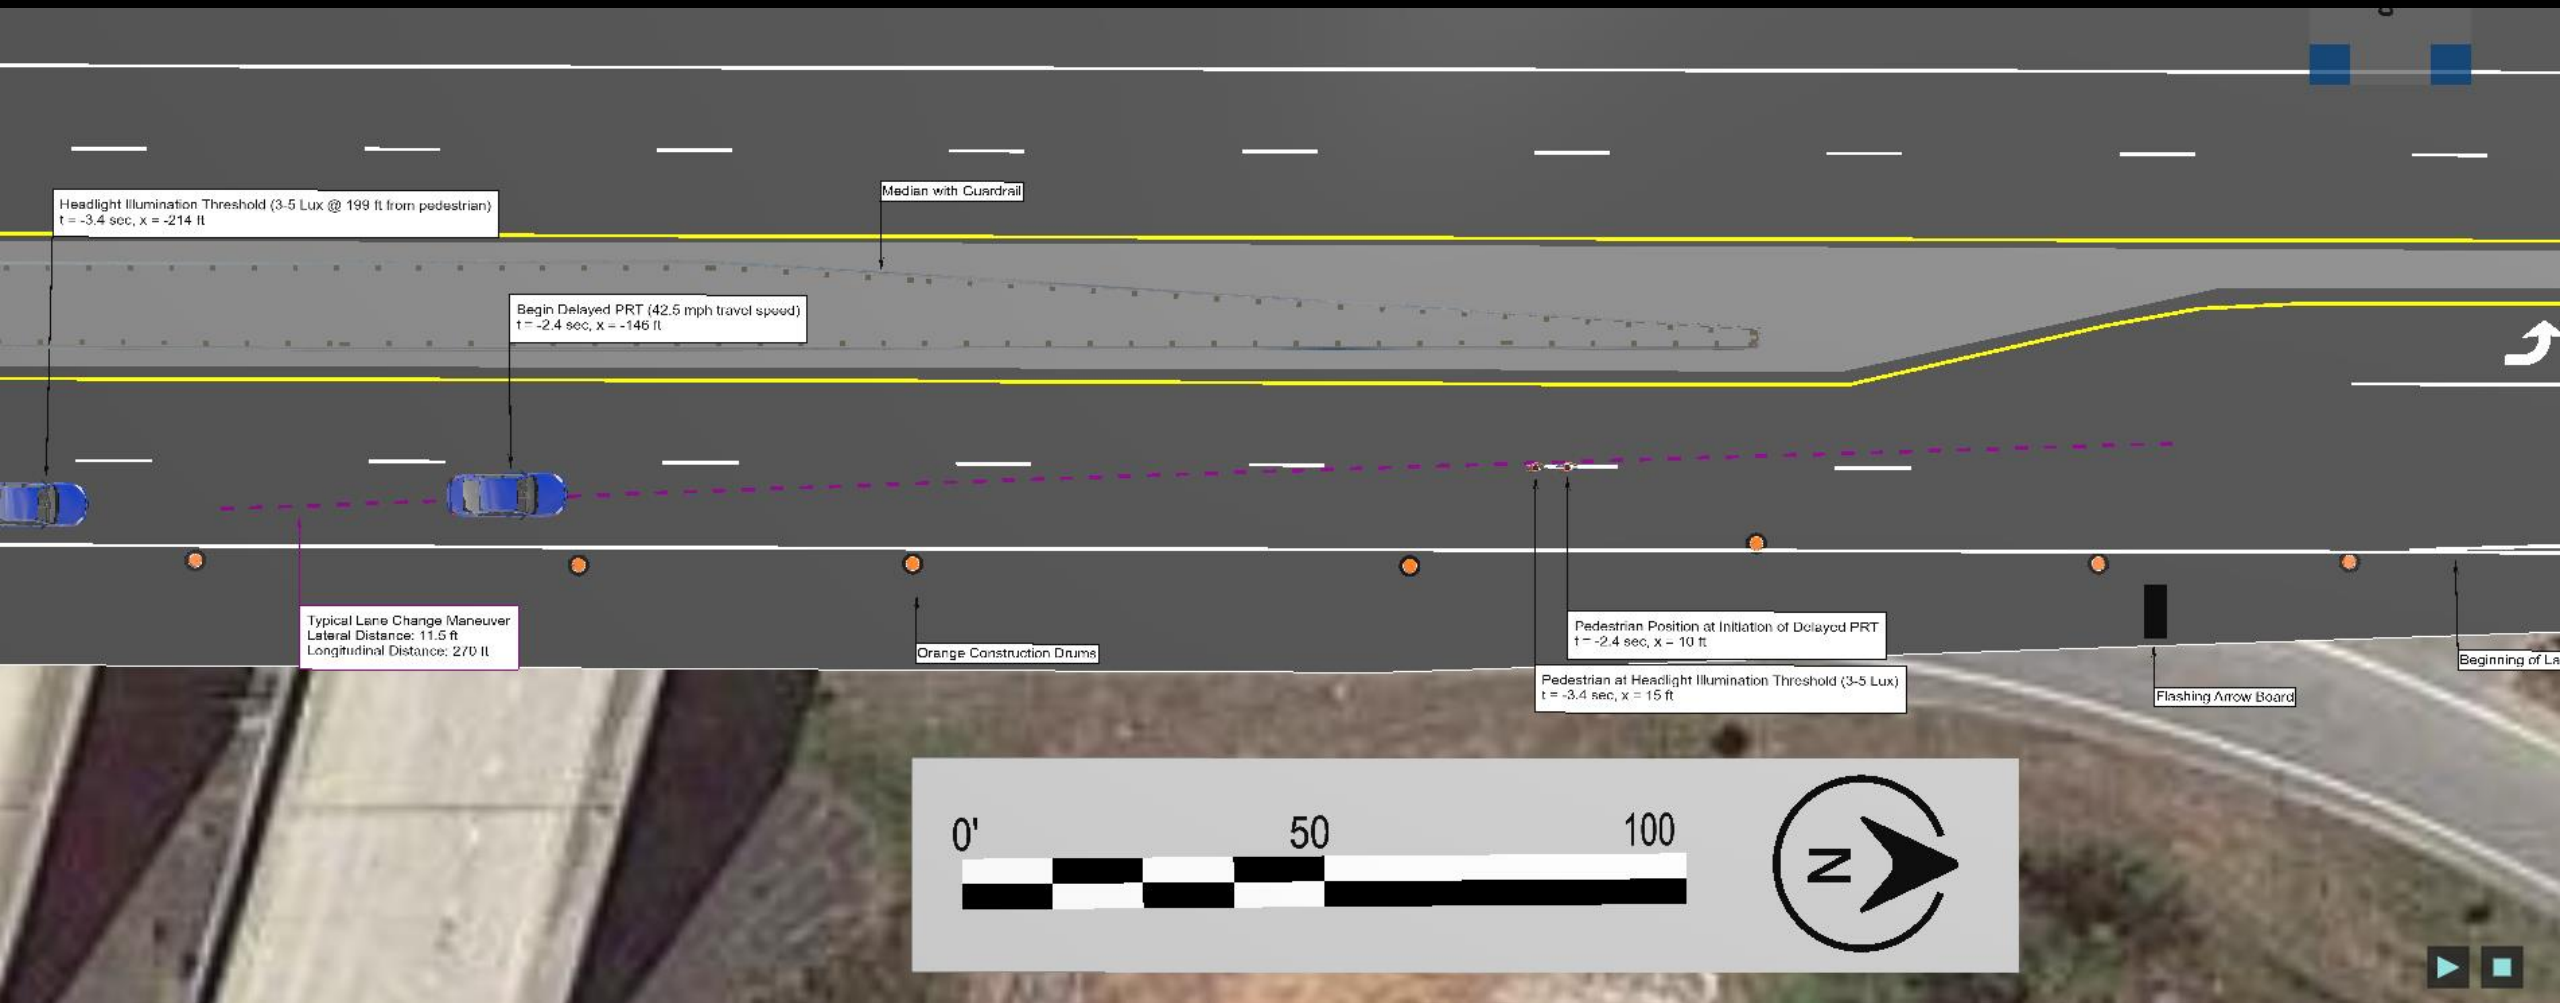
Reconstruction Hypothetical

- In order to decelerate from 42.5 mph to an impact speed of approximately 35 mph, the driver would've began to see and detect the pedestrian approximately 1.0 seconds after the pedestrian was detectable within the vehicle's headlight beams.

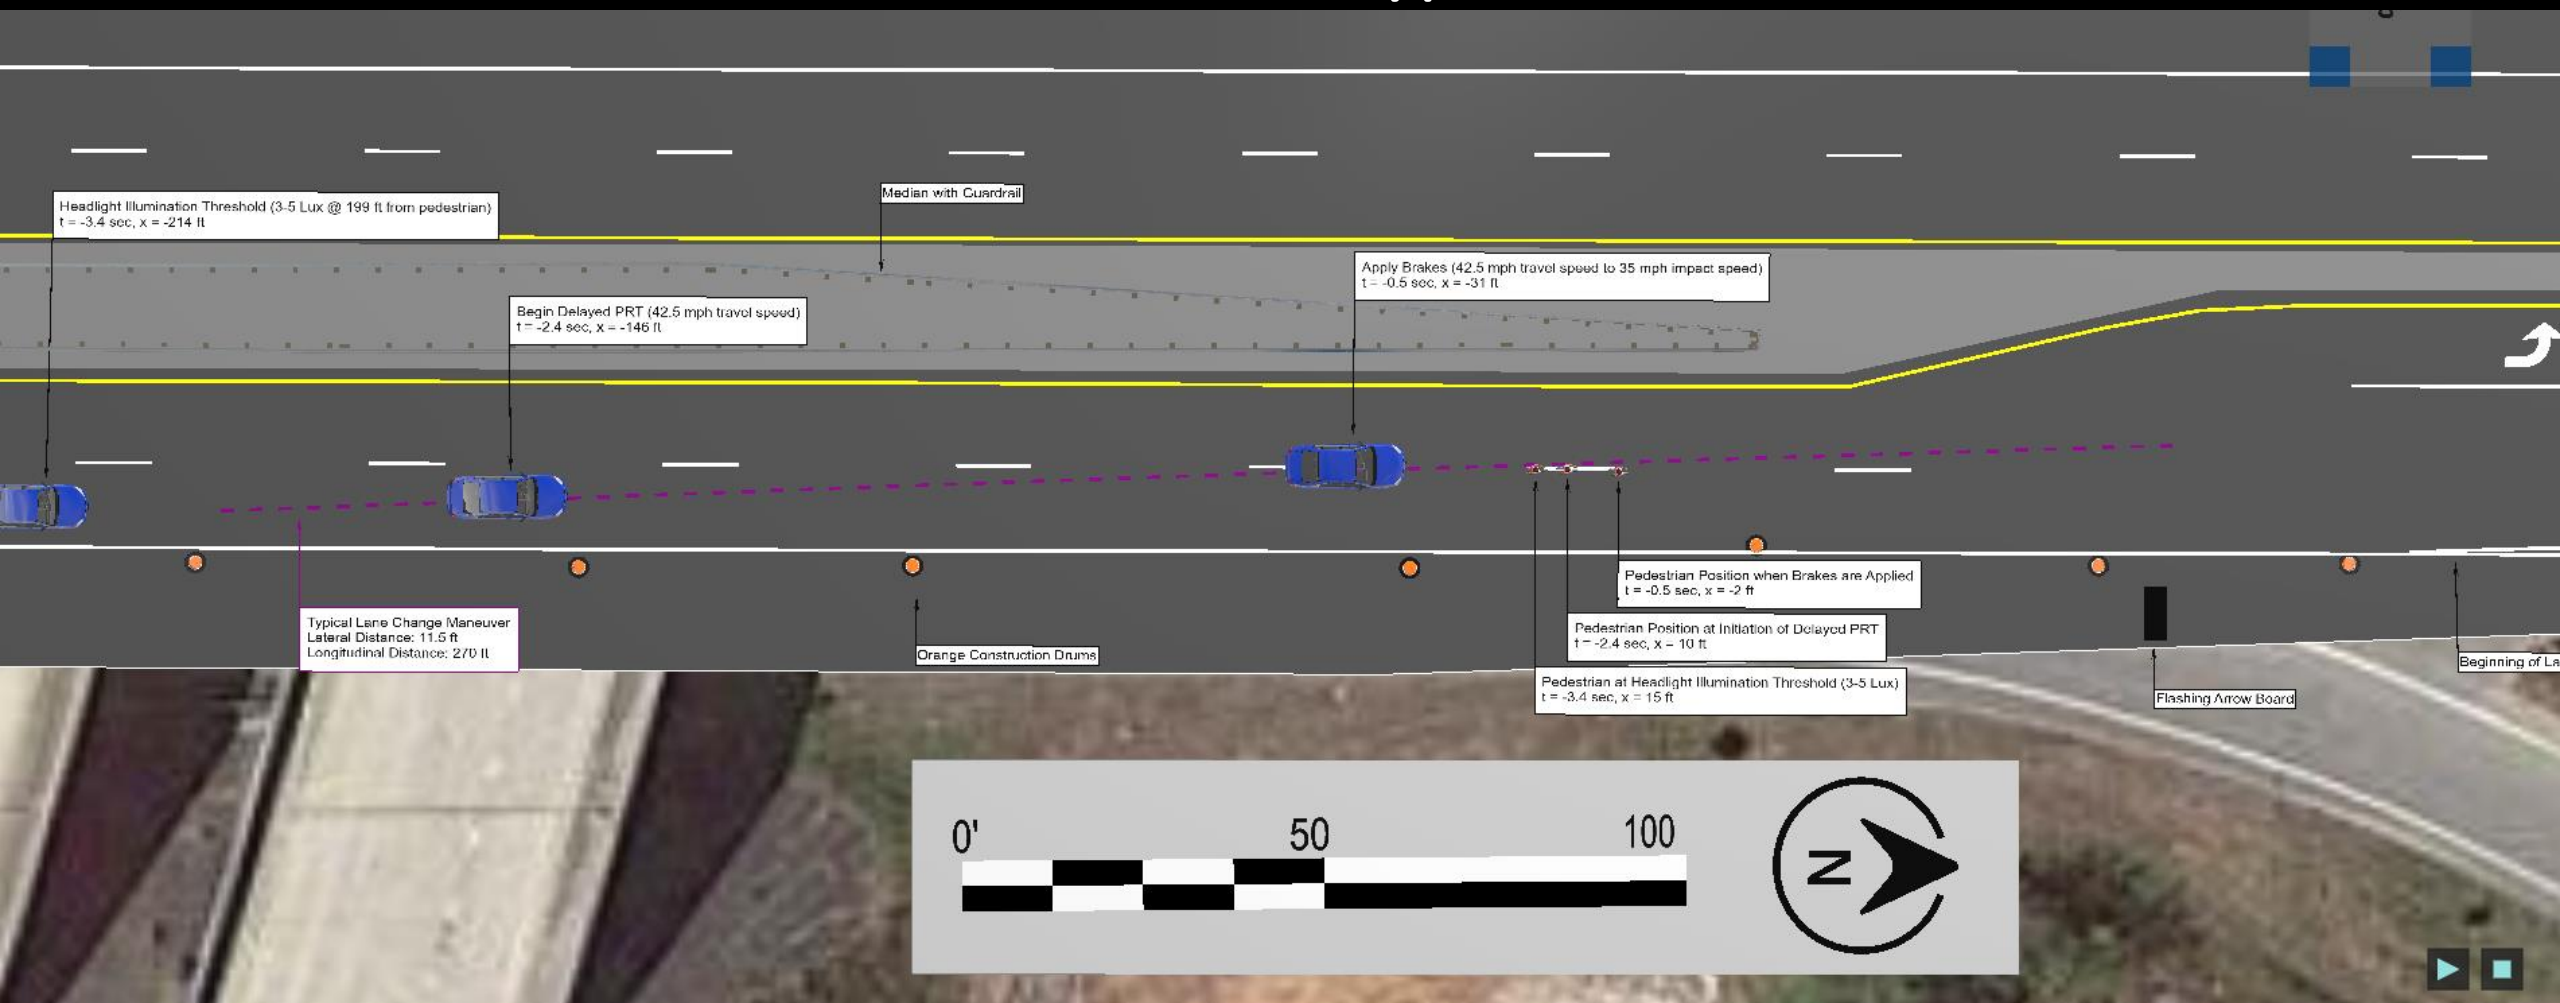
Reconstruction Hypothetical

- Driver would've began braking approximately 0.5 seconds prior to impact to reach an impact speed of 35 mph.

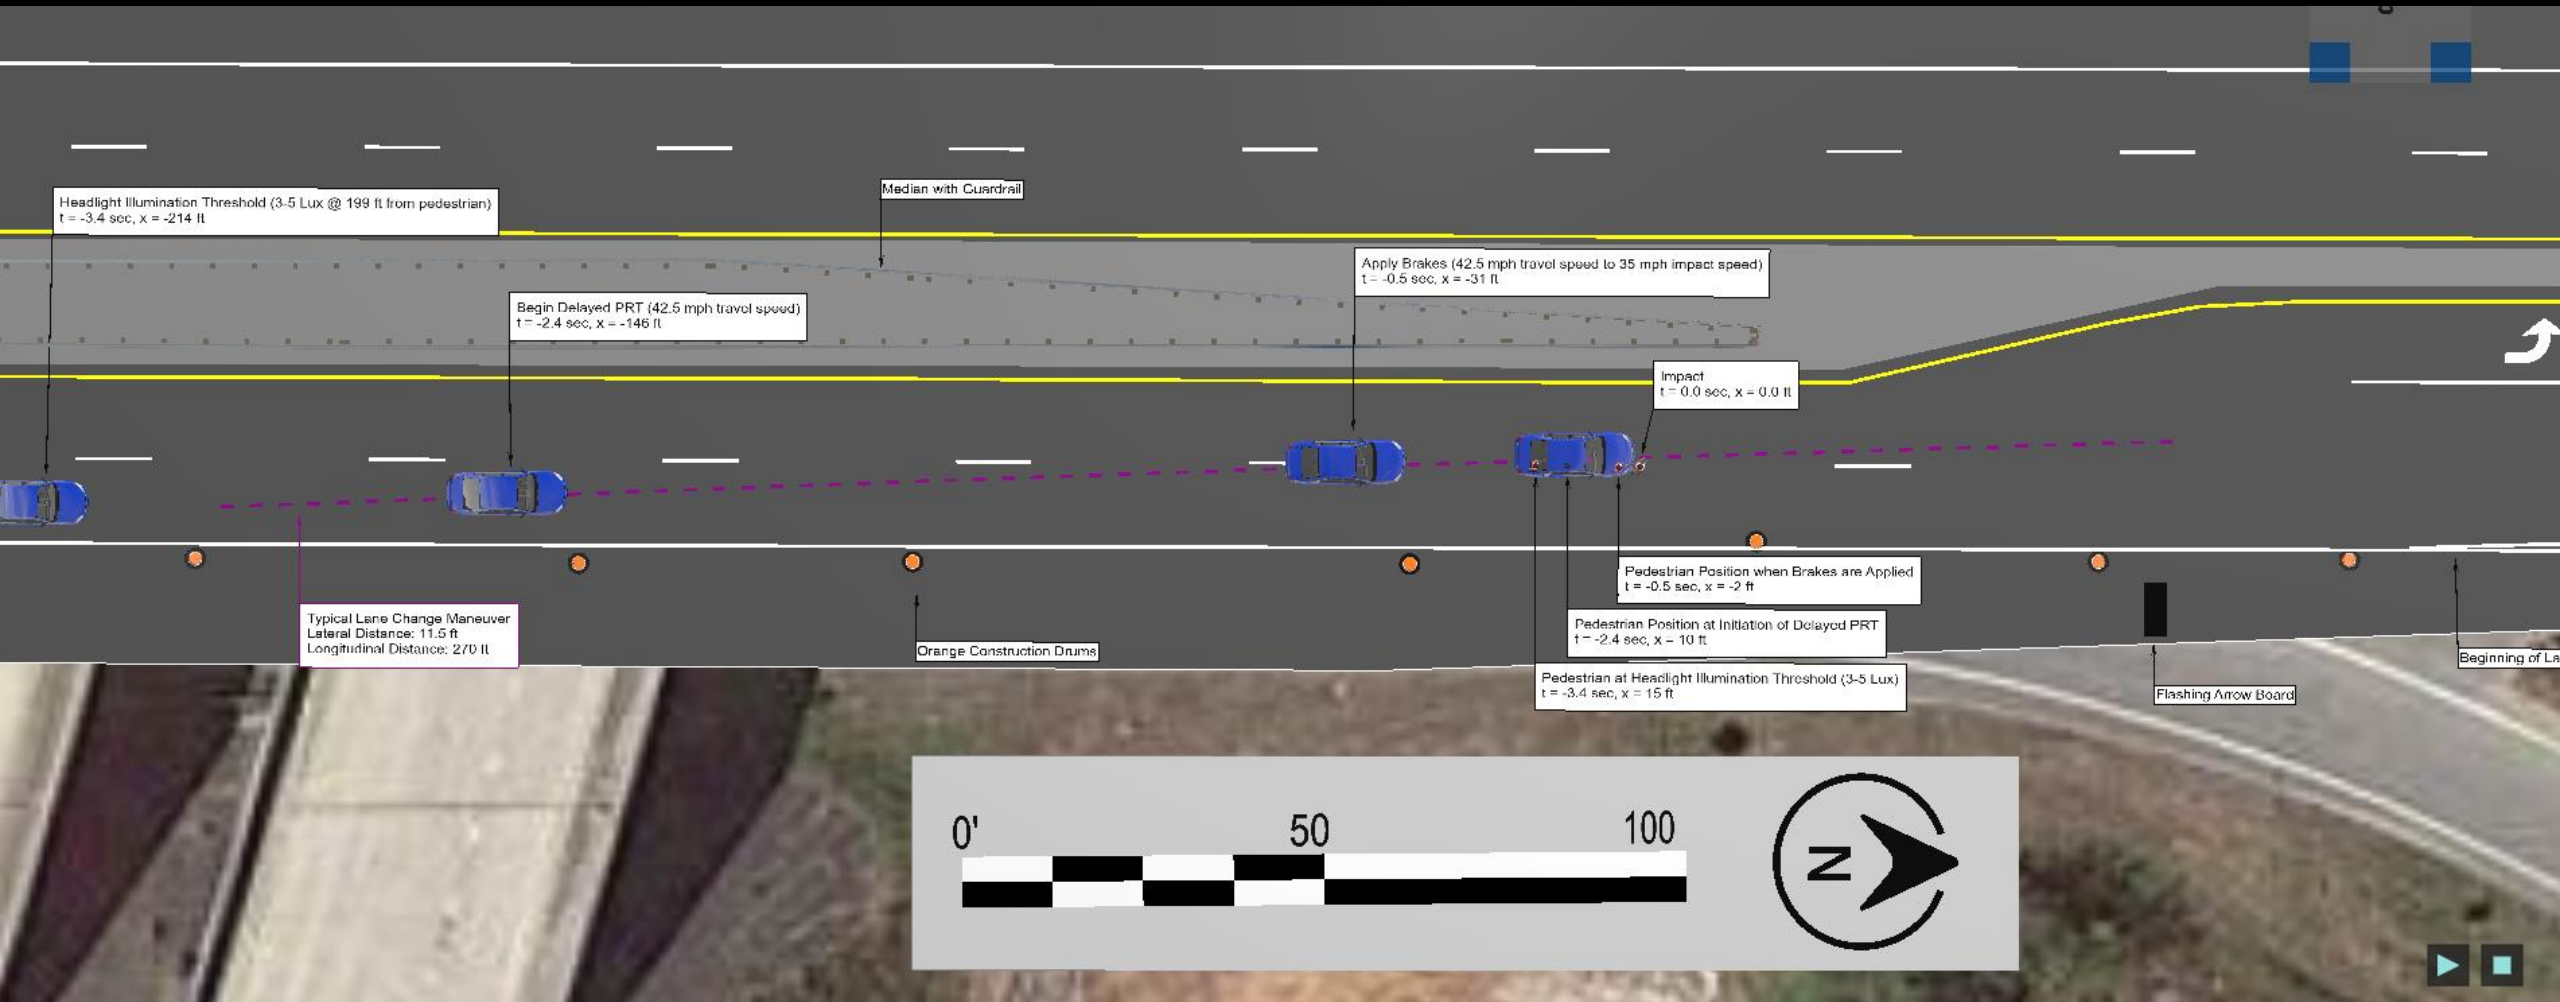
Reconstruction Hypothetical

- Impact would've occurred at the same location and speed as the previous analysis.

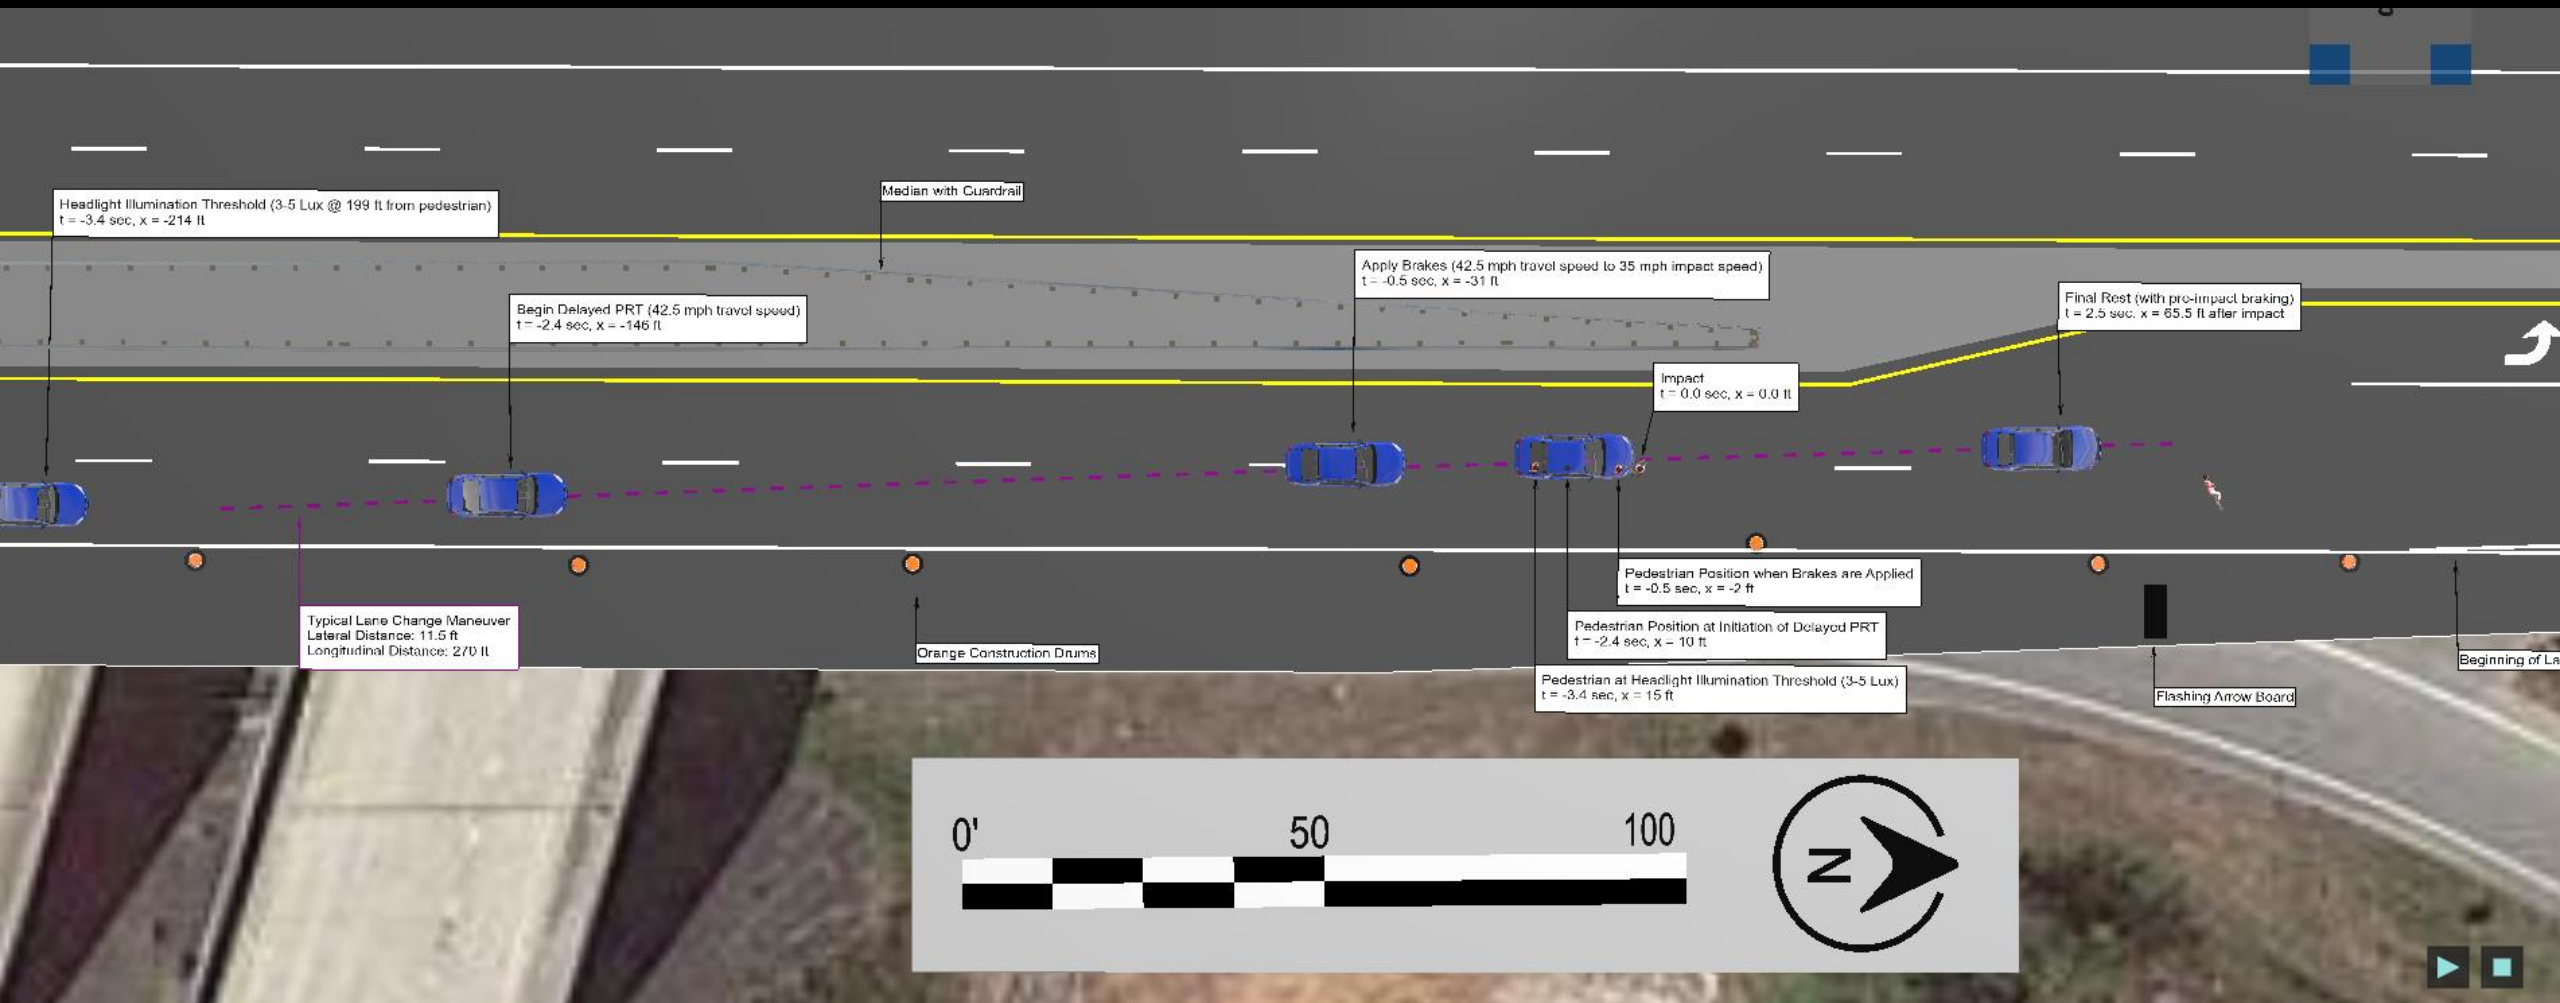
Reconstruction Hypothetical

- A typical, unimpaired driver would continue to apply the same level of braking and be at a complete stop approximately 65.5 ft after impact.
