Crash Reconstruction and Transportation Engineering Analysis

40-12724 (State v. Norris)

Kelly Palframan, Ph.D., P.E.

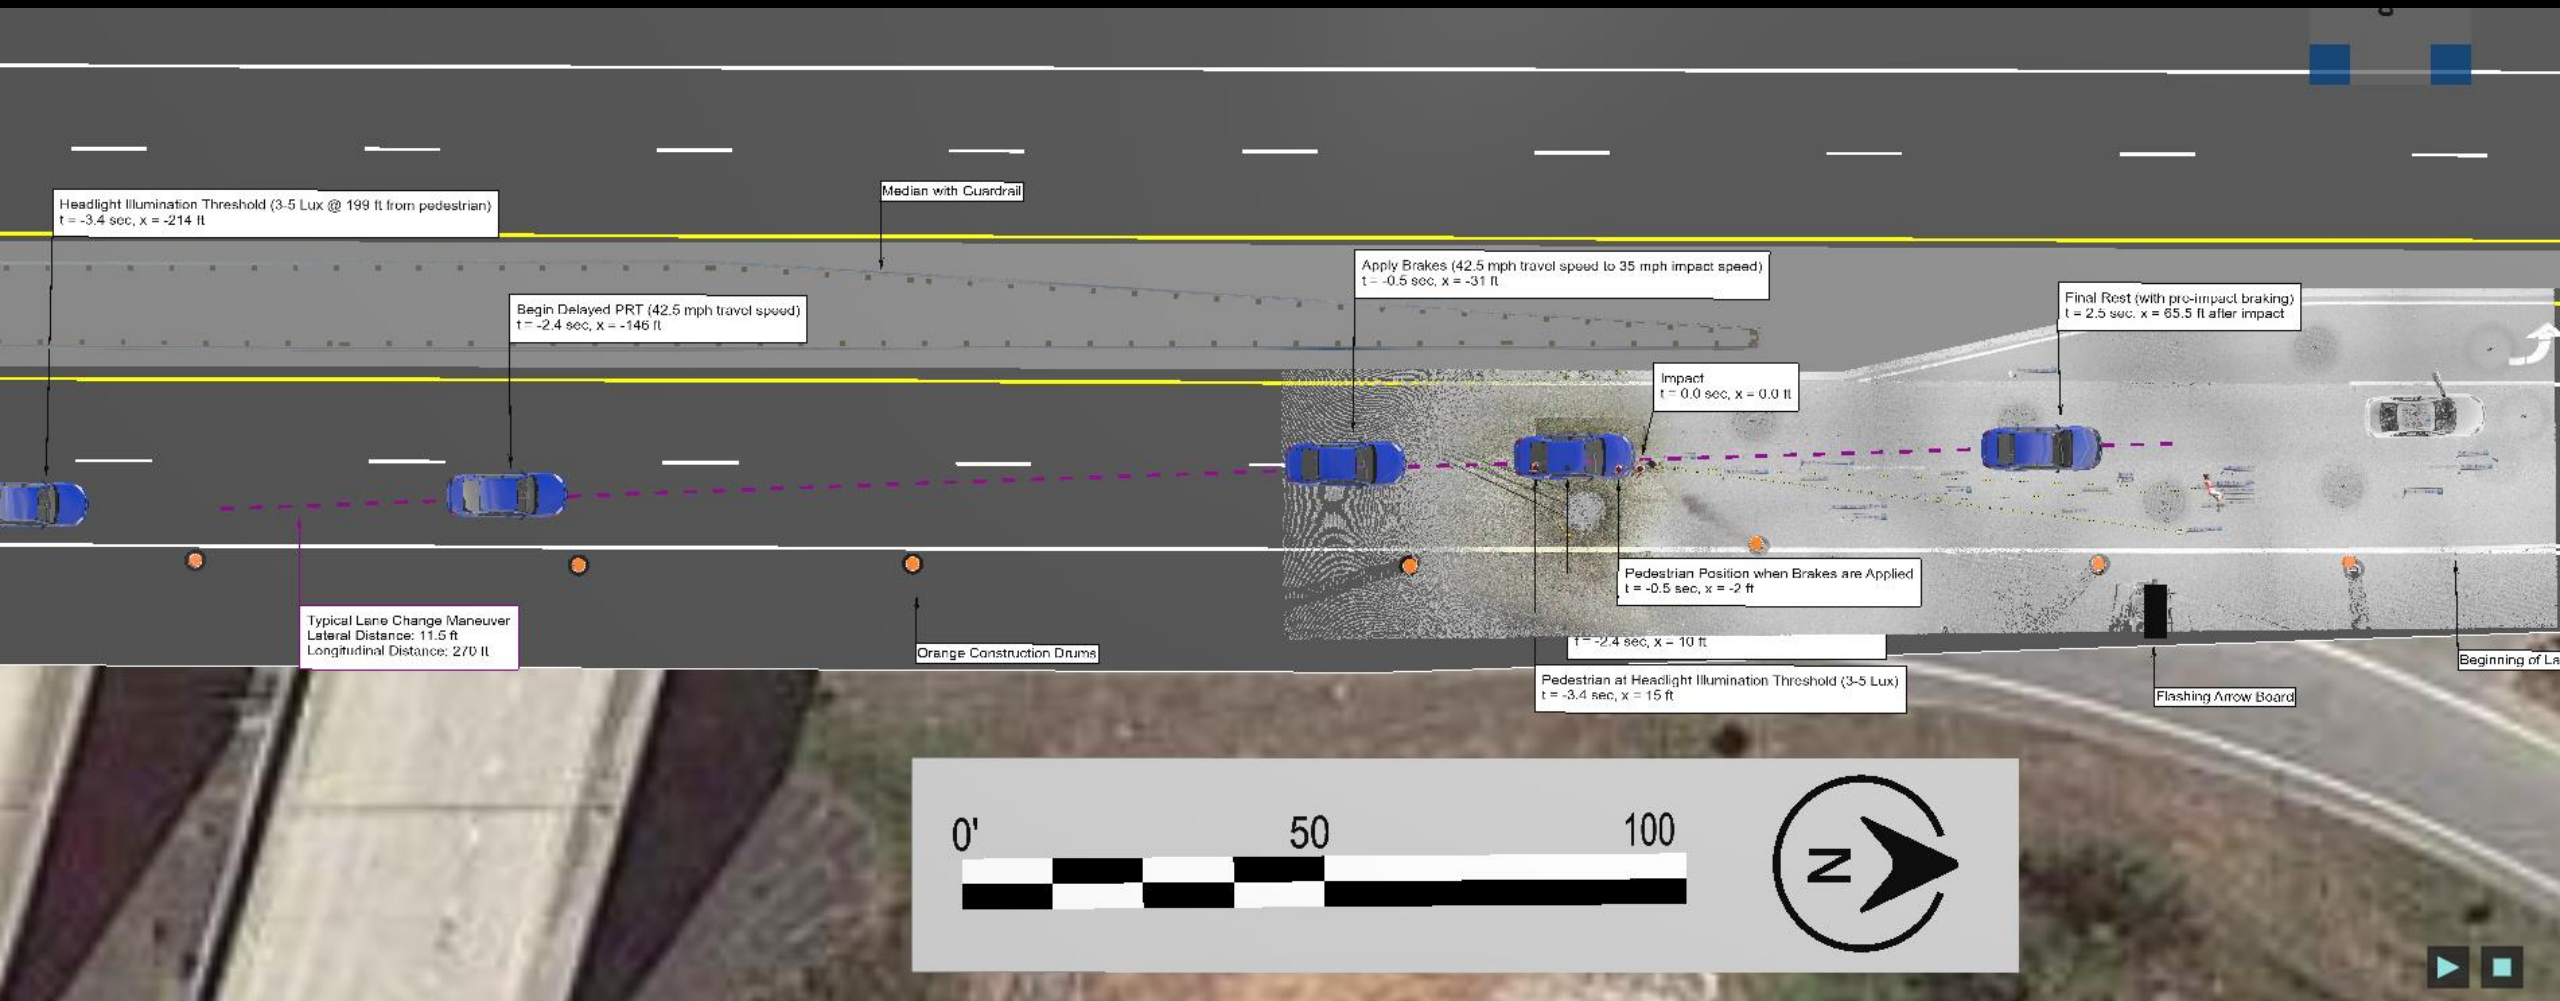
Reconstruction Hypothetical

- The documented stopped position of Ms. Norris's vehicle is further downstream than would be expected for a driver who was constantly braking for at least 0.5 seconds prior to impact.

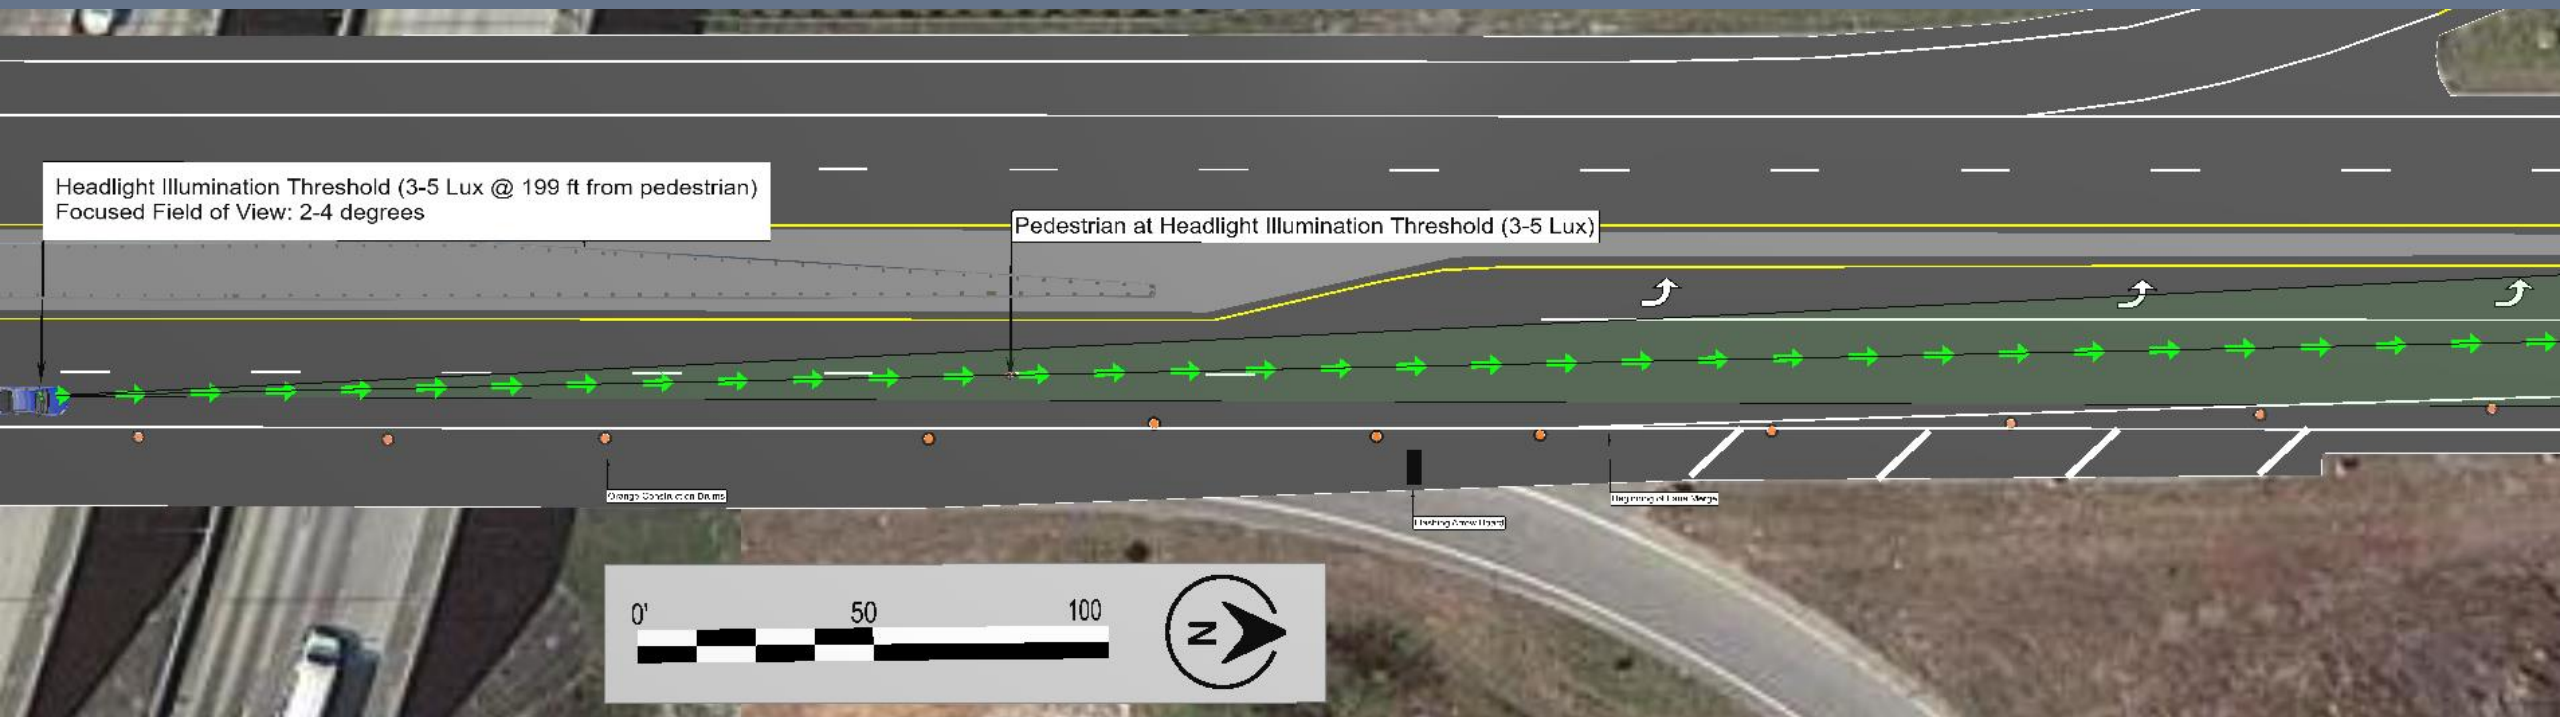
Driver's Field of View

- Given a typical field of view of 2-4 degrees,
 - The pedestrian was centered within the field of view at the time she was detectable.
 - The orange construction drums were laterally and longitudinally distanced from the pedestrian, and outside of the driver's field of view by over 500 ft.
 - The presence of the orange construction drums had a negligible effect on the pedestrian's detectability.
